## *St. Croix National Scenic Riverway*

### *Ruins of a Forgotten Highway: Survey and Documentation of Historic Water Control Features*

A product of the National  
Park Service Submerged  
Resources Center

Denver, Colorado  
2015

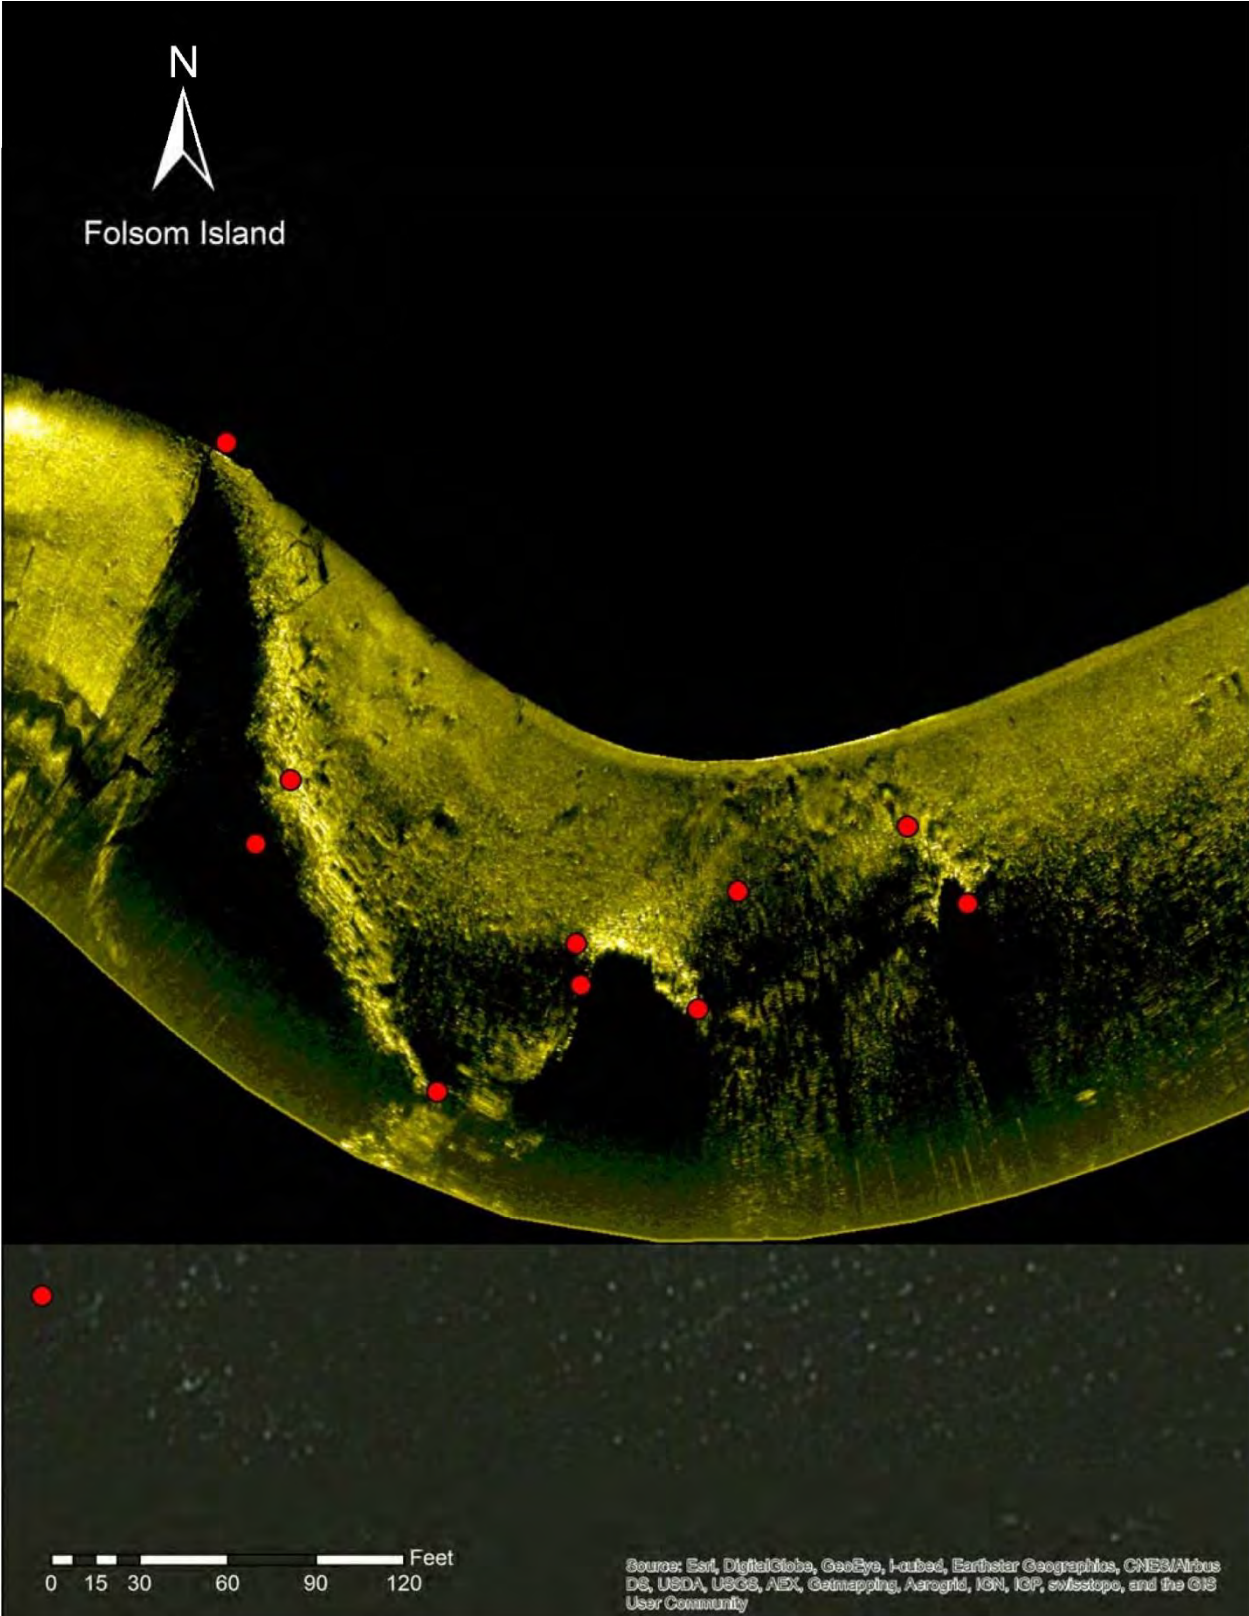
The largest feature on the northern tip of the main island was identified as the remains of a closing dam (Figure 12). The 1937 USACE river survey referenced this dam as an existing structure, also shown on the overlay aerial map in Figure 7. The second closing dam at the southern end of the island also appears on the 1937 USACE map. Sonar survey found two rock piles in this area, but they were not as linear and coherent as the northern closing dam (Figure 13). Nonetheless, we believe the rock piles are remnants of the closing dam depicted in the historical documents. Both original and actual GPS locations for the southern features remain on the maps below, but are also identified in detail in the GPS files, GIS attribute table, and Excel findings spreadsheet.

FIGURE 12. Side scan image of the northern section of Folsom Island taken in 2015.

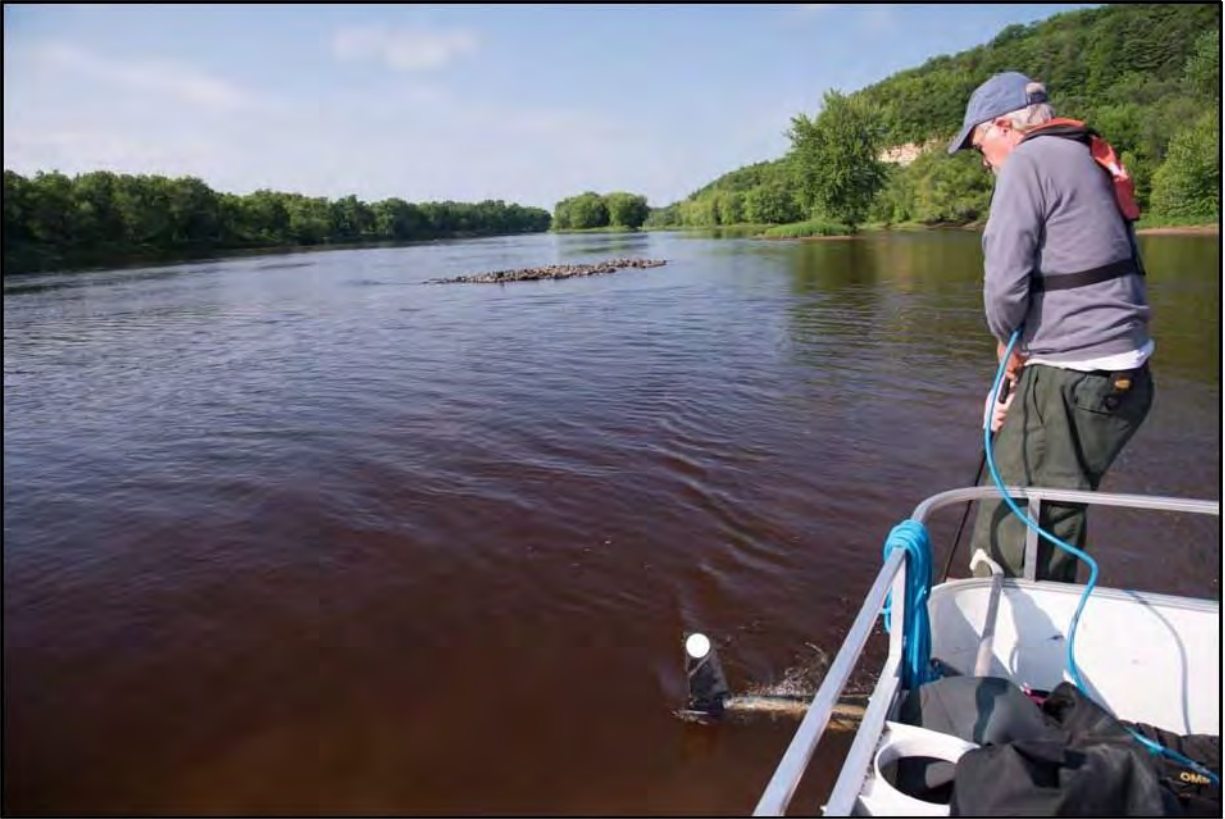
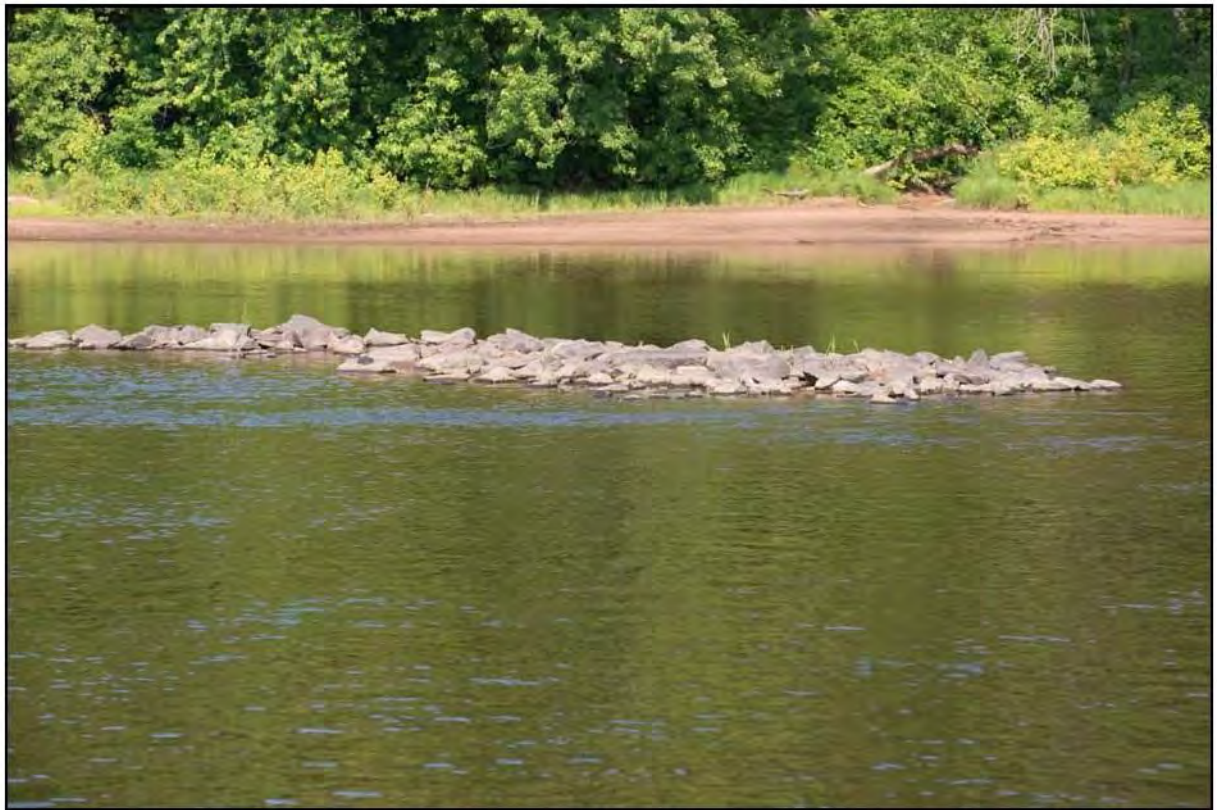
Towards the end of the project, water levels dropped and sections of the rock piles above the island broke the river's surface (Figures 19 and 20). A fifth rock pile was identified, and appeared to be associated with the other four, though the placement of its rocks differed from the other piles (possibly due to original construction or modern visitor manipulation). Nevertheless, its location and size were documented. These features may have been constructed out of a foundation from an old local French fort, though we noted no evidence of this on the site (Jean Schaeppi-Anderson 2015, pers. comm.).

FIGURES 19 and 20. Clark Island field photos.

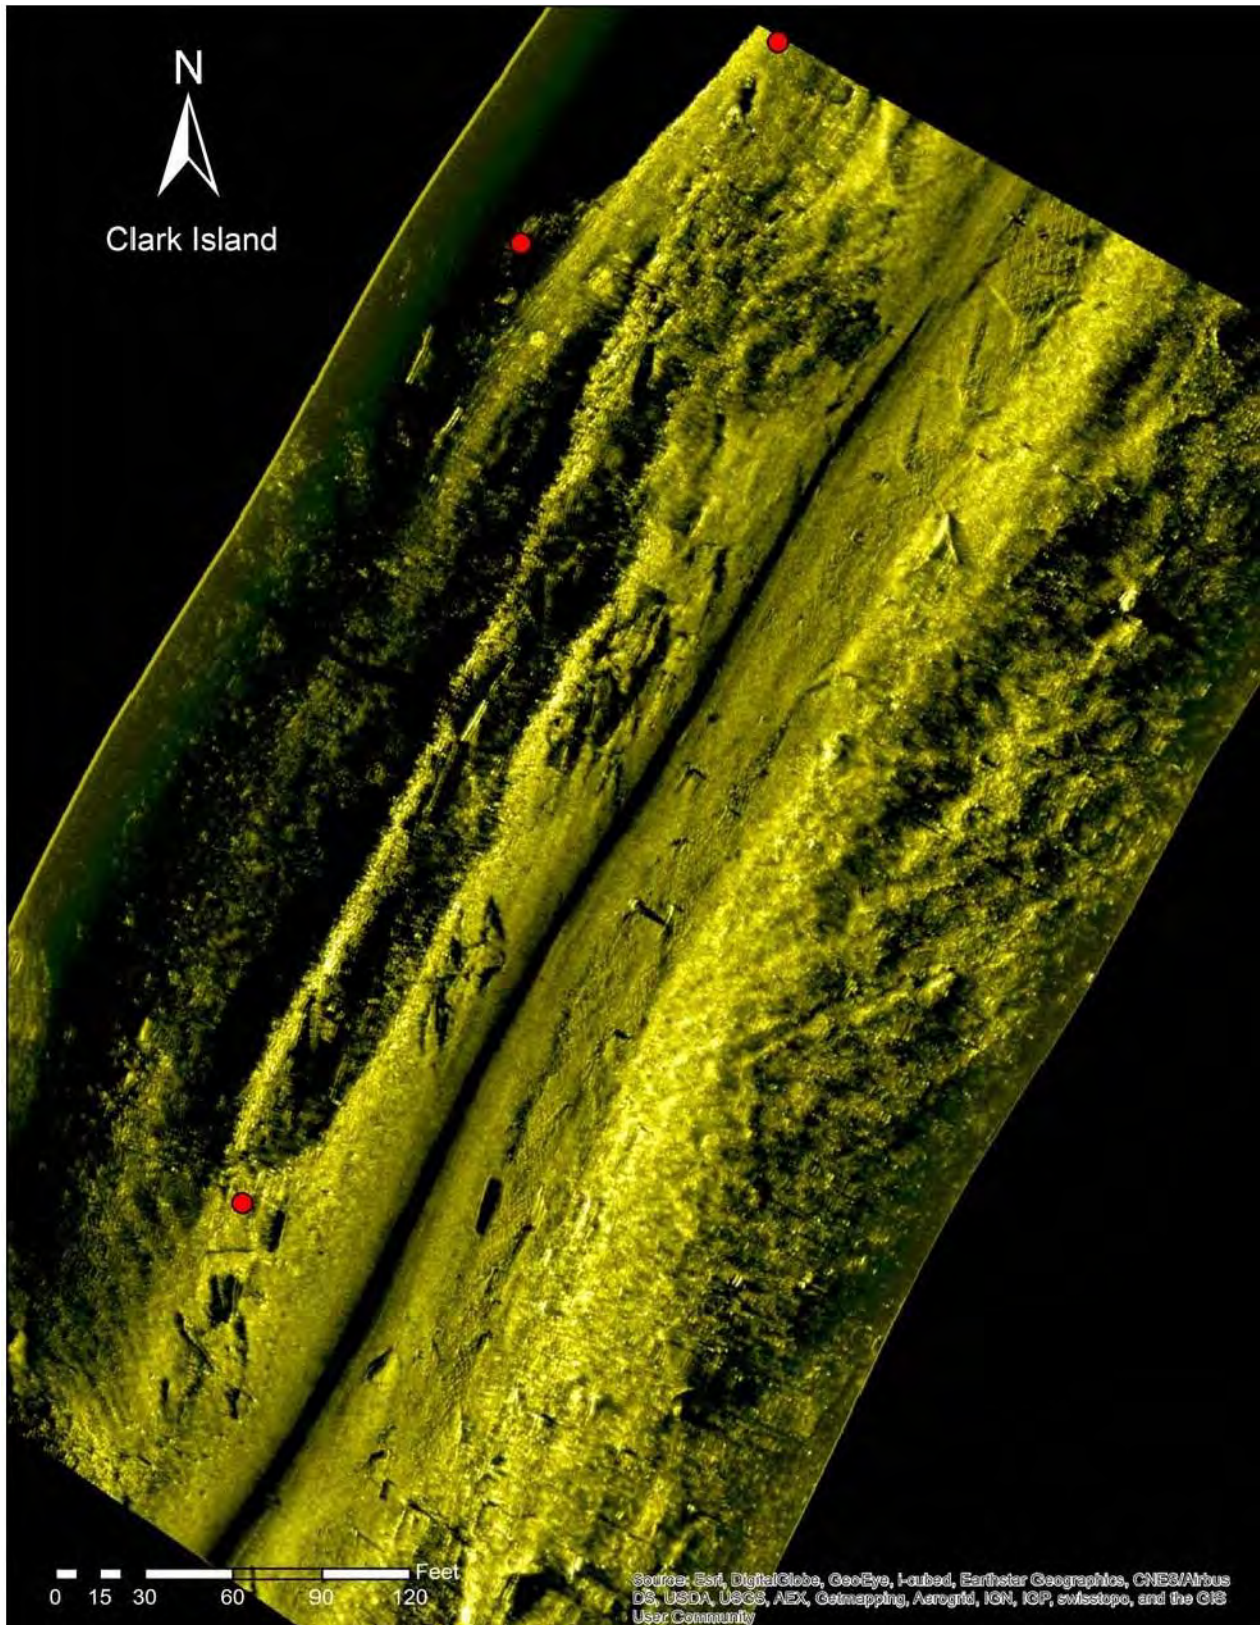
The final feature identified was a very large wing dam, approximately 400 feet in length, located at the southern tip of the island and extending to the east (Figure 21). Historical records indicate the dam was constructed on the west side of the island, but due to the island's erosion and position shift over the years, the feature now rests in the main river channel. The structure appears to be very stable and poses a navigational hazard to boaters.

FIGURE 21. Sonar imagery of the southern section of Clark Island showing a large dam.

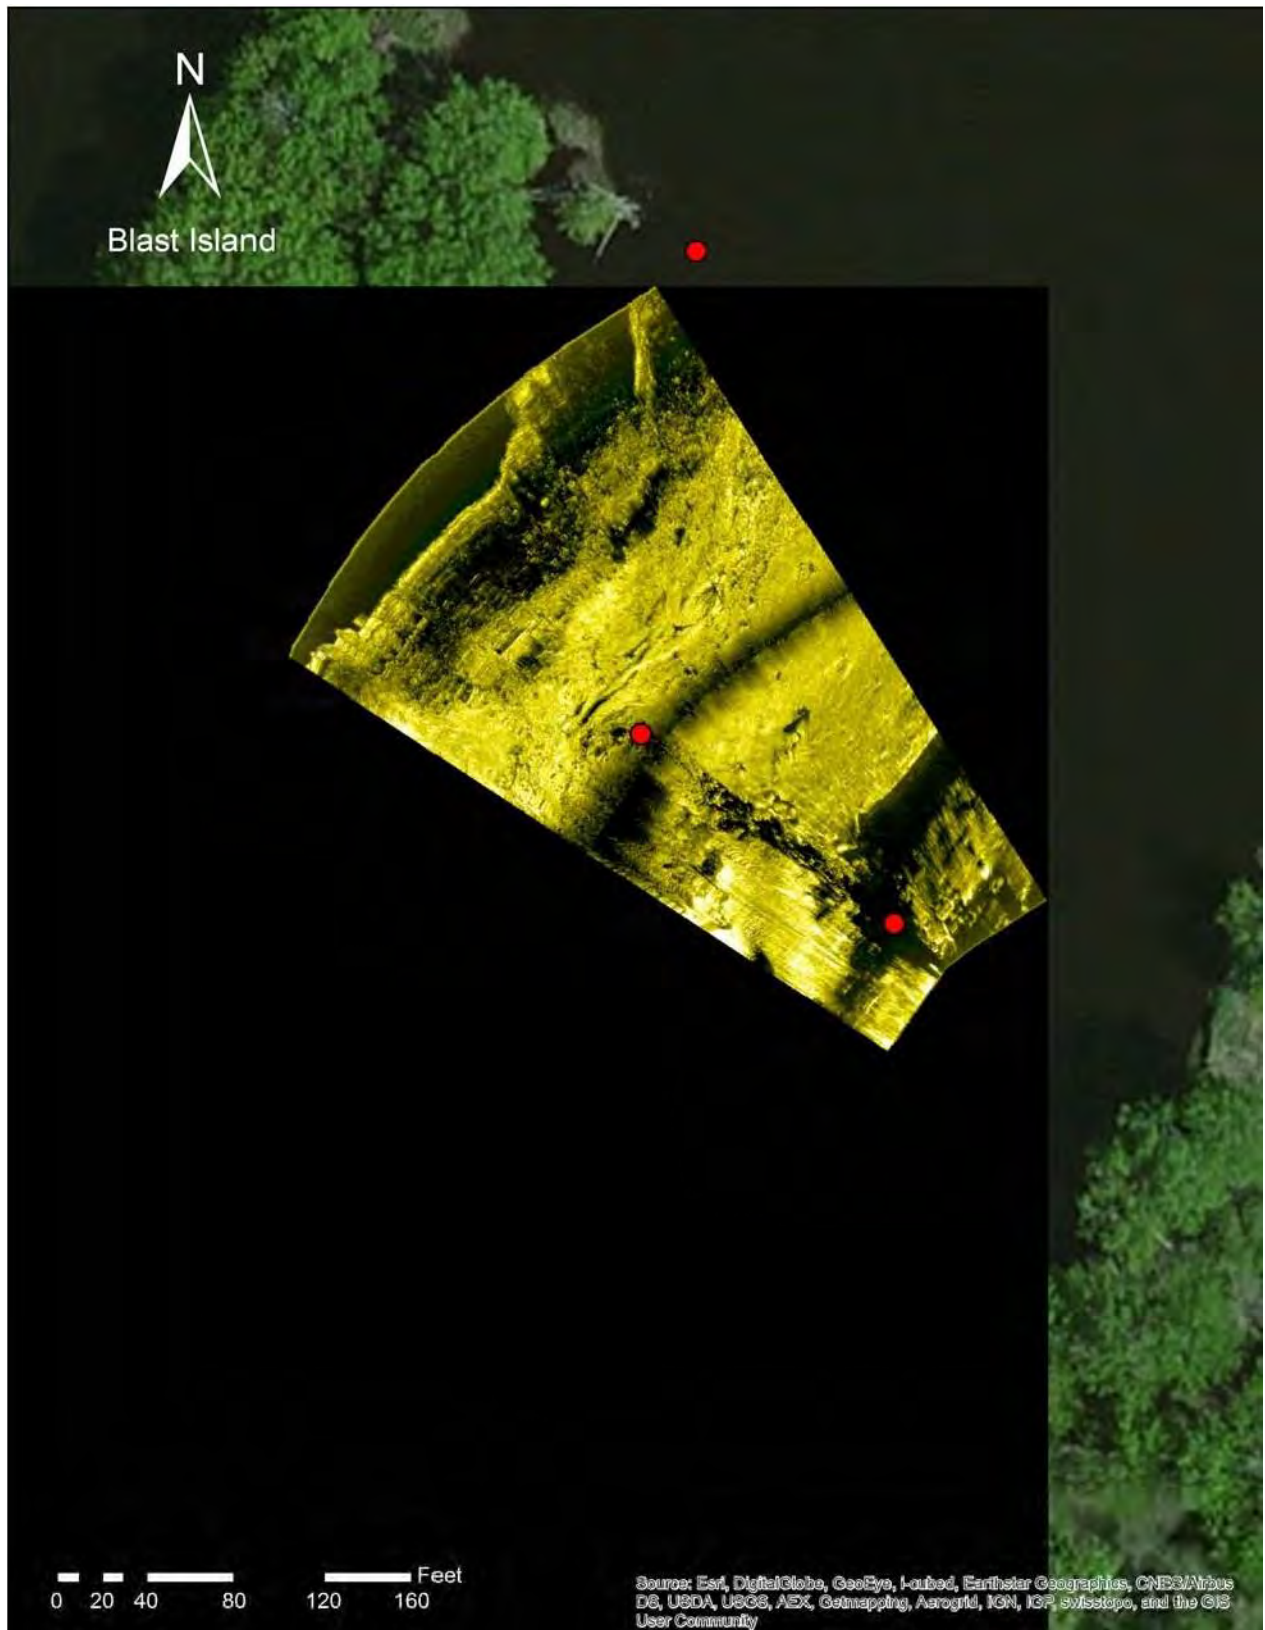
FIGURE 25. Sonar imagery of Blast Island revealing linear rock dam.

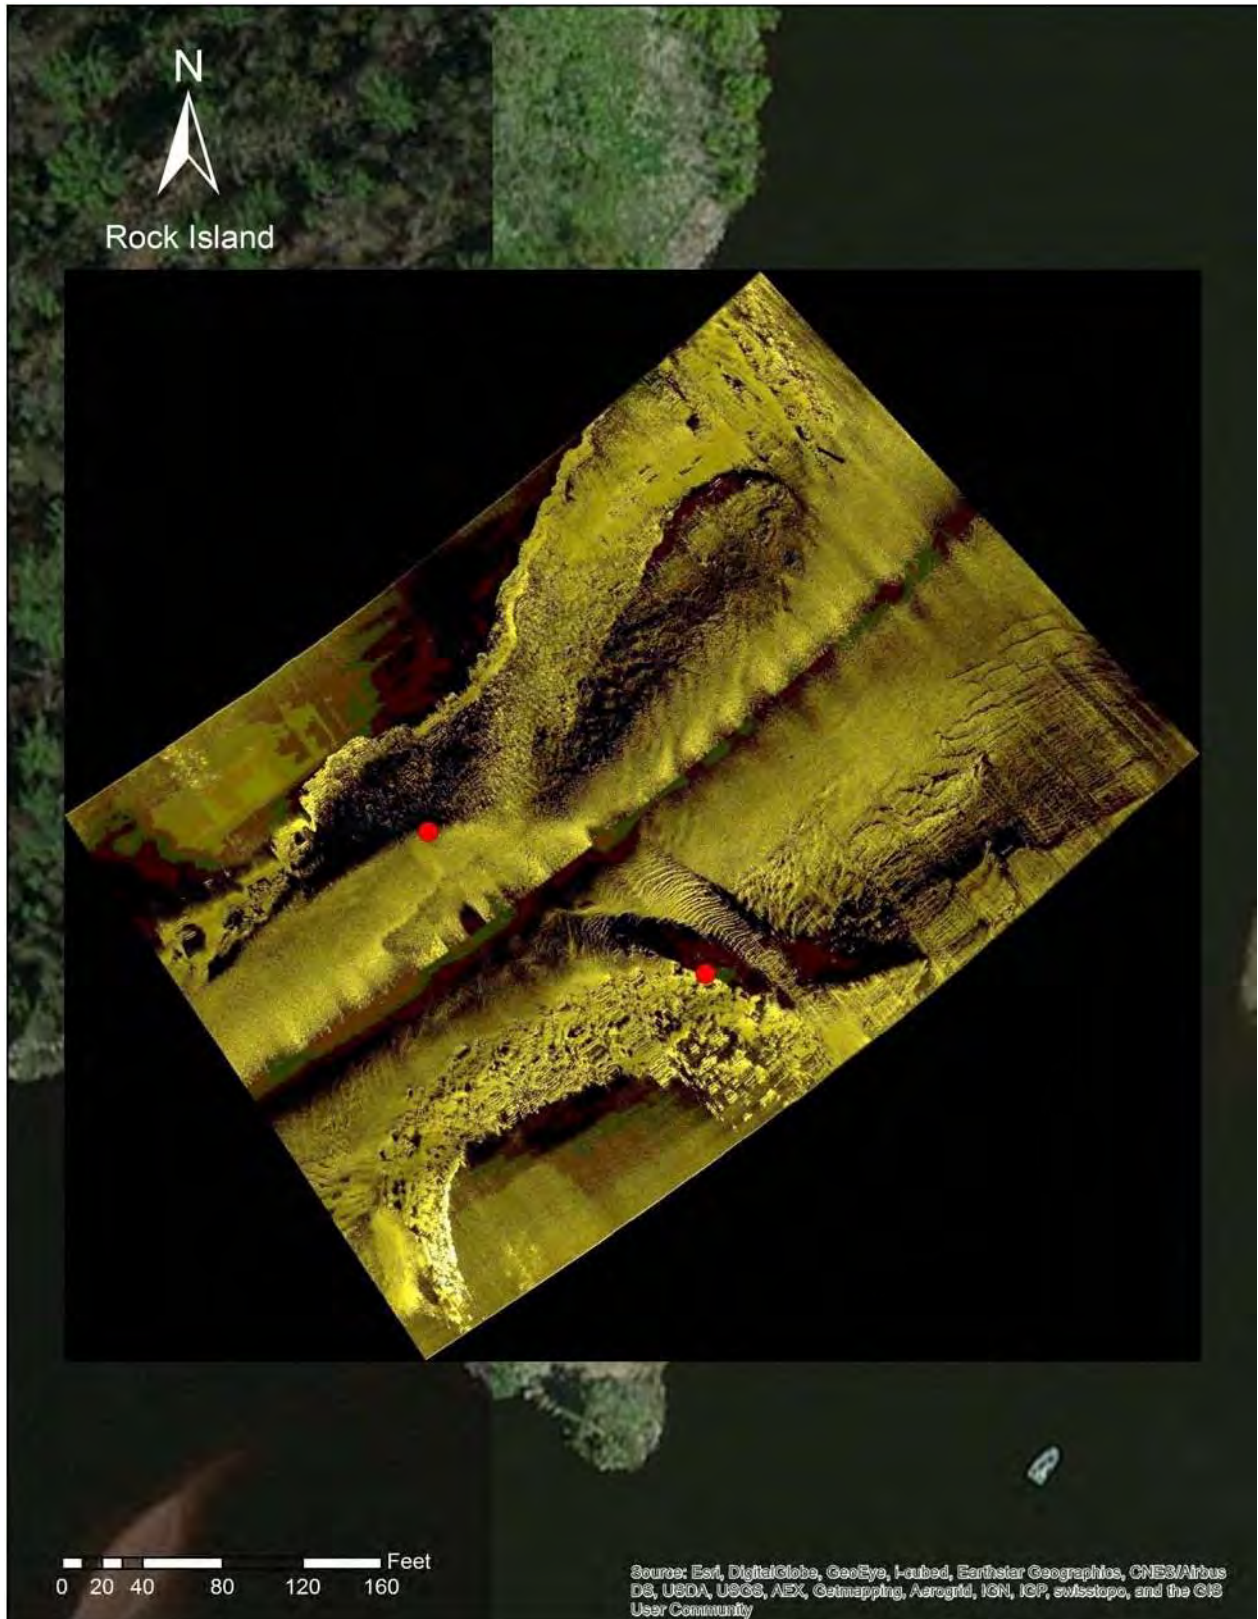
FIGURE 29. Sonar imagery around Rock Island identified as natural rock outcroppings.

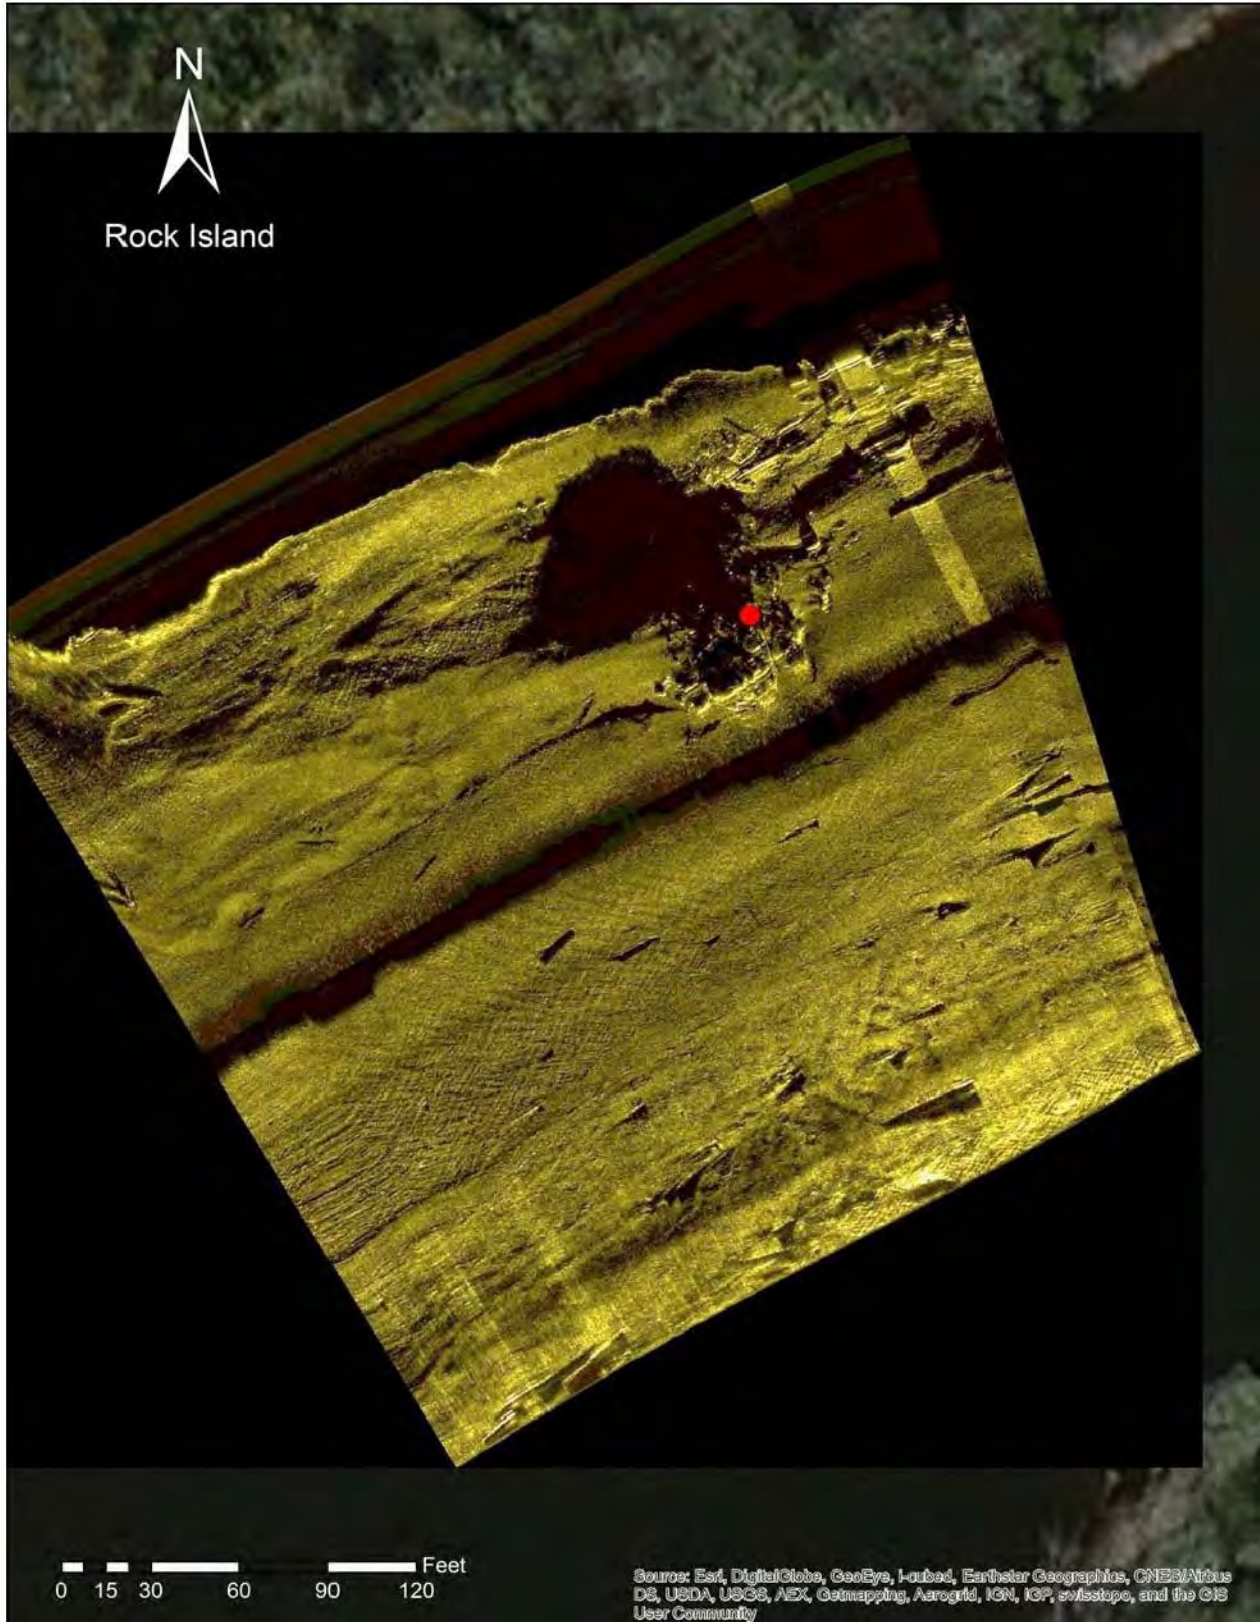
FIGURE 30. Sonar imagery below Rock Island revealing a natural rock outcropping.

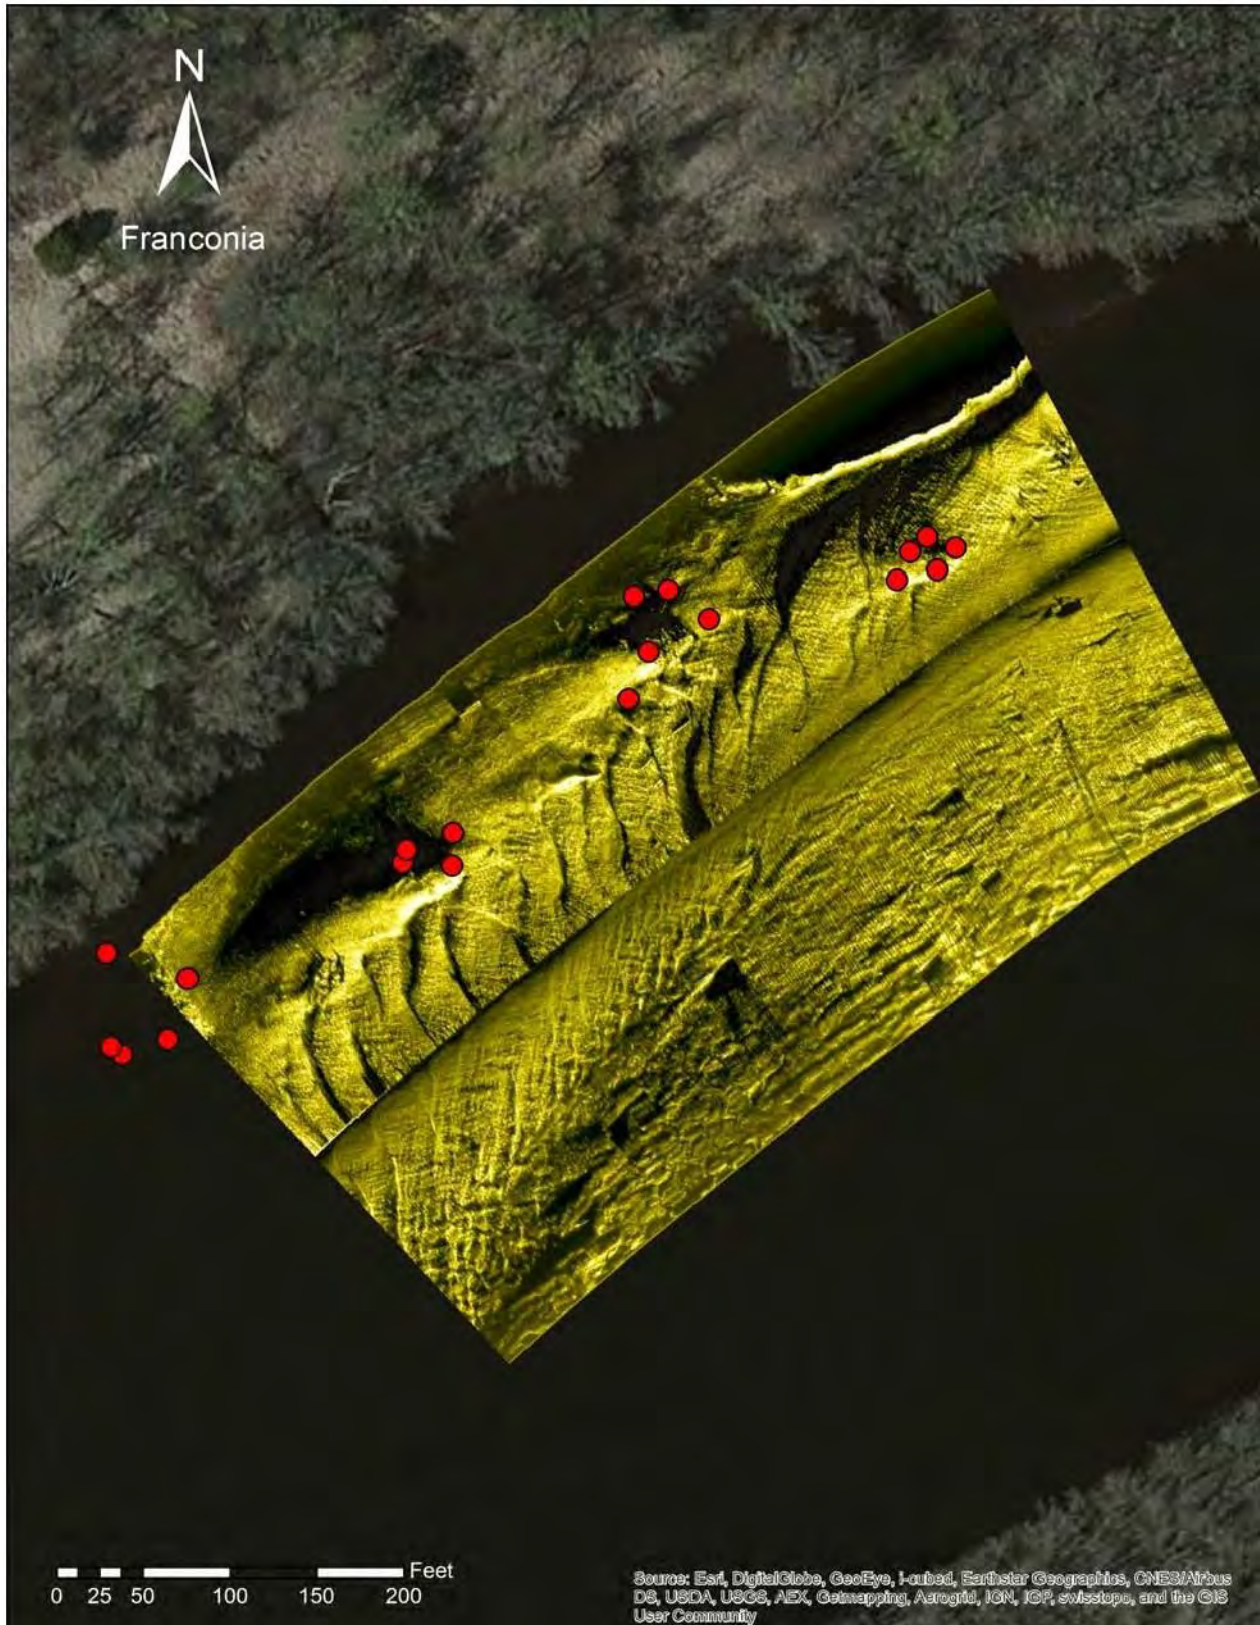
FIGURE 37. Sonar imagery above Franconia Landing at GPS 28 revealing a series of features.

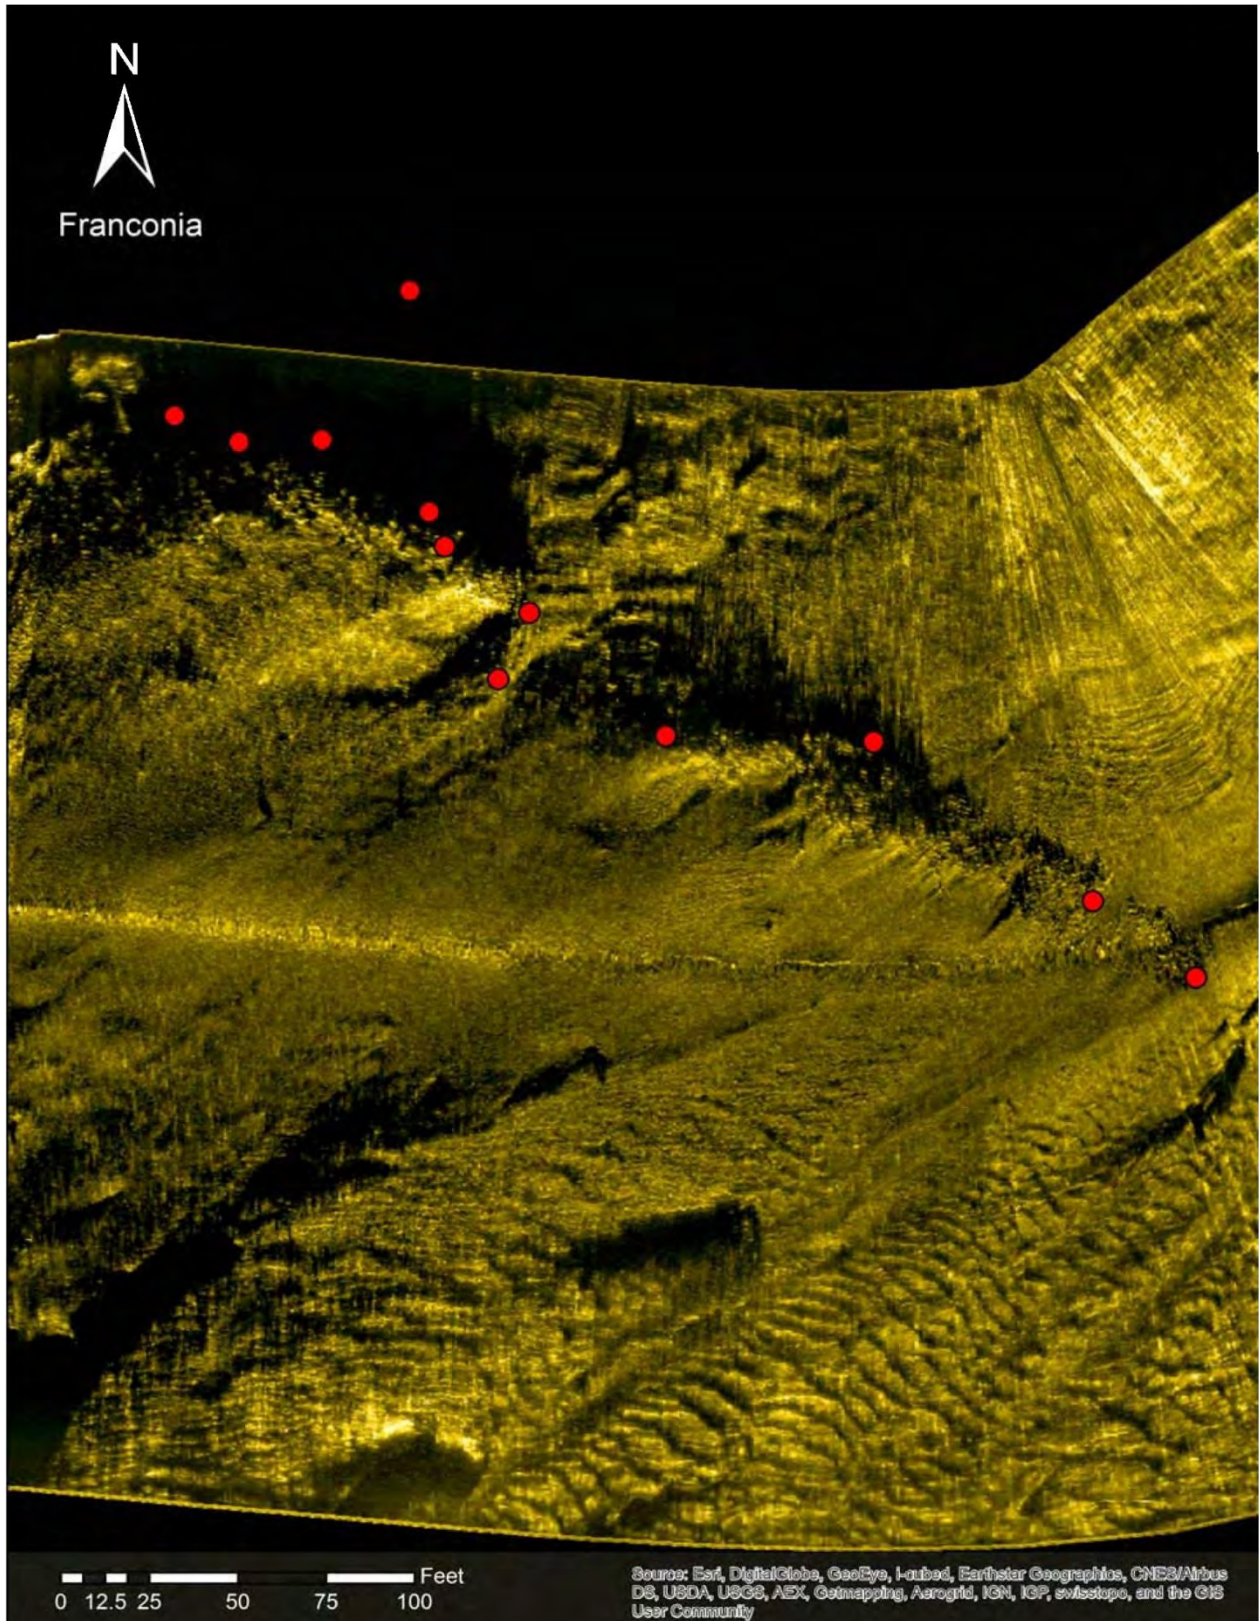
FIGURE 38. Sonar imagery below Franconia Landing at GPS 29 revealing a large wing dam.

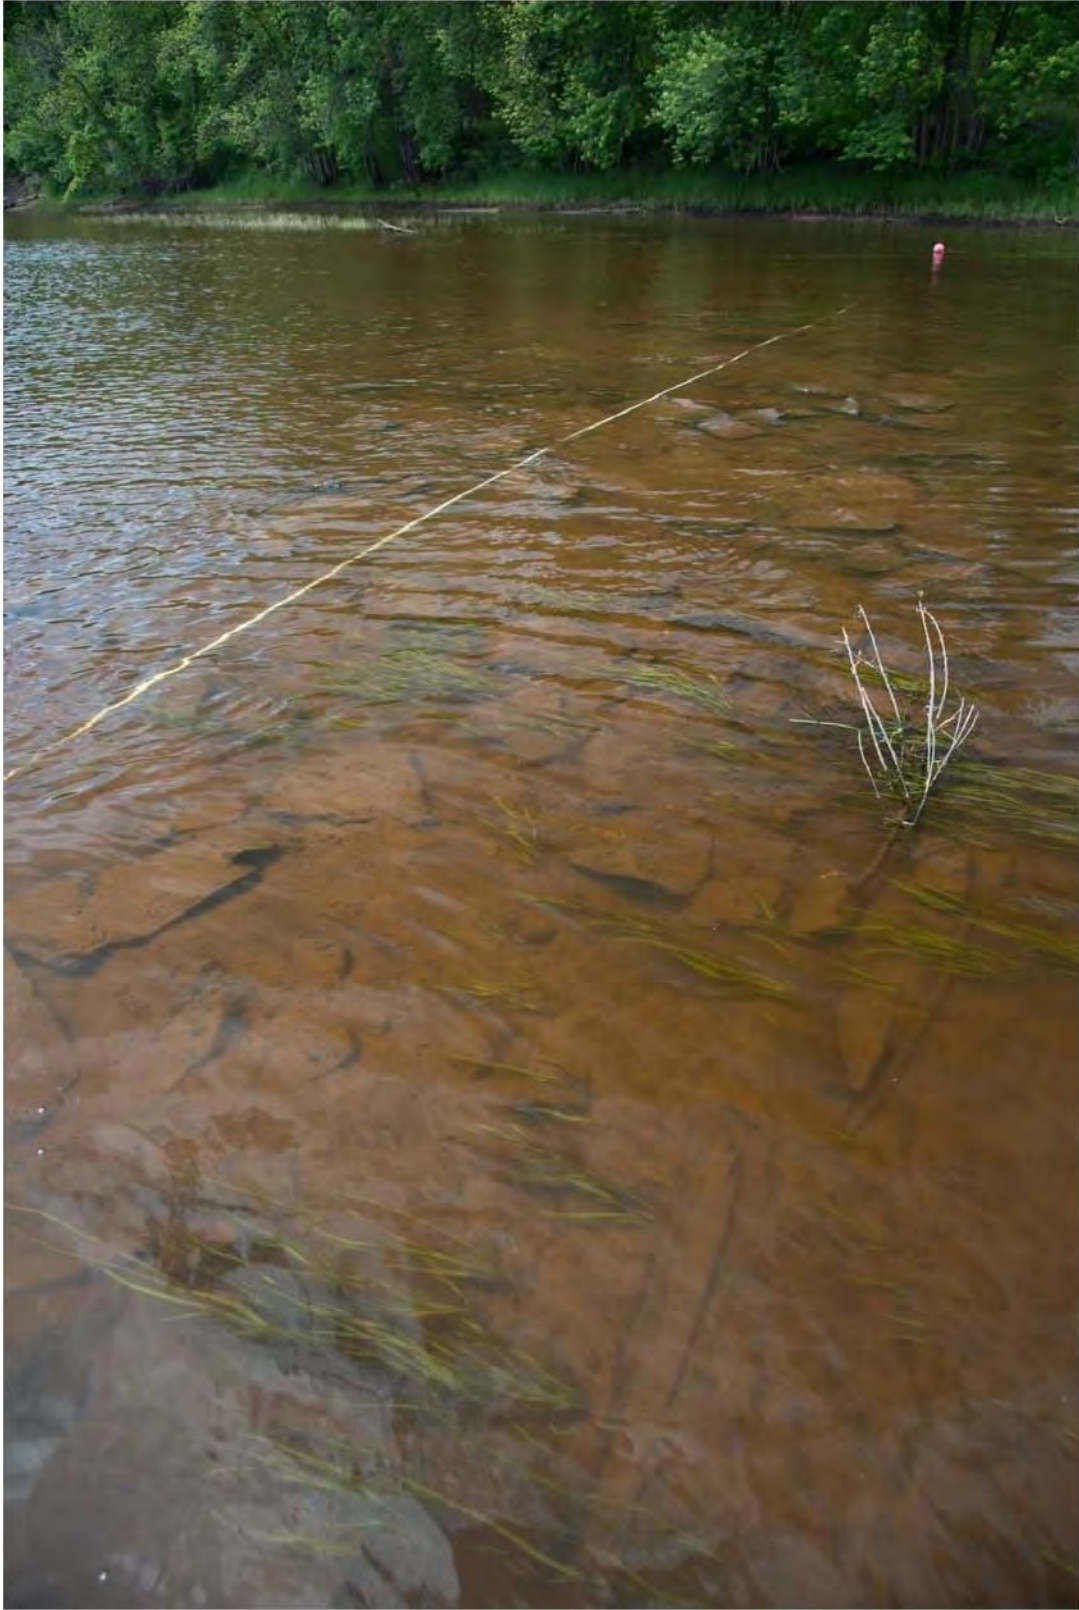
FIGURE 39. An image from GPS 29 showing the large wing dam at Franconia.

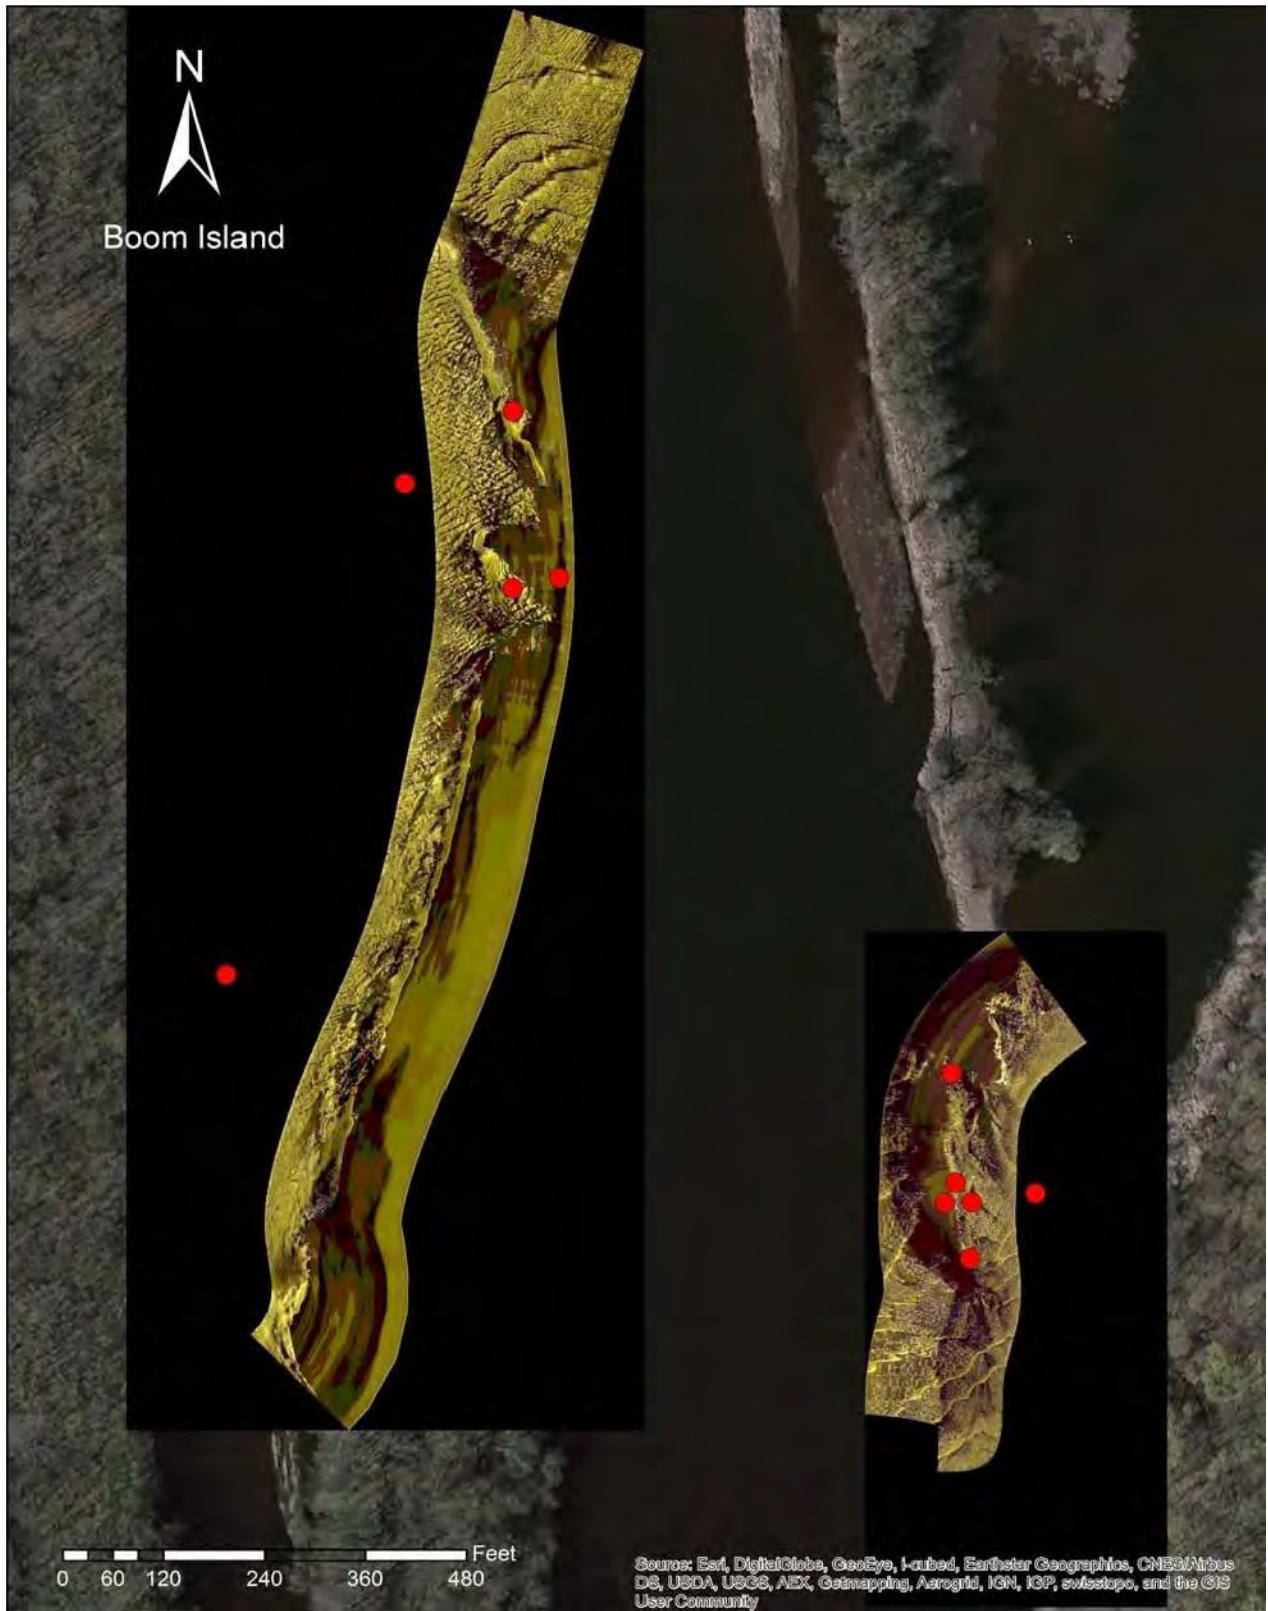
FIGURE 48. A sonar overview of Boom Island showing dams on either side of the river.

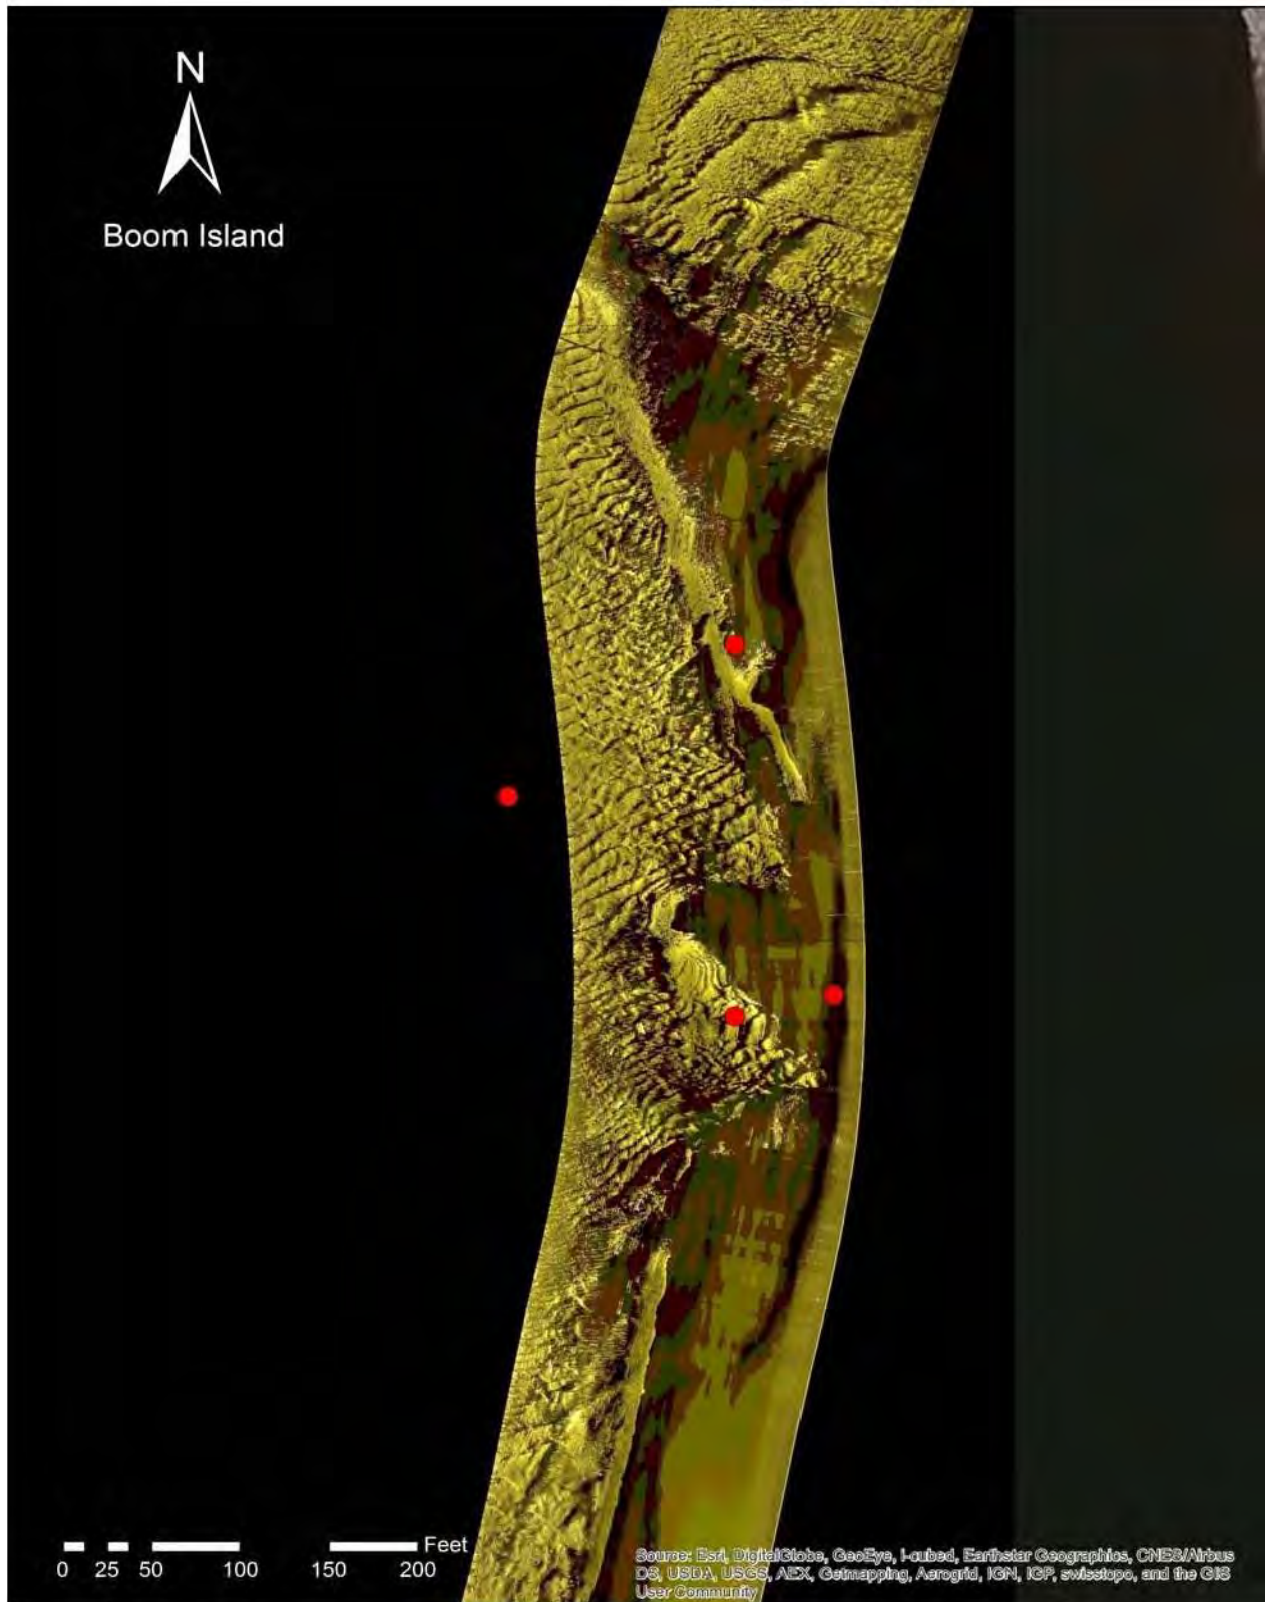
FIGURE 55. The sonar imagery from the large dam north of Boom Island.
