## *St. Croix National Scenic Riverway*

### *Ruins of a Forgotten Highway: Survey and Documentation of Historic Water Control Features*

A product of the National  
Park Service Submerged  
Resources Center

Denver, Colorado  
2015

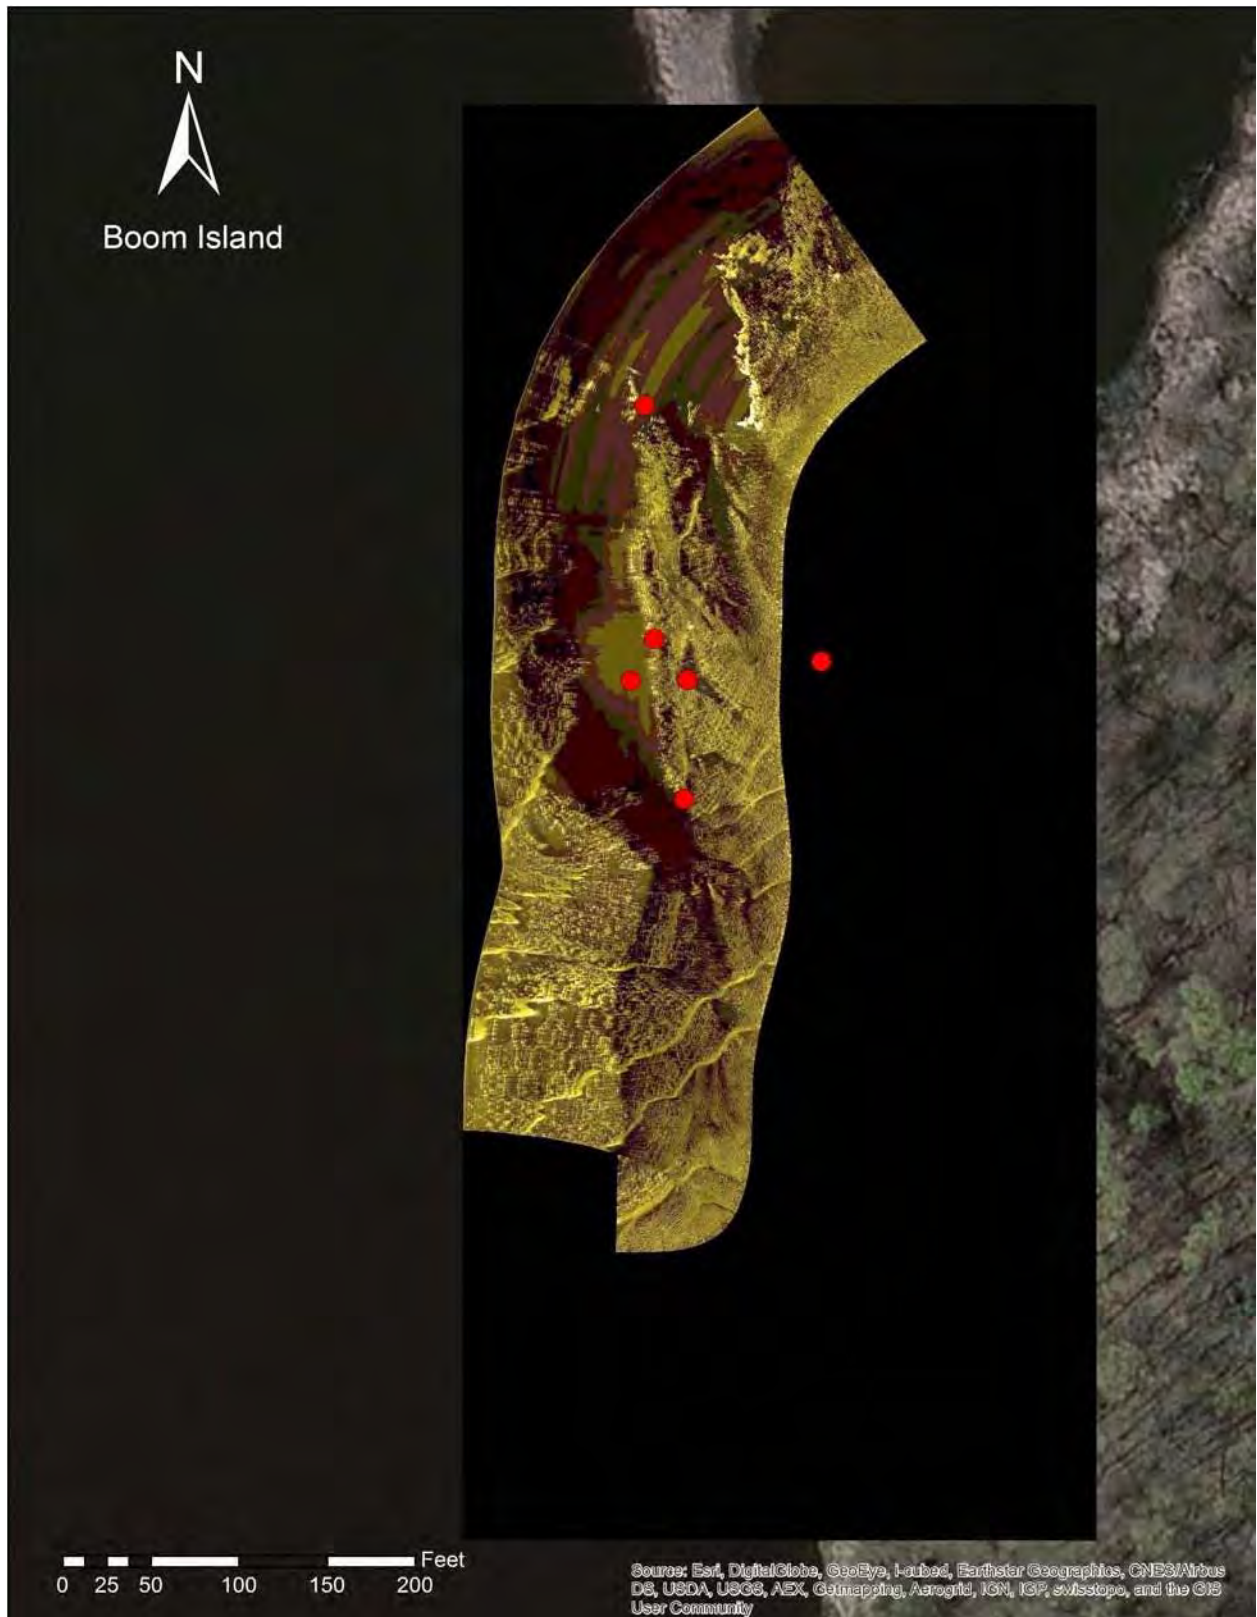
Sonar imagery of target 31 prompted investigations on foot of a closing dam (Figure 56). GPS points were collected on the site's cardinal extents to delineate its boundaries. Target 32 was also a SACN park GPS point, and while sonar data collection was attempted, the target was shallow enough to require examination on foot. The team found one main pile of rocks (approximately 20x20 feet), and a few associated large rocks off the pile's western side. While the two areas did not connect to form a coherent dam structure, they establish an east-west line across the Boom Island channel.

FIGURE 56. The sonar imagery from the closing dam east of Boom Island.

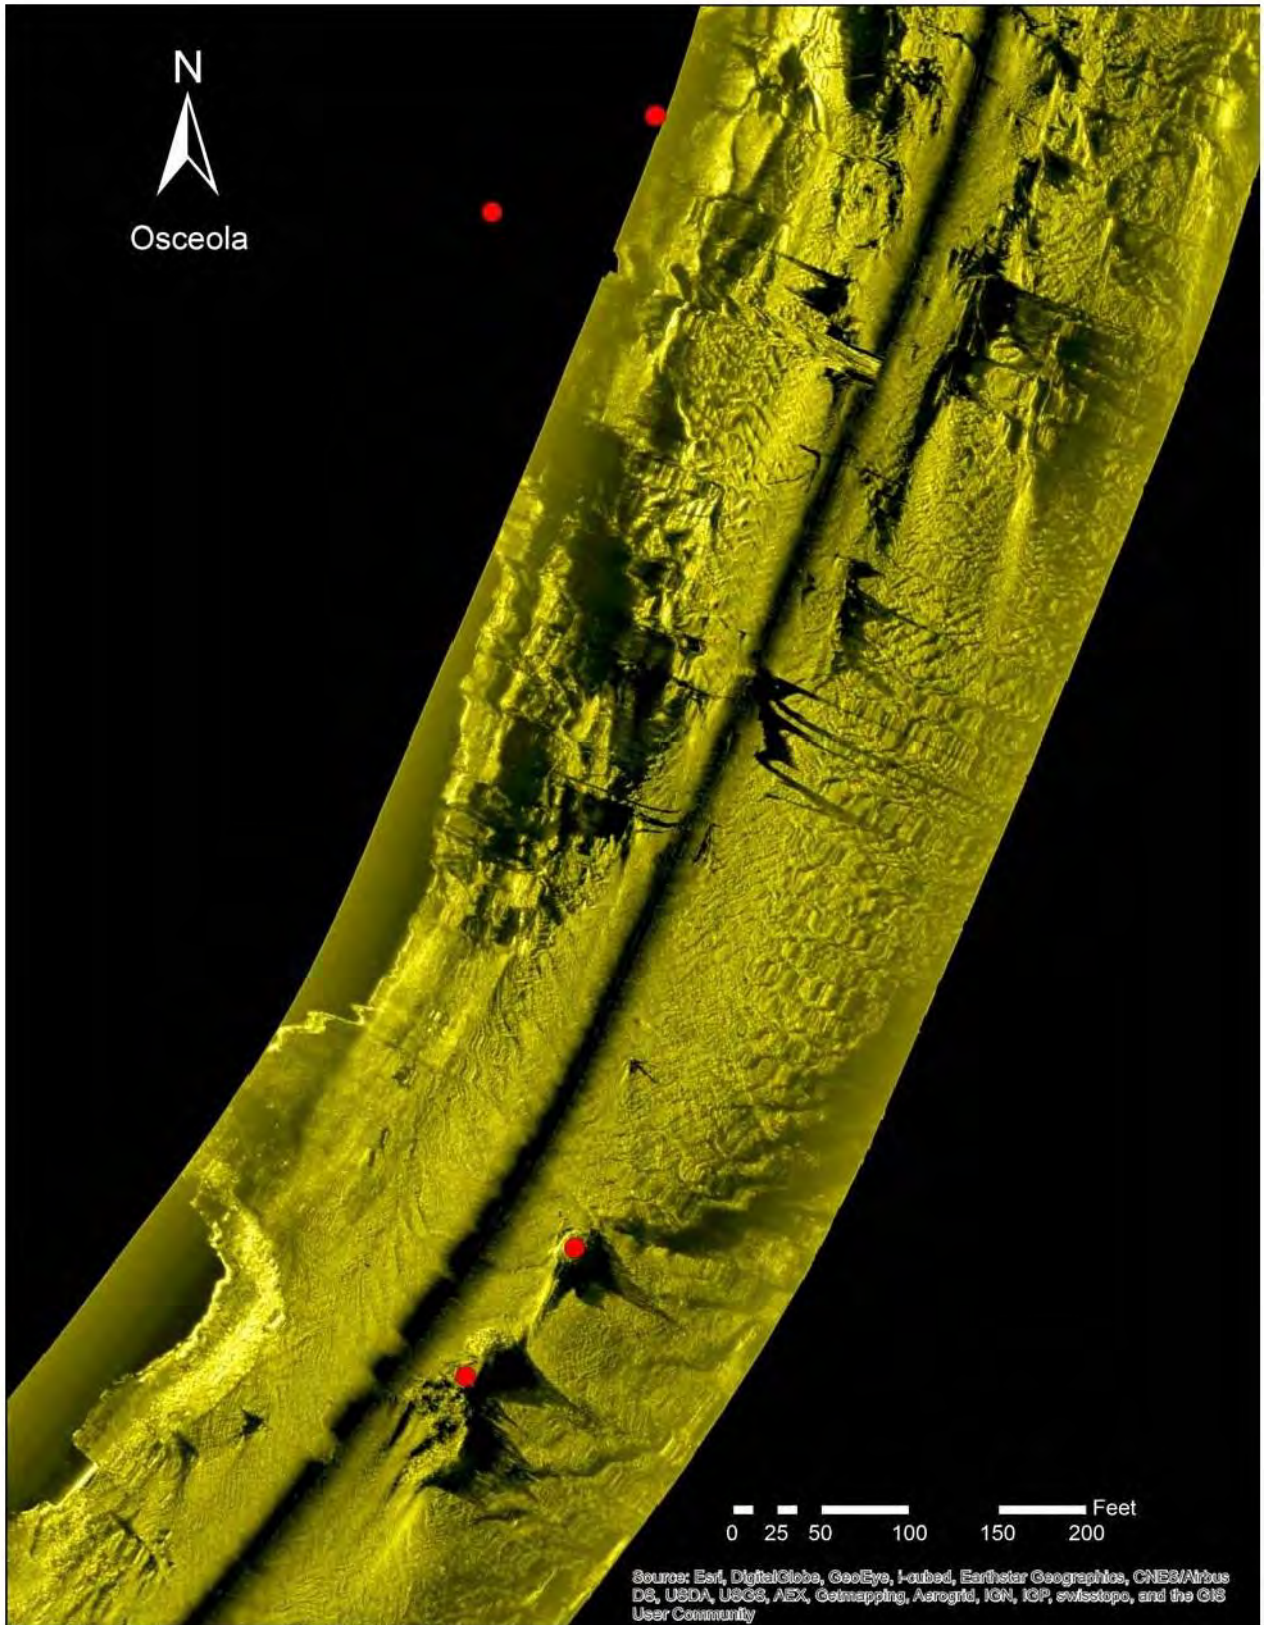
FIGURE 61. Sonar imagery from Osceola showing two structures possibly associated with construction of the previous bridge.

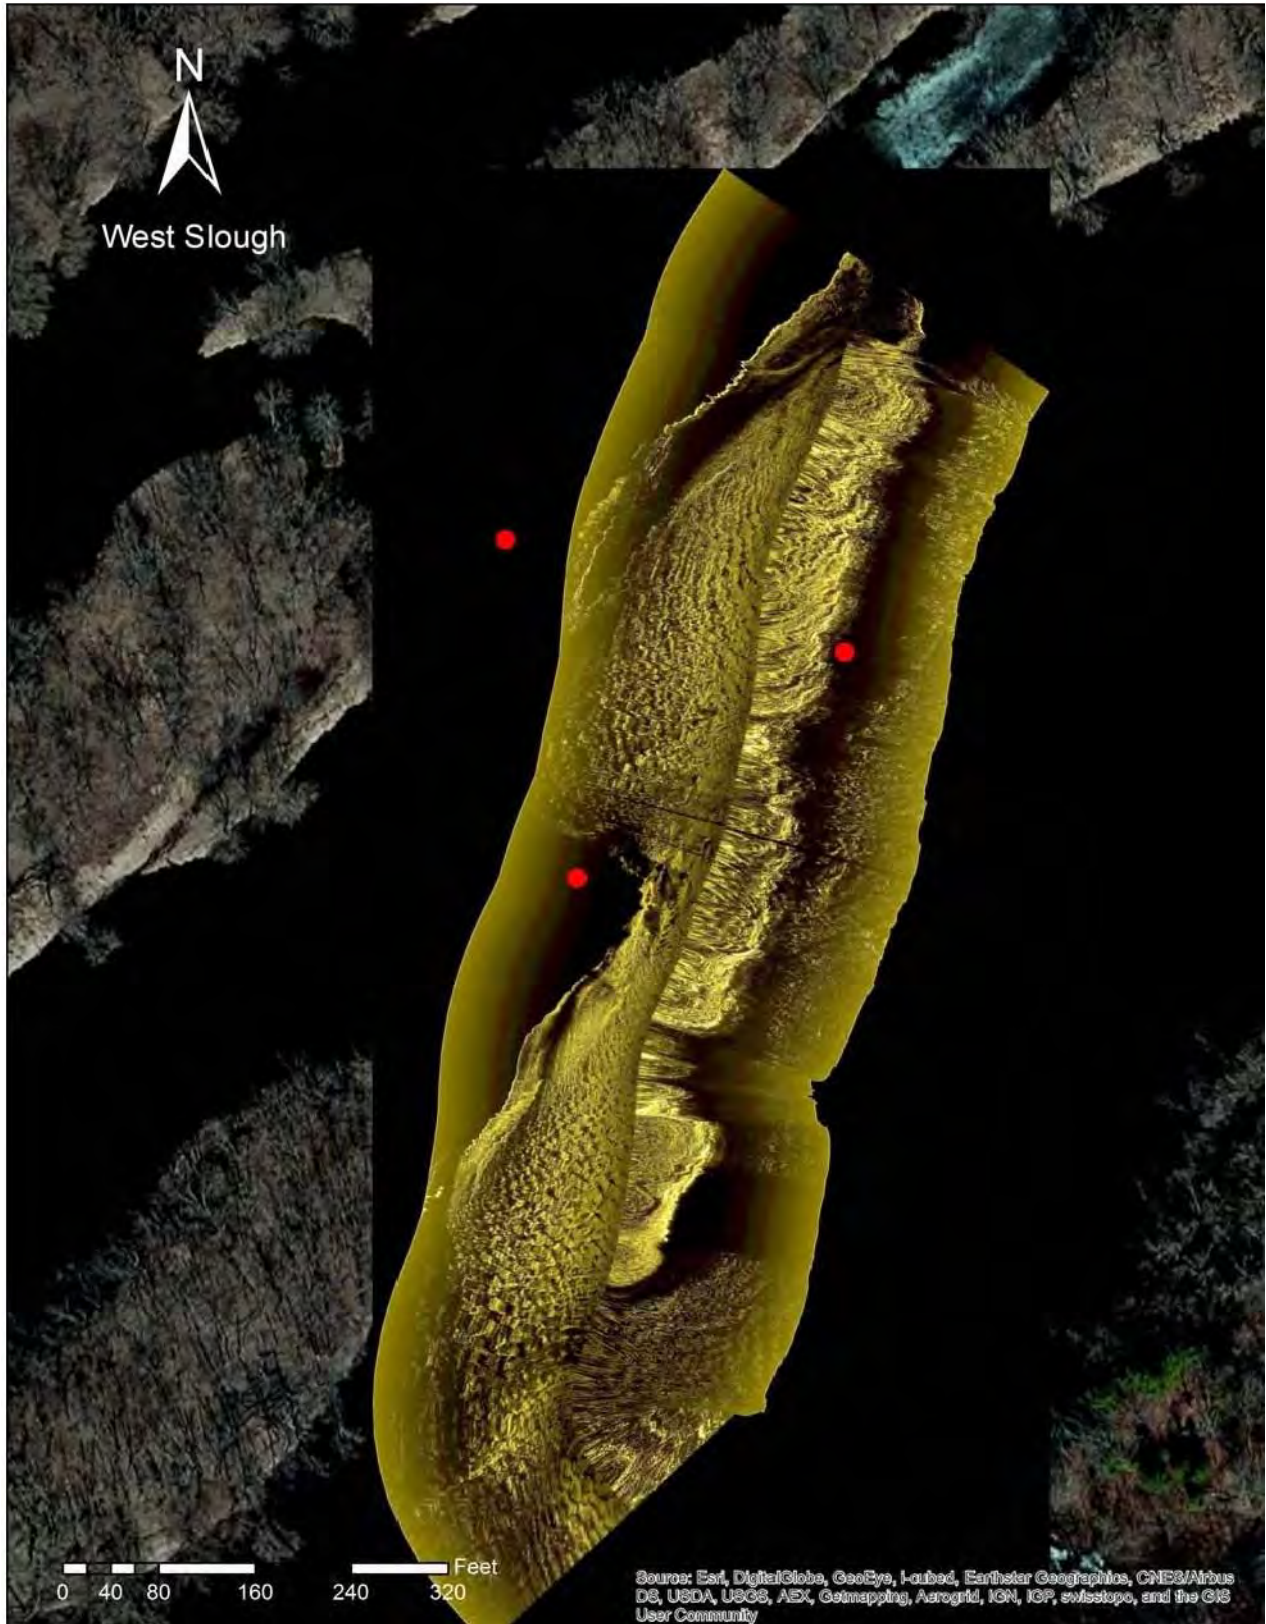
FIGURE 71. The sonar imagery from the large dam (GPS target 65) at West Slough.

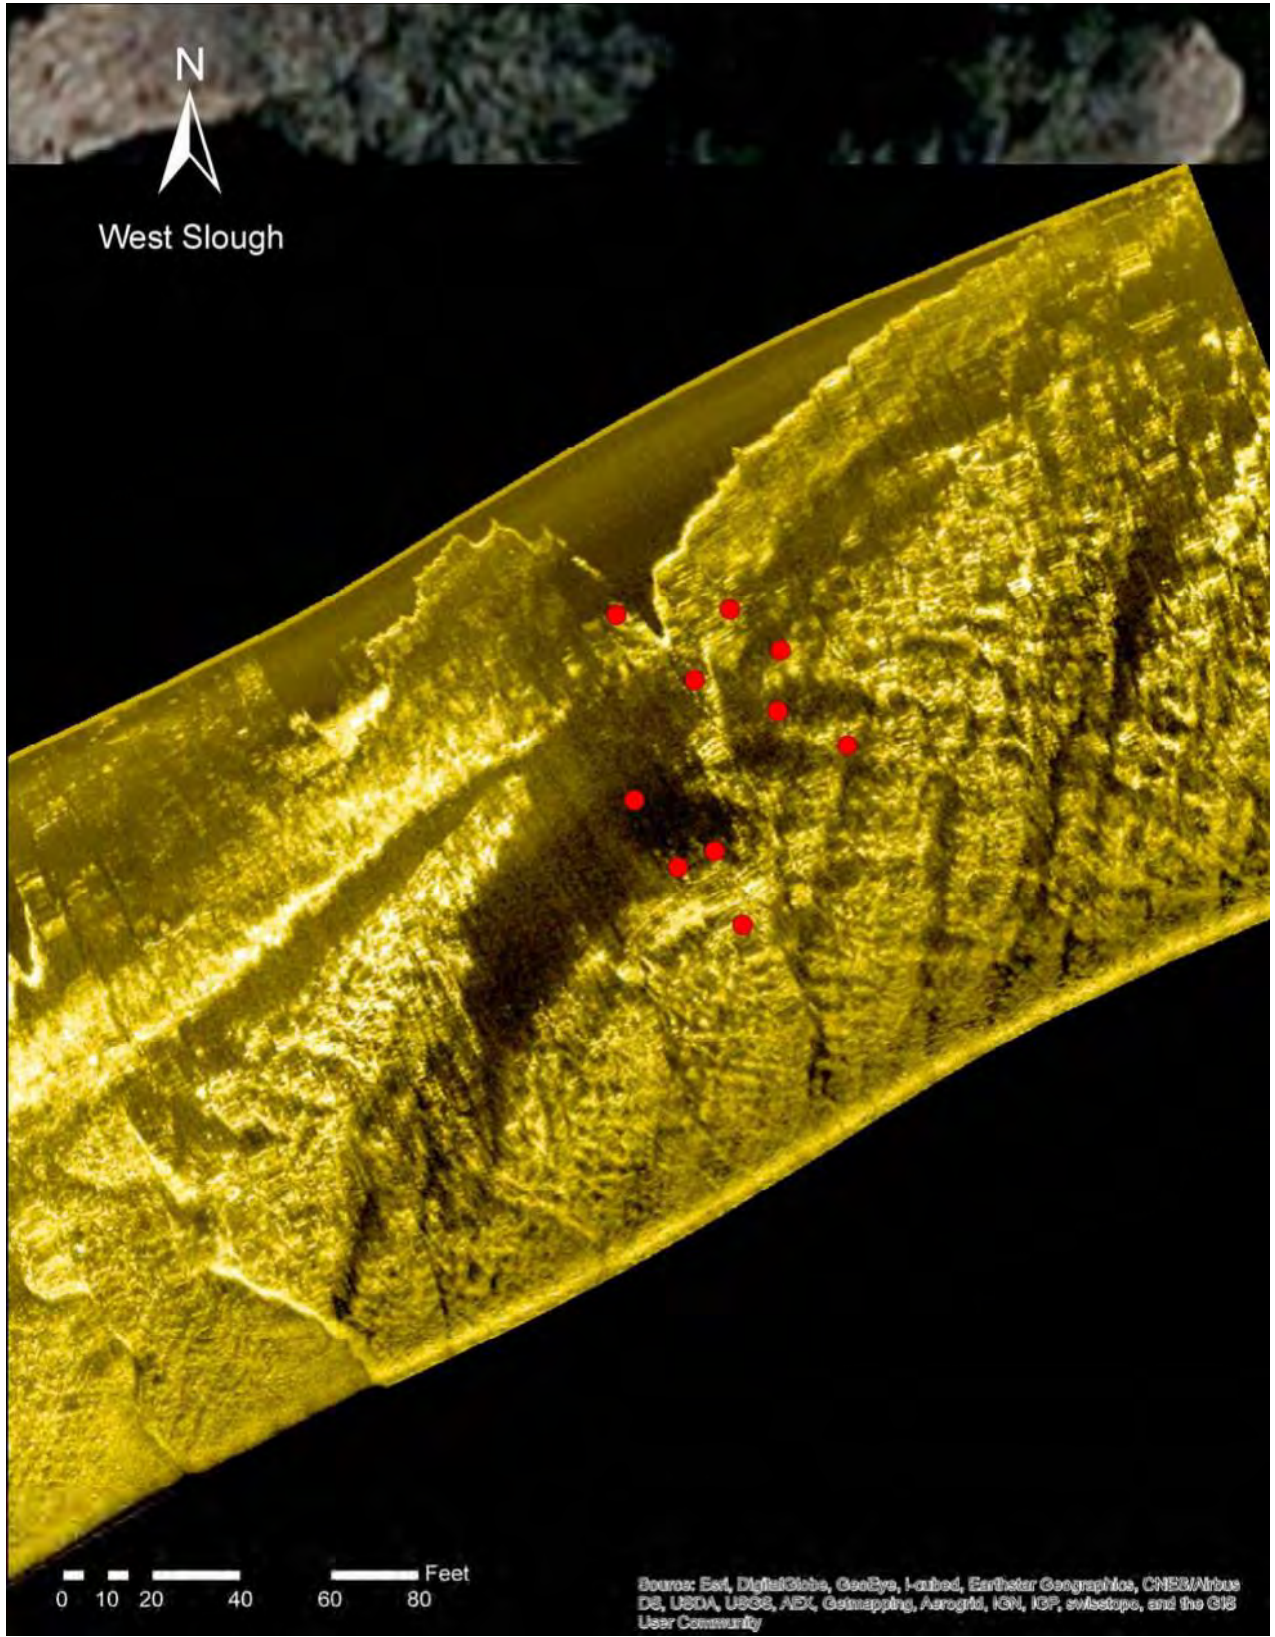
FIGURE 72. The sonar imagery from West Slough's GPS target 69 wing dam.

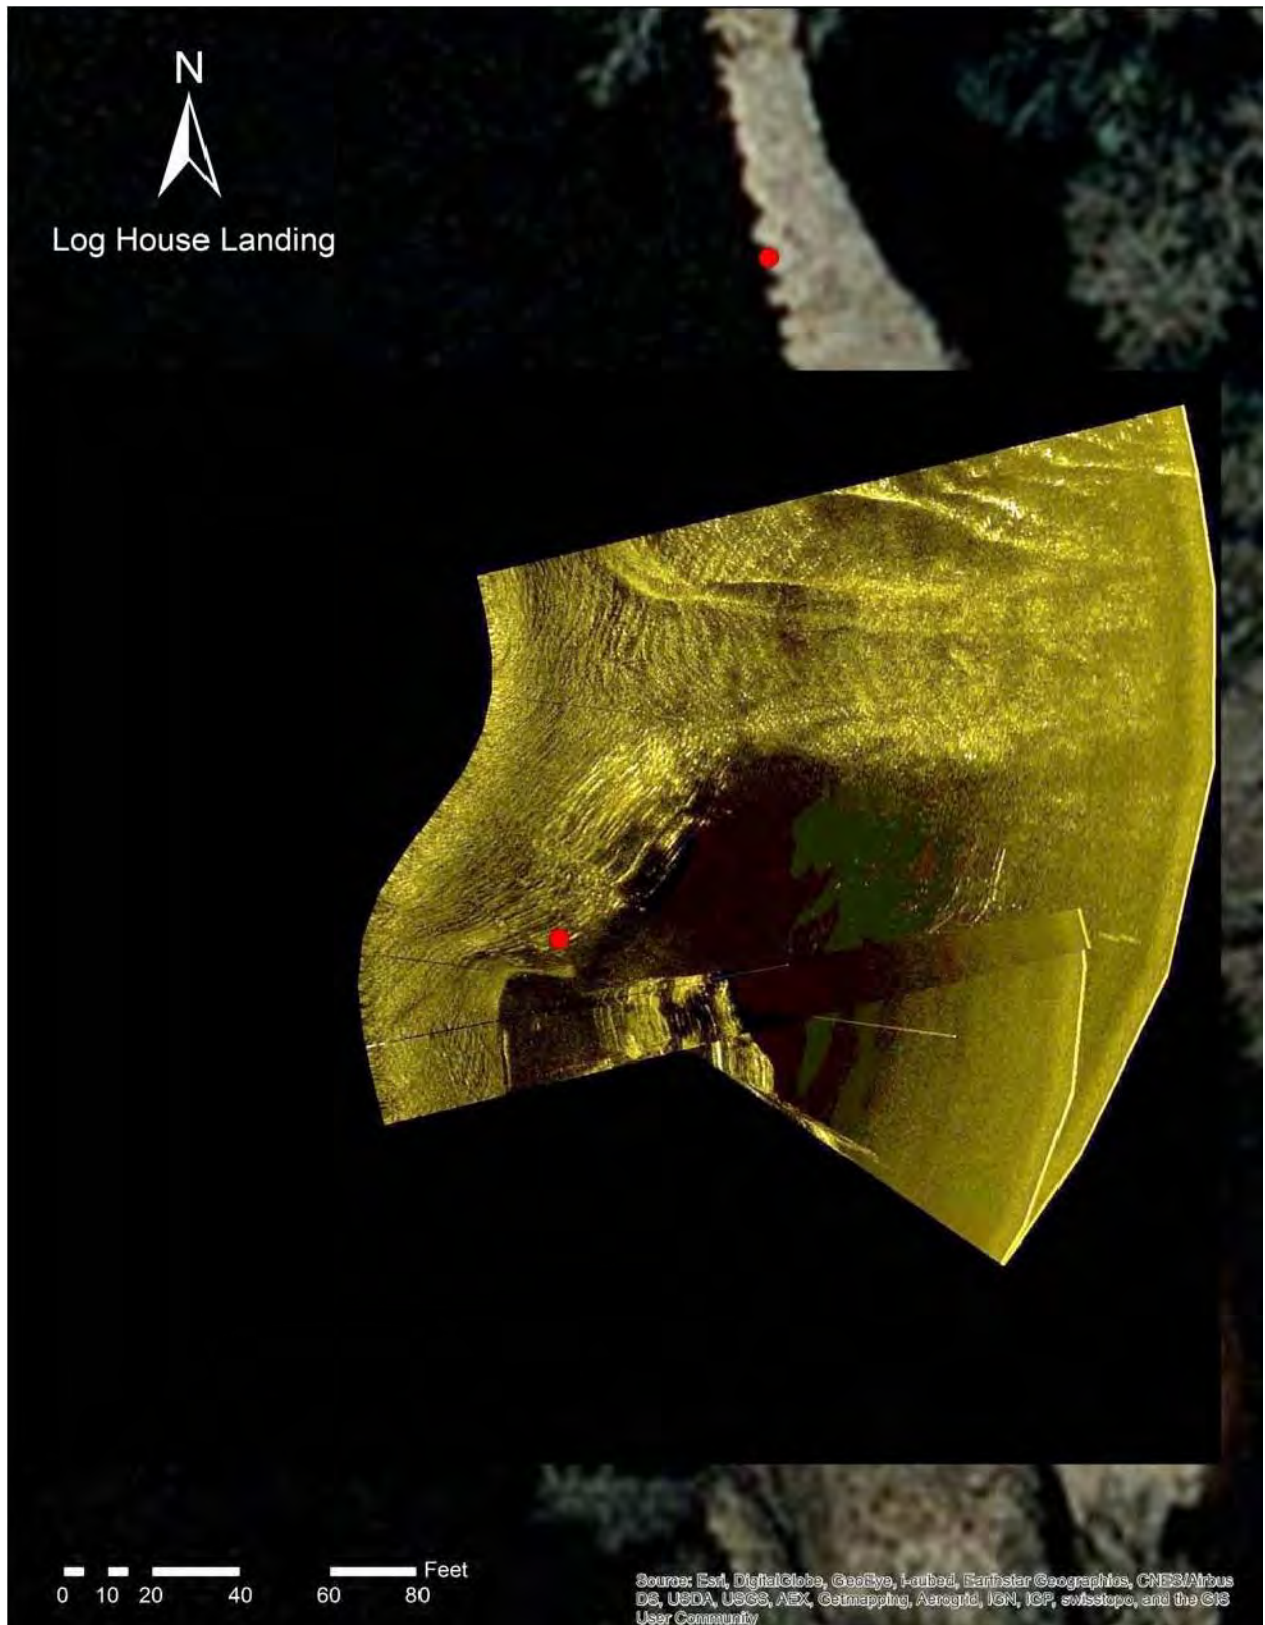
FIGURE 87. The sonar imagery from the dam at Log House Landing.

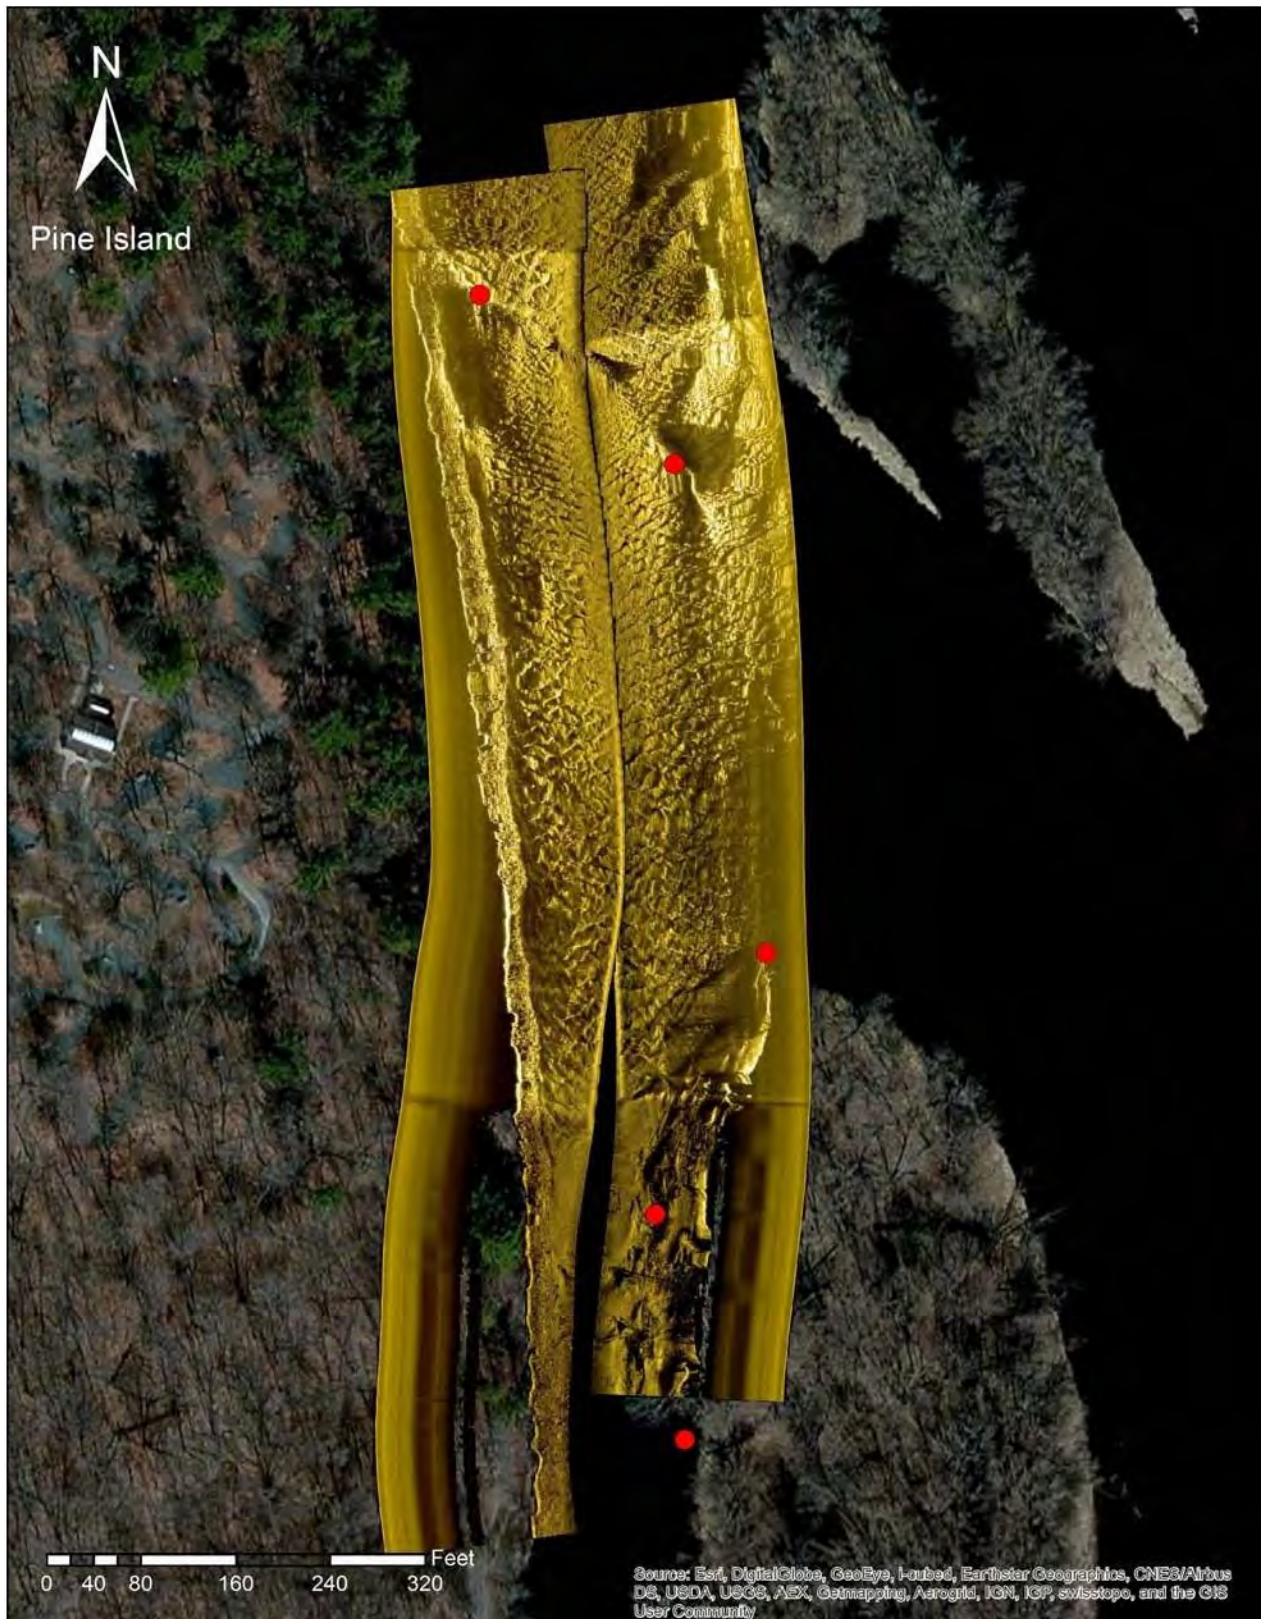
FIGURE 102. The sonar imagery from upper Pine Island showing the large wing dam labeled PinelandsLargeWingDam.

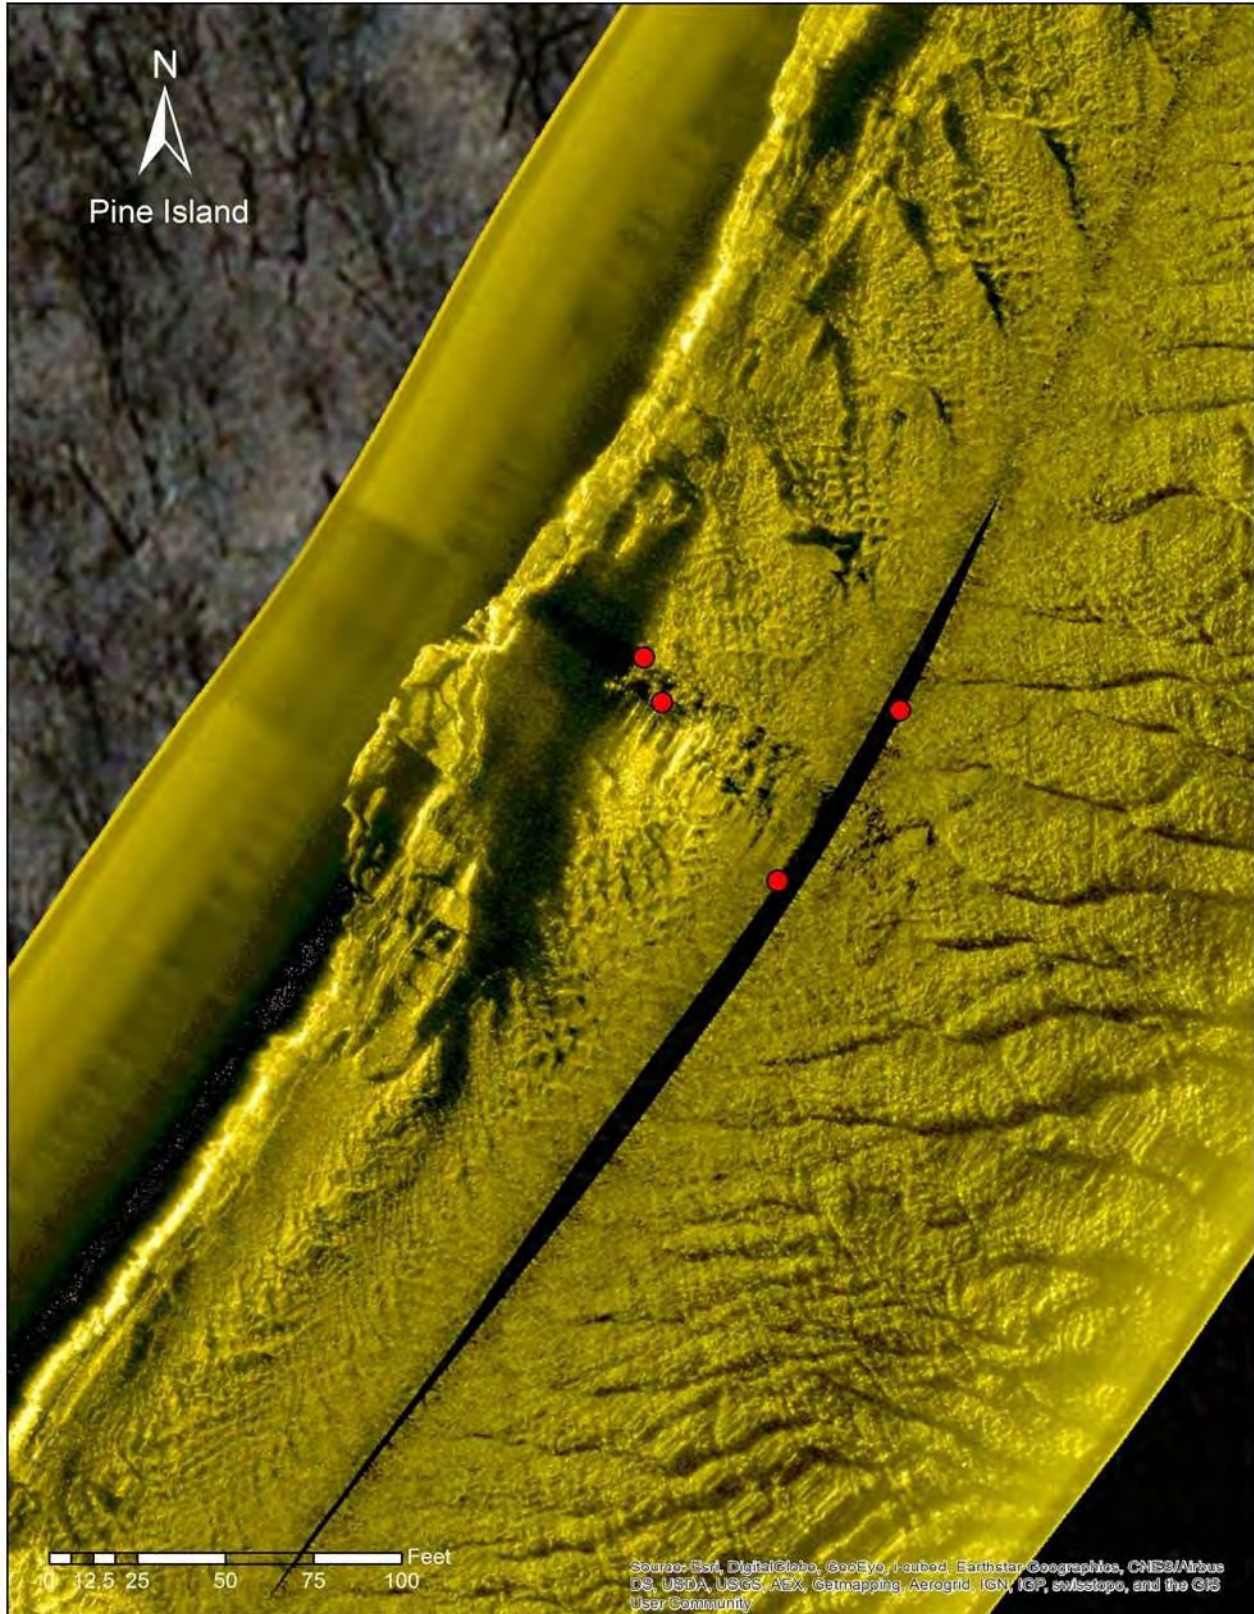
FIGURE 105. A close up of the sonar imagery of the dam atPine89.

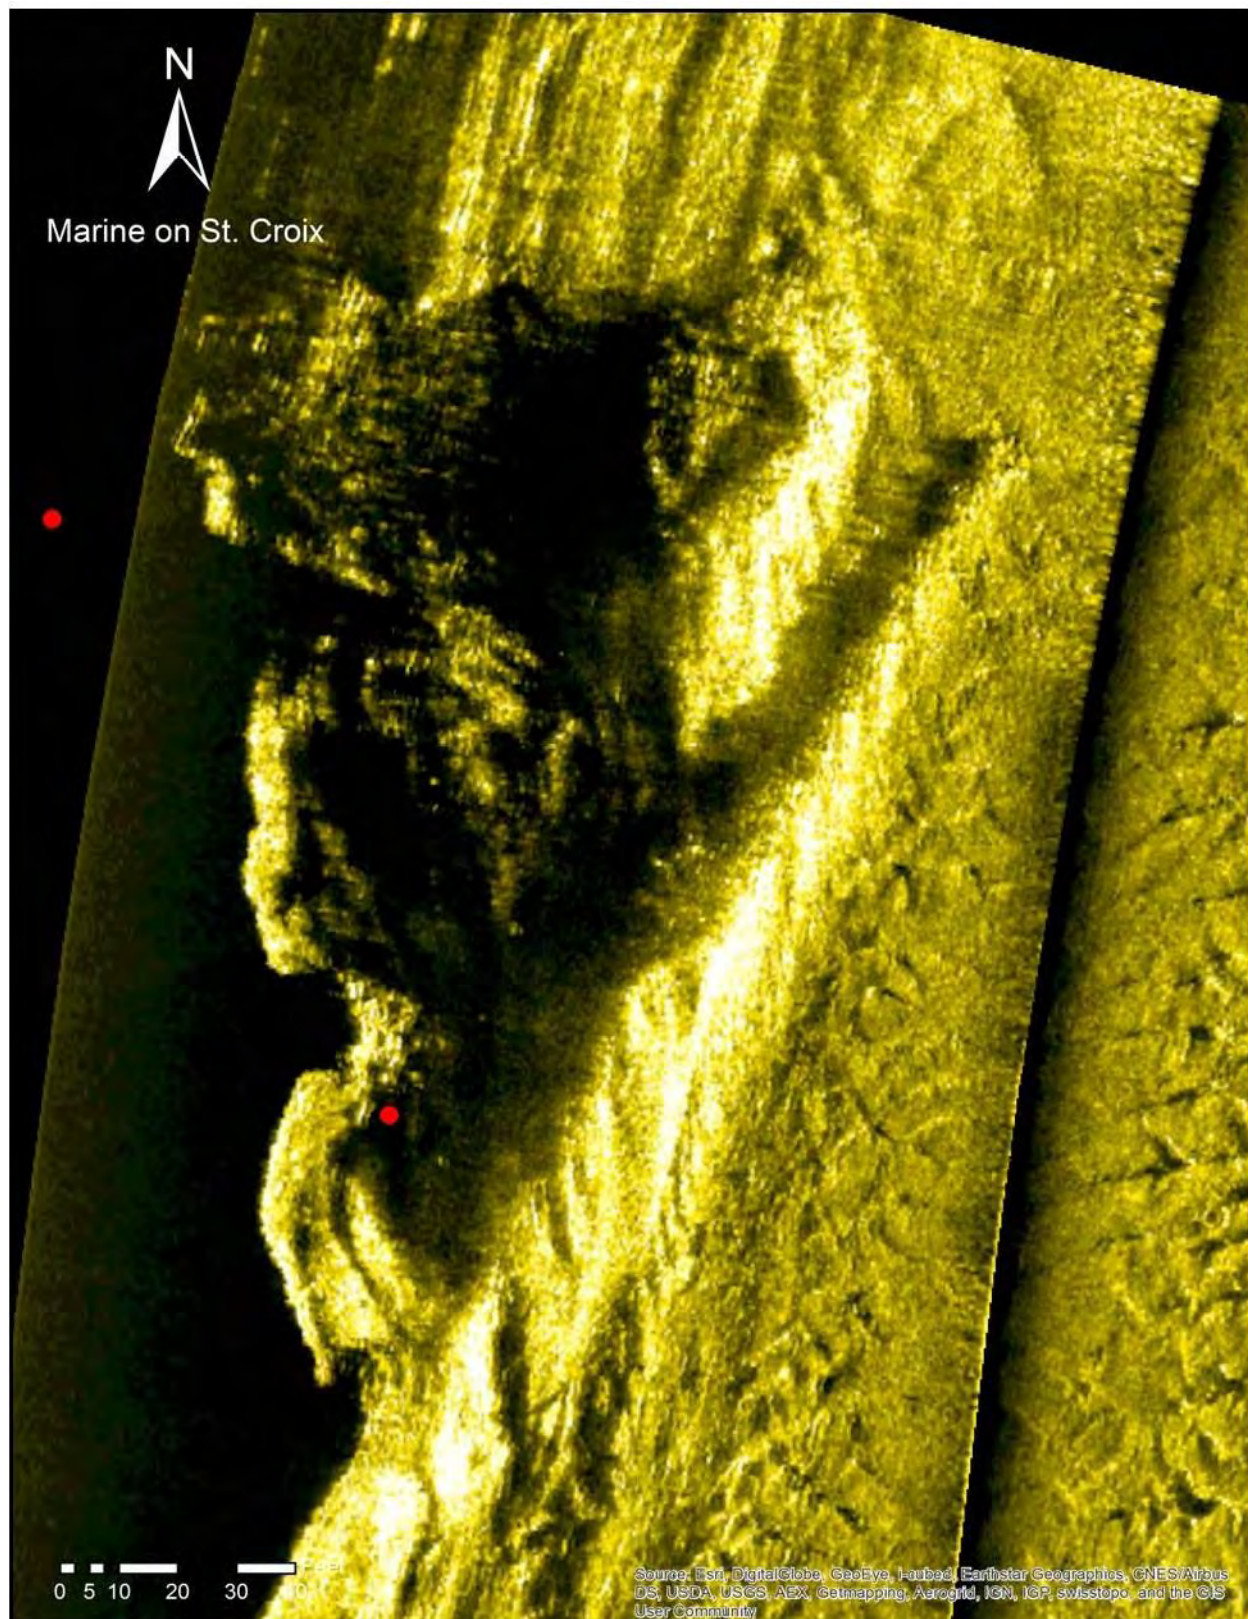
FIGURE 112. Sonar imagery from the wing dam and cribbing at Marine on St. Croix.

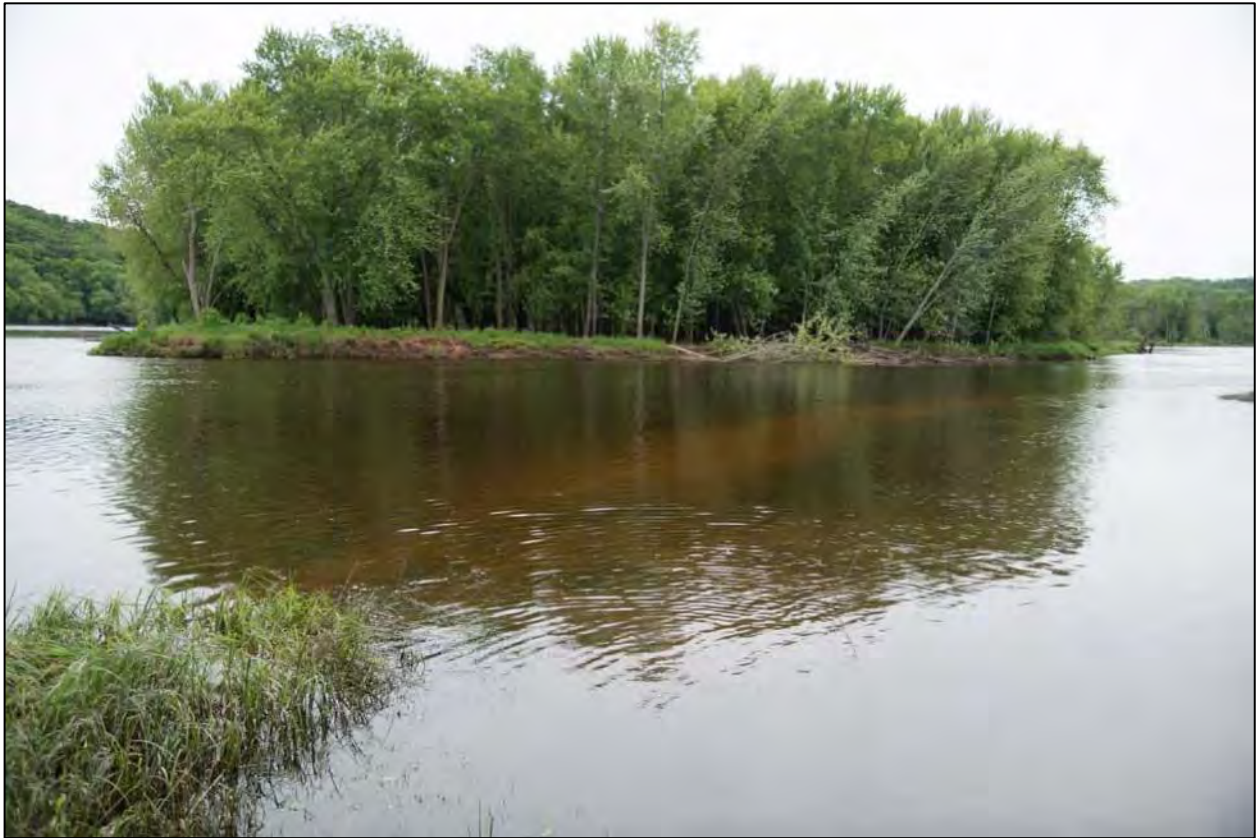
FIGURE 137. Image from Kelly's Slough GPS target 107 showing a submerged sediment-covered structure.

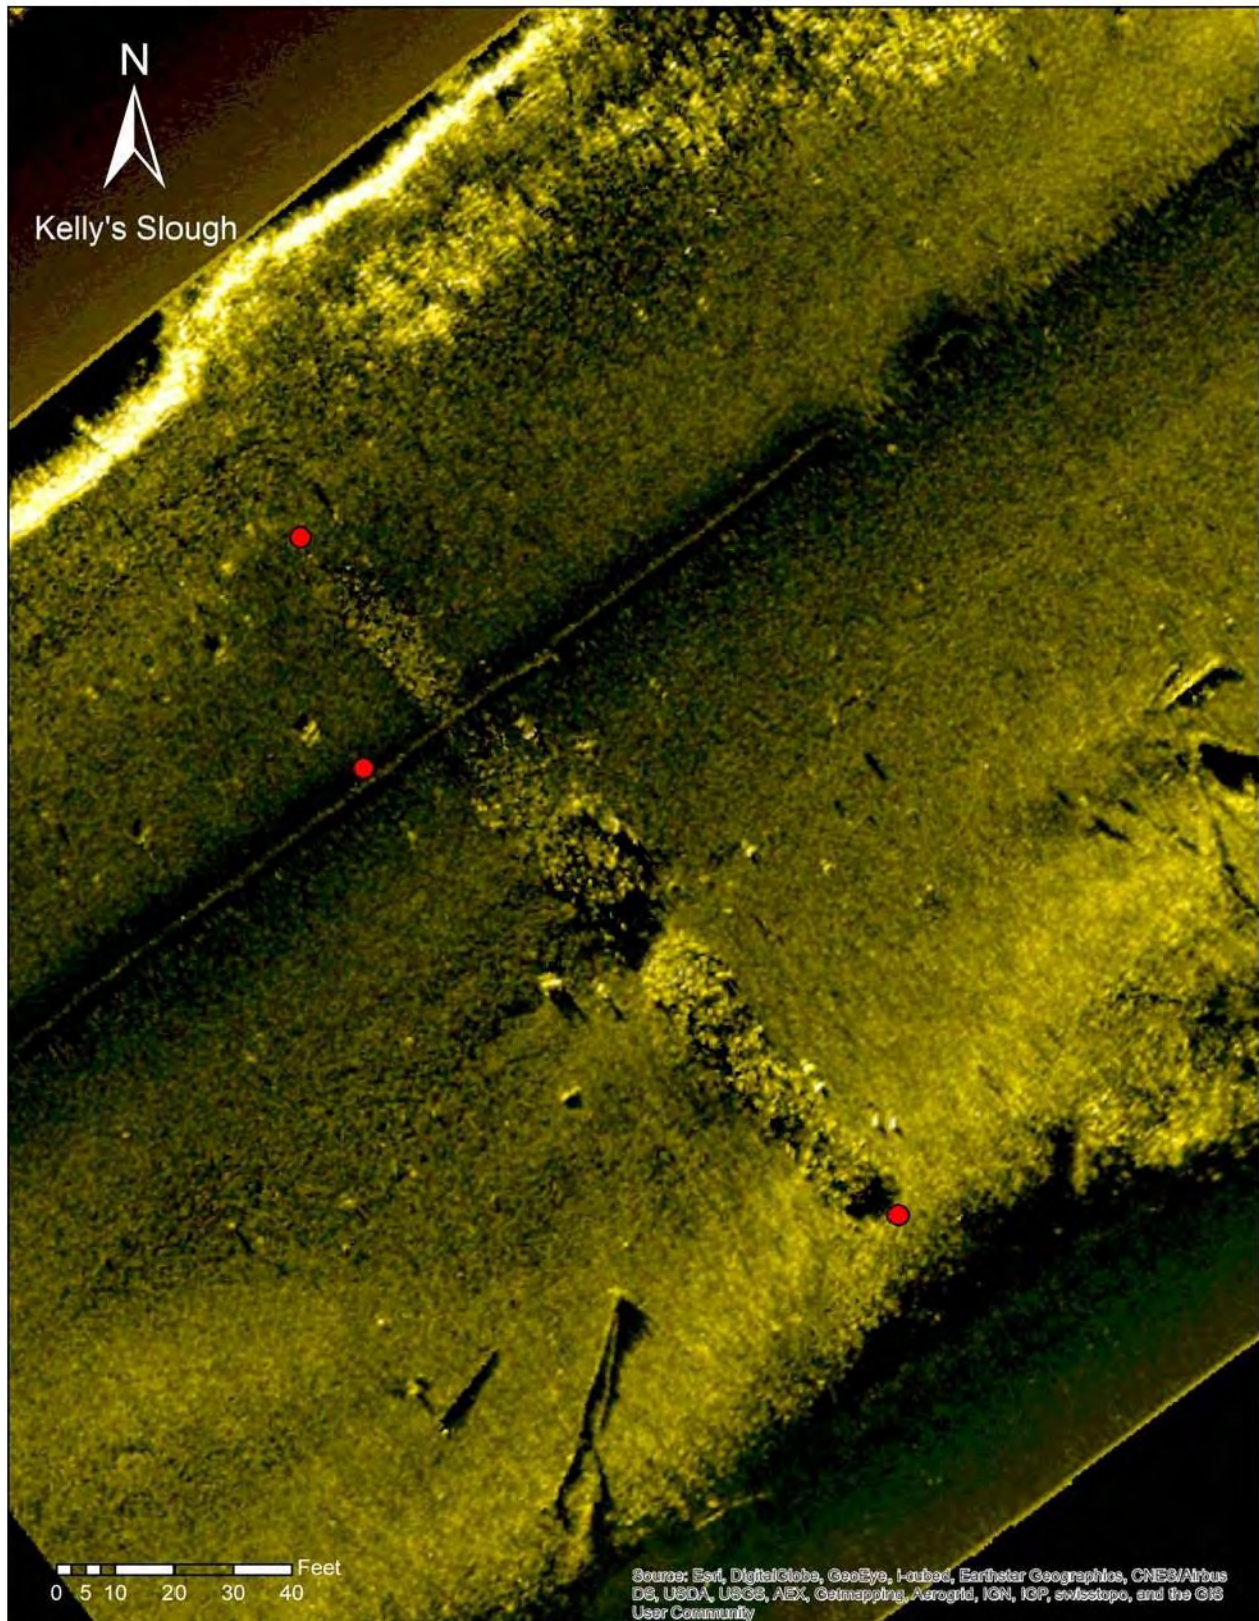
FIGURE 138. The sonar imagery from the rock dam at GPS Target 115 in Kelly's Slough.

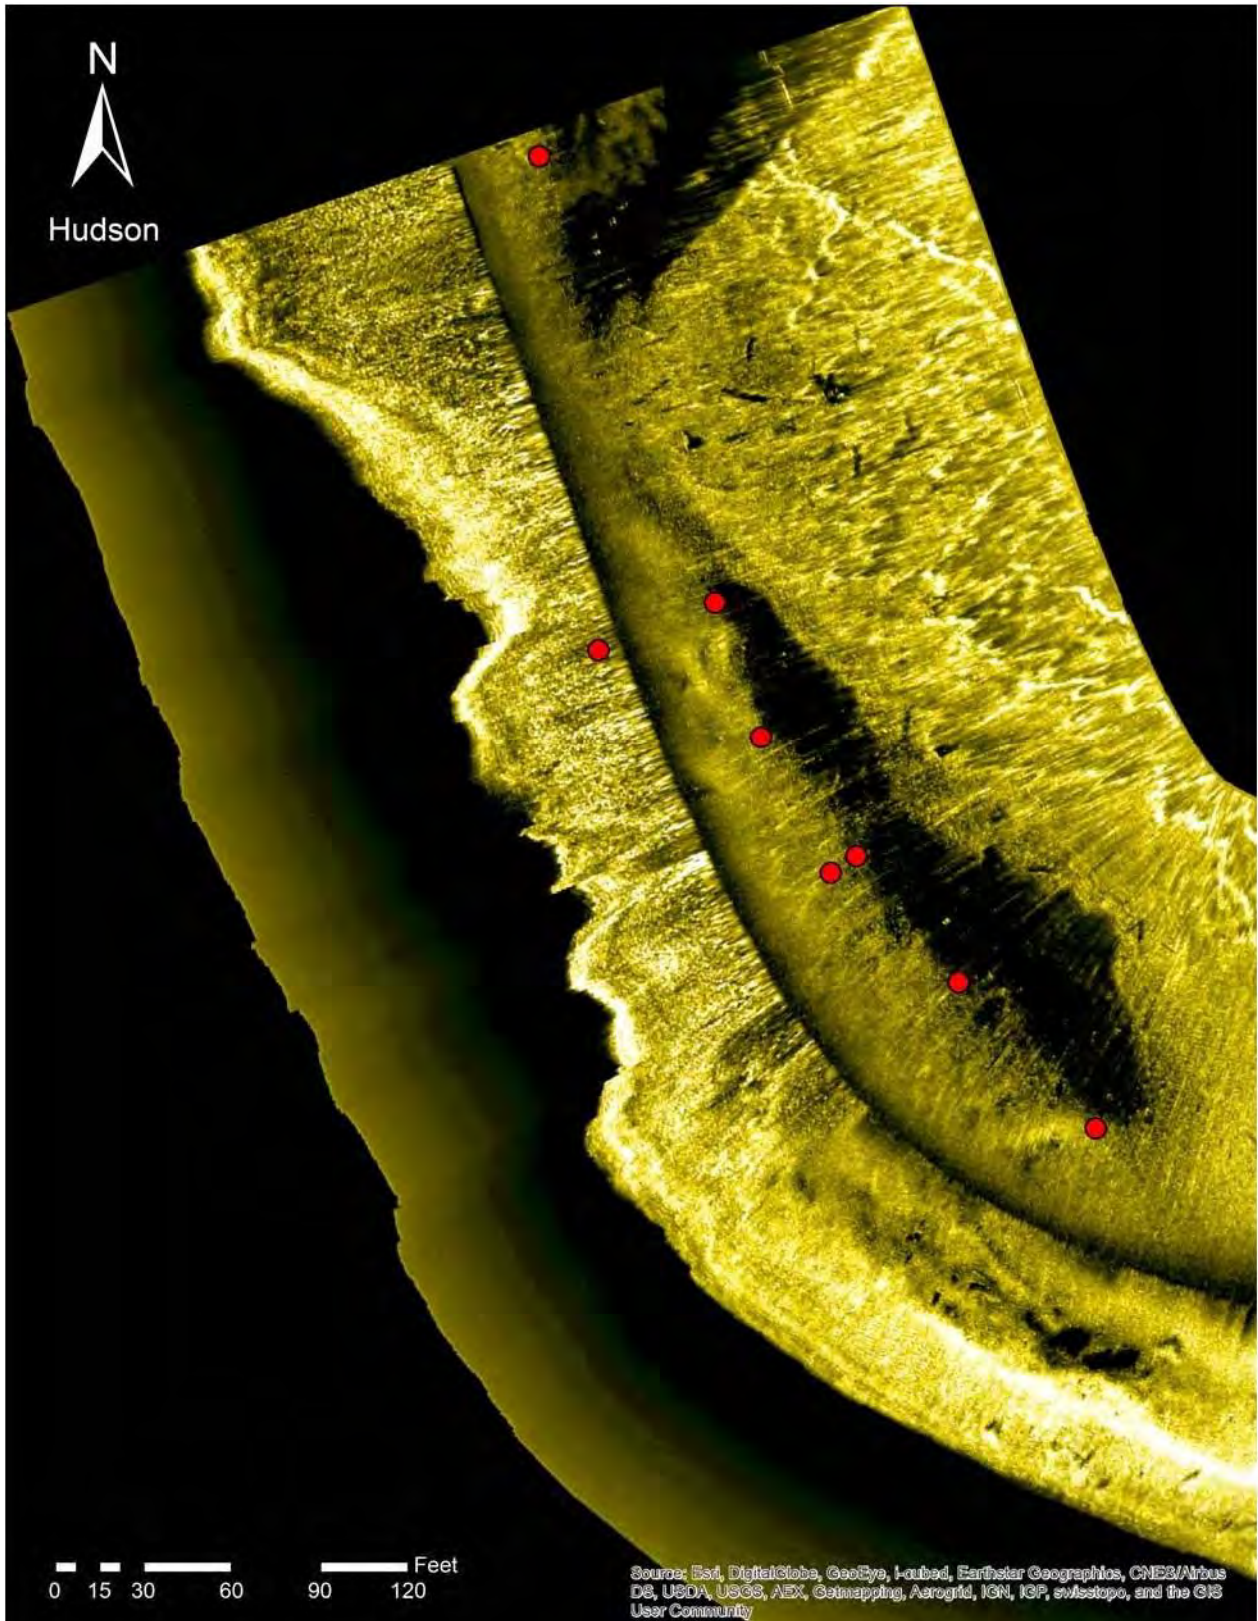
FIGURE 144. The sonar imagery from the dam at Hudson.
