## *St. Croix National Scenic Riverway*

### *Ruins of a Forgotten Highway: Survey and Documentation of Historic Water Control Features*

A product of the National  
Park Service Submerged  
Resources Center

Denver, Colorado  
2015

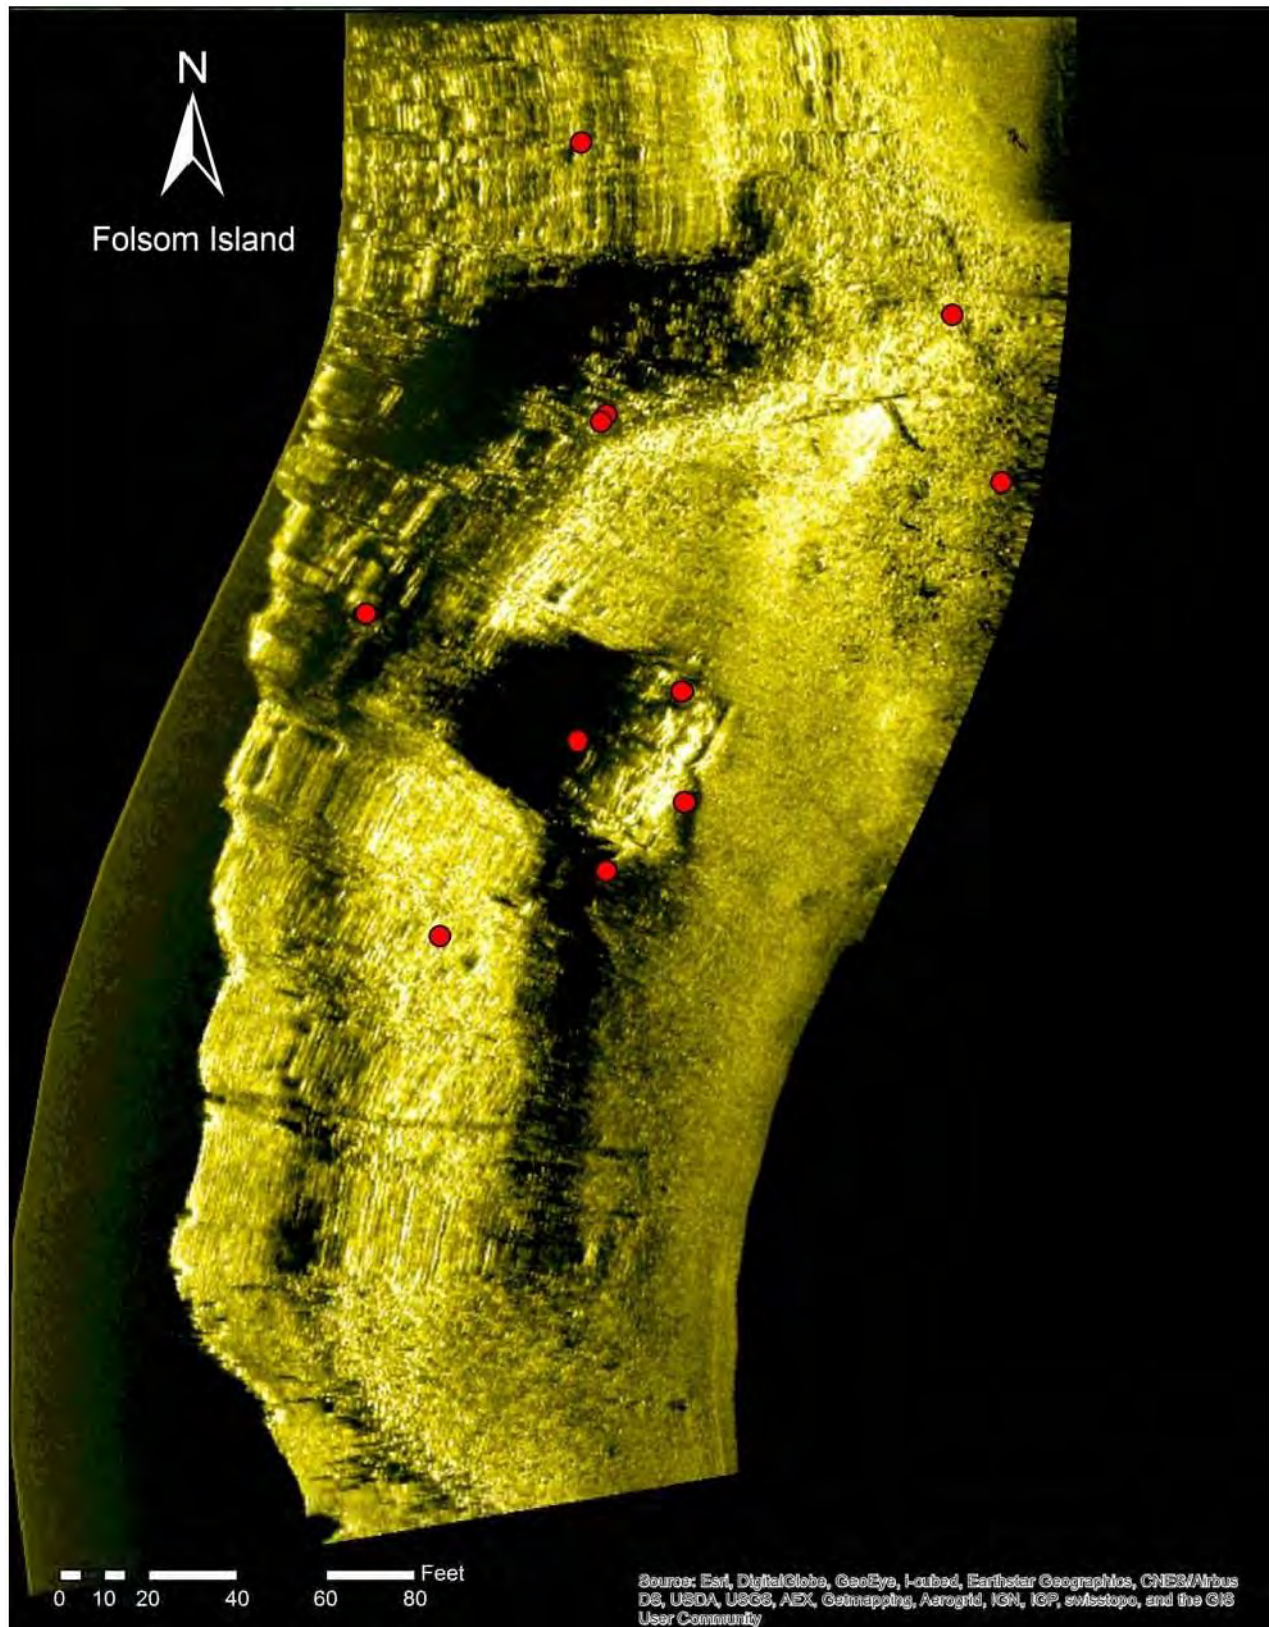
FIGURE 13. Side scan image of the southern section of Folsom Island taken in 2015.

The largest feature on the northern tip of the main island was identified as the remains of a closing dam (Figure 12). The 1937 USACE river survey referenced this dam as an existing structure, also shown on the overlay aerial map in Figure 7. The second closing dam at the southern end of the island also appears on the 1937 USACE map. Sonar survey found two rock piles in this area, but they were not as linear and coherent as the northern closing dam (Figure 13). Nonetheless, we believe the rock piles are remnants of the closing dam depicted in the historical documents. Both original and actual GPS locations for the southern features remain on the maps below, but are also identified in detail in the GPS files, GIS attribute table, and Excel findings spreadsheet.

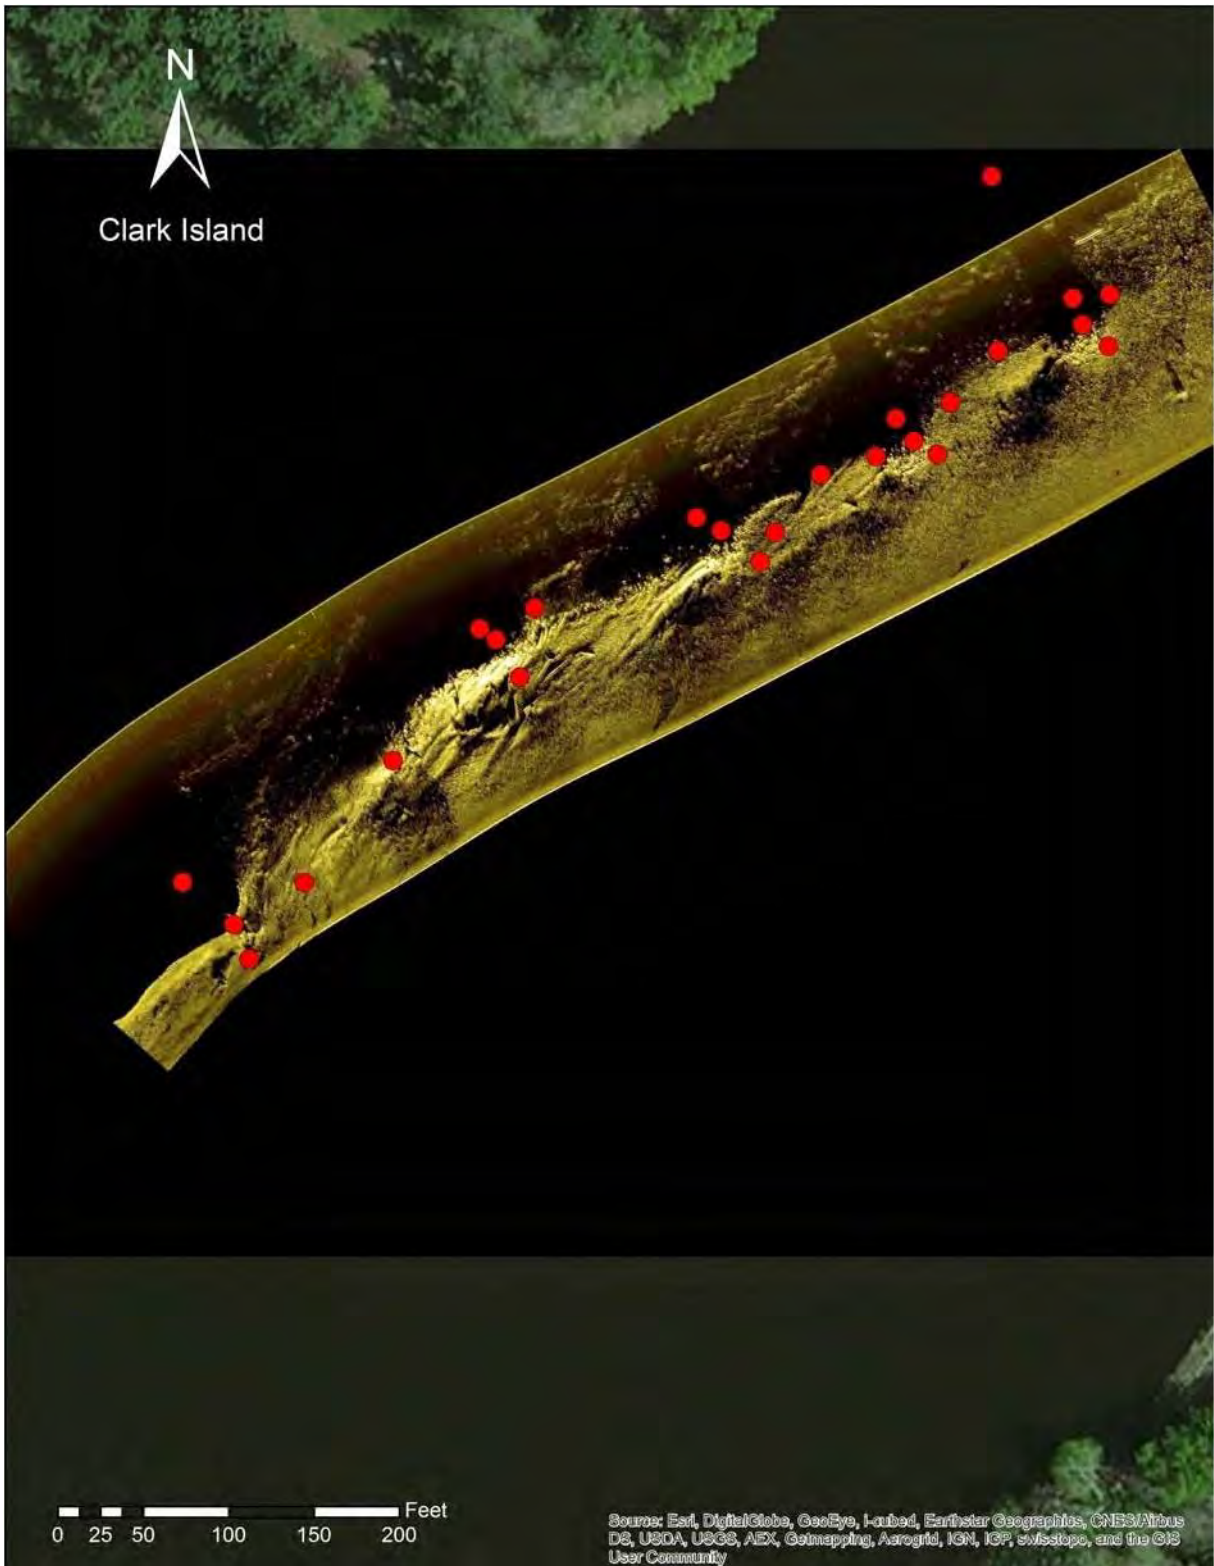
FIGURE 16. Sonar imagery of the northern section of Clark Island taken in 2015.

Investigations at Clark Island revealed six individual features. GPS points were taken on each feature's extents to document their size and location (Figures 14 and 15). The first four features were very shallow, but their imagery was captured by side scan sonar (Figure 16). Based upon historical sketches from 1881 and 1883, it appears these four rock piles once formed a continuous line of river modifications at the northern tip of the island (Figures 17 and 18). The Annual Report of Chief of Engineers (1880:1663) reported that Clark Island or Clark Slough had old cribs, a wing dam at the upper end of the island, and a revetment on the right bank of the island. This report also recommended the addition of a "small dam between island and tow-head, and, probably, about 200 feet brush and stone wall at lower end of island [sic]."

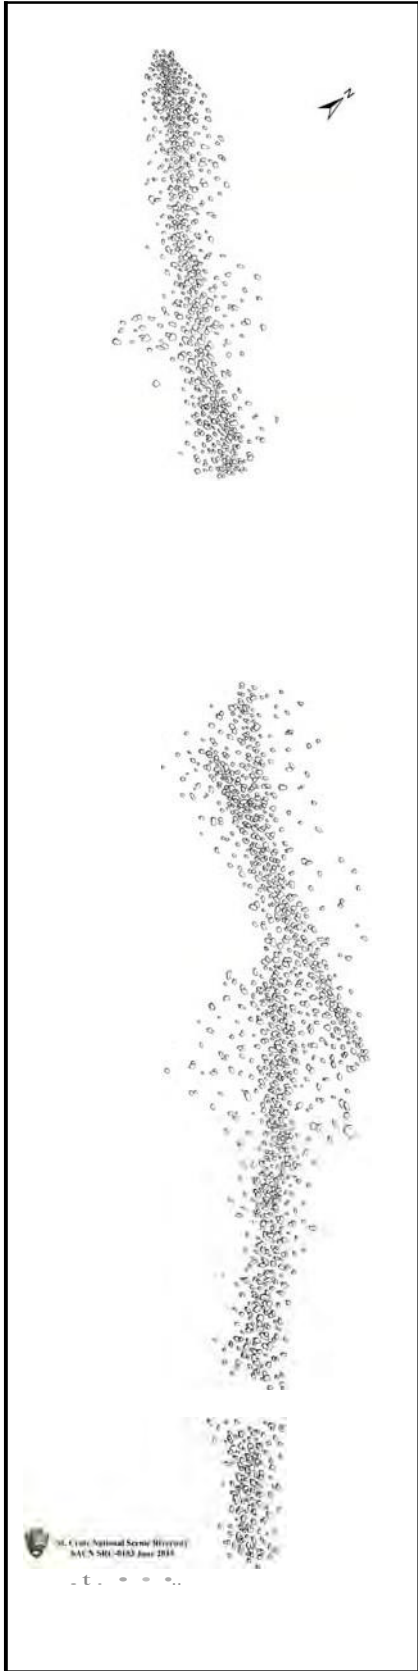
FIGURE 40. Franconia Site Map 2015.

The team placed a 235 foot long baseline running west to east, at a 100 degree compass heading (Figure 39). The team took baseline offsets of the dam every ten feet via wading and SCUBA. The intensity of the current increased as the team progressed east, so beginning at 210 feet on the baseline, they acquired measurements every five feet. After completing the offset measurements through 235 feet on the baseline, the team discovered that the dam continued further to the southeast, extending at least another 55 feet out into the river at a compass bearing of 160 degrees. A GPS point could not be collected on the southeastern tip of the underwater structure, due to its distance from shore, the depth of the water, and the speed of the river's current, but the team was able to use the sonar imagery to establish the total extent of the entire structure (approximately 310 feet long, with an overall compass bearing of 118 degrees). The measurements collected on the main dam structure along the baseline were mapped on Mylar at a 1/8 inch scale, and then inked. The final site map (Figure 40) illustrates the remains of the Franconia wing dam. This dam was composed primarily of stone, and was separated into two distinct sections.

The reason behind the dam's division can only be speculated upon, but one possibility is that it naturally degraded, a deterioration perhaps prompted by a high water flood event or from the impacts of ice. Searches around the area, however, did not reveal a scatter of rocks extending downriver from the dam break to support this theory. While it is possible that the structure of the middle section of the dam was

Another option is human interaction. The dam could have been struck by a vessel, resulting in a breach in the dam structure that widened over time. The dam might also have been purposely modified to alter the river flow. Such intentional modification would speak to the river's role as a living highway, and the ongoing importance of its control features to local constituents, long after official USACE operations ceased. Finally, given the differing angles of the dam (Figure 40), it is also possible that the dam was constructed in several stages, to adapt to changing needs, river flow patterns, or loss of dam structure.

A final option is that the missing section was never constructed at all. If the dam was indeed constructed as a patchwork of control features over many years, it is possible that the missing section was intentional or neglected, and merely another element in the effort to control the Franconia river area.

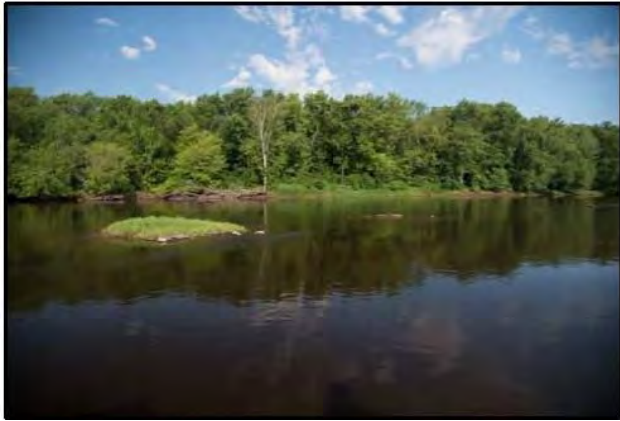
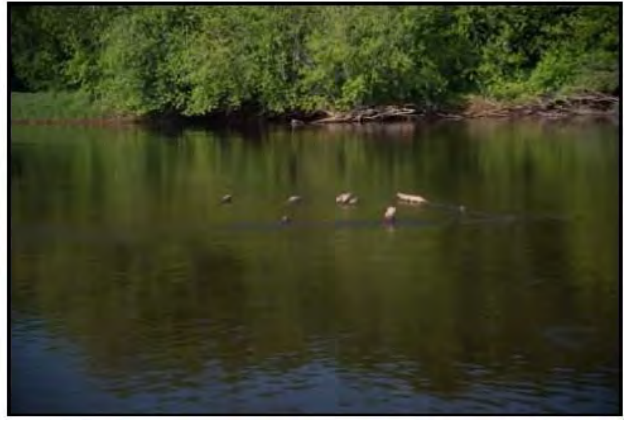
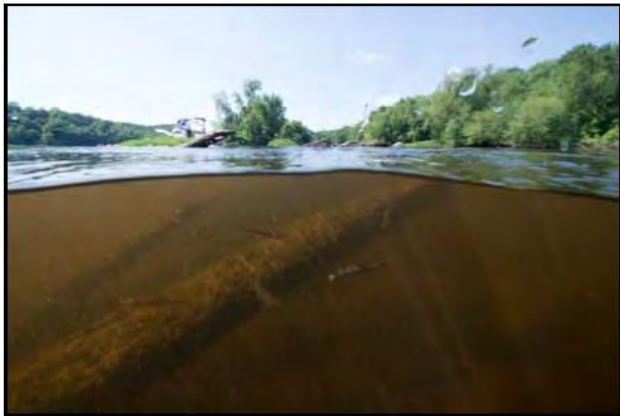
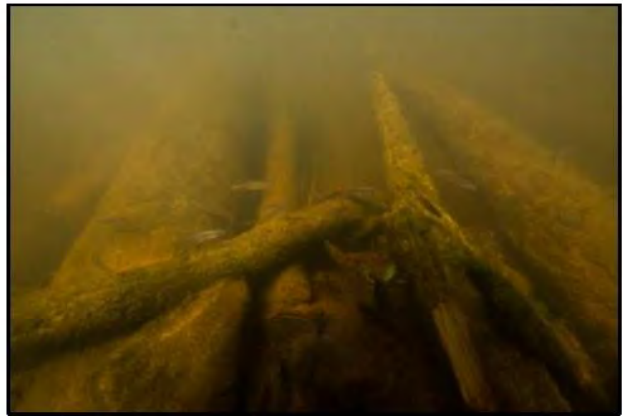
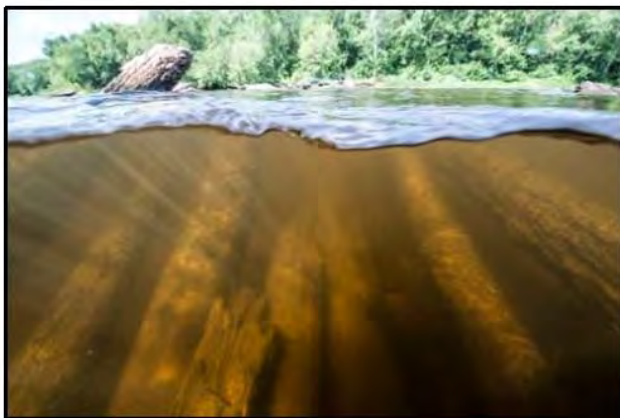
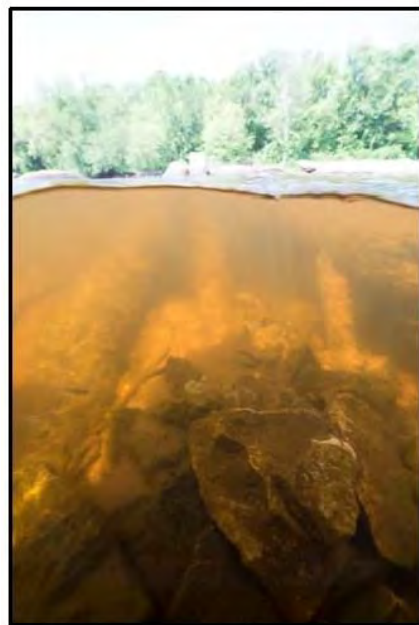
FIGURES 49-54. Images showing details of the large dam at Boom Island.

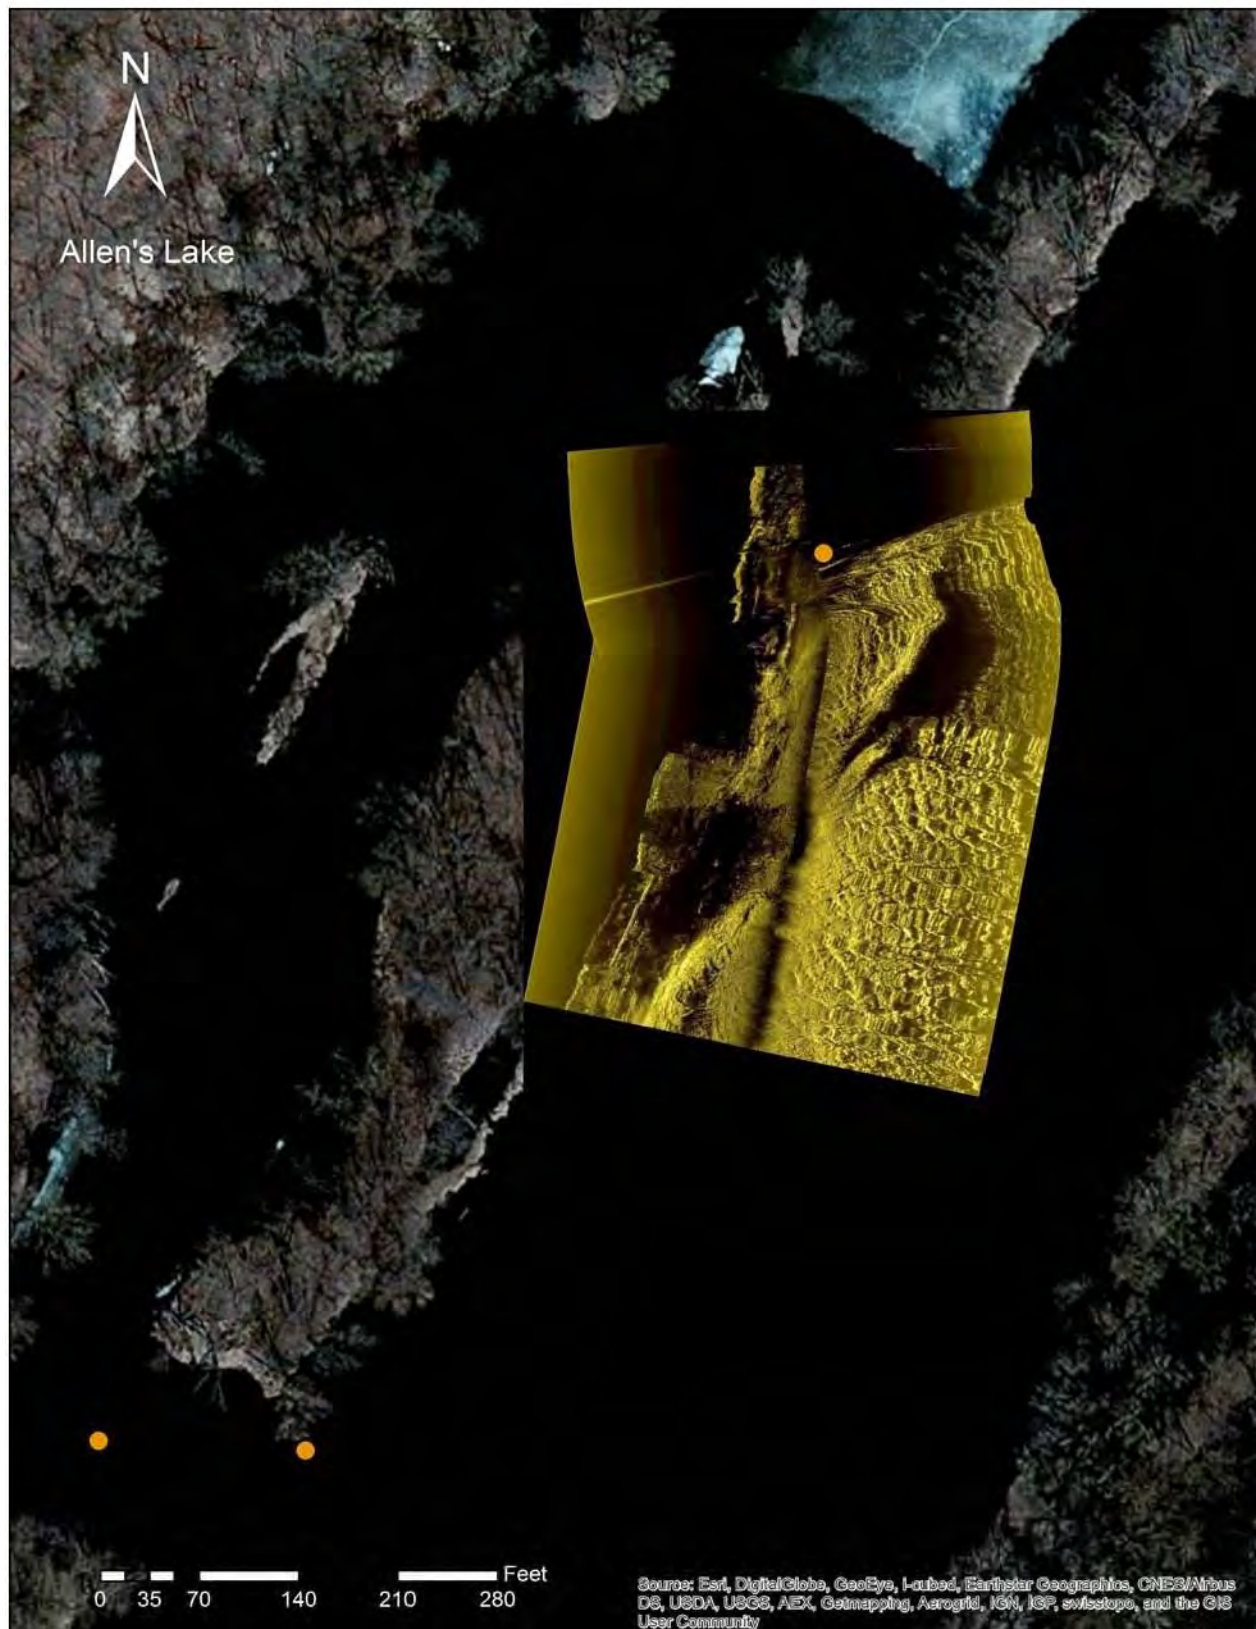
The 1937 USACE map indicated one wing dam and two proposed closing dams, providing a search area for sonar survey (Figures 63 and 64). The survey team established eight GPS targets for investigation, via sonar and in-person searches on foot and kayak (Figure 65). GPS target 123 proved to be the remains of a wing dam, 40 feet long and approximately 10 feet wide. Target 57 was another wing dam, at the site indicated on the 1937 map. This dam had approximately 10 feet of remaining timber structure *in situ*, running towards the south. The other six targets were investigated, but no further remains of historical water control features were identified.

FIGURE 65. The sonar imagery from Allen's Lake.

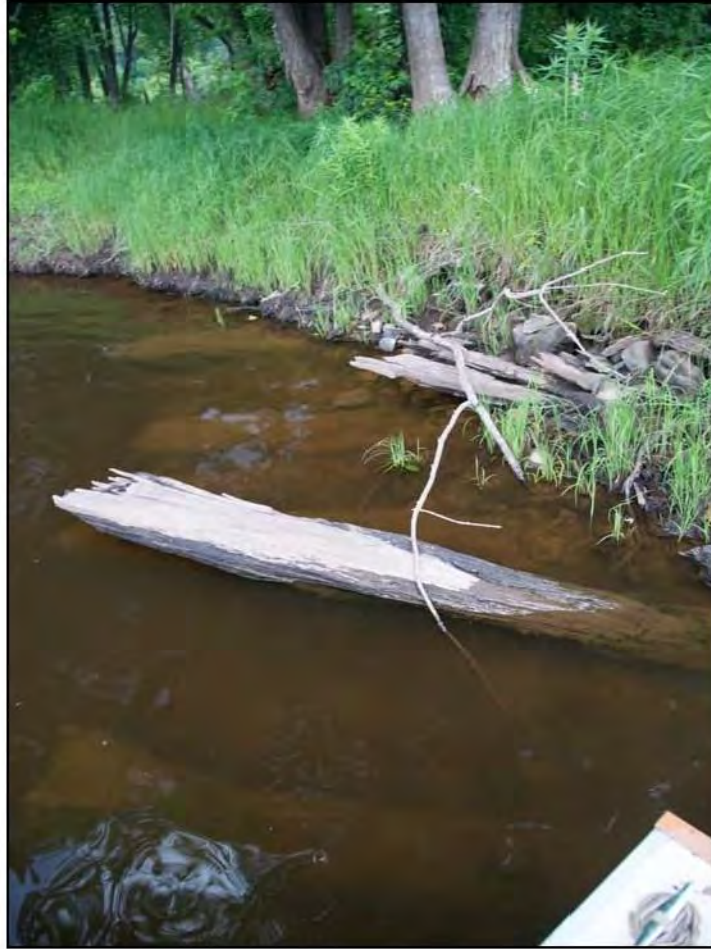
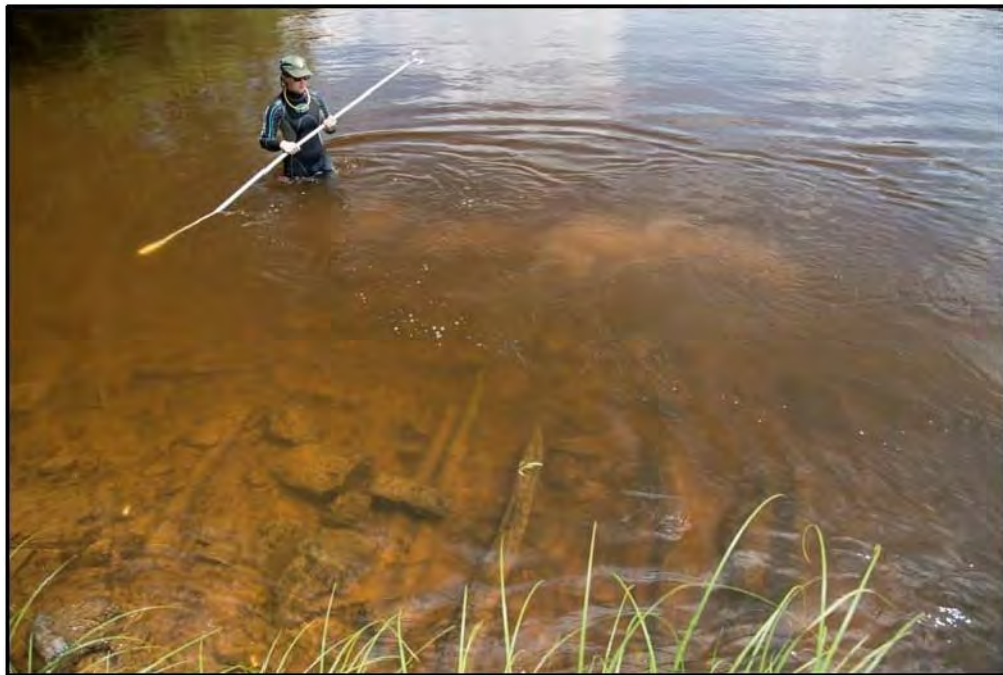
This historical information provided the survey team with nine targets for sonar investigation, four of which proved to be associated with West Slough water control features (Figures 71 and 72). GPS target 65 proved to be the large closing dam recommended in the 1937 map, with a smaller rock dam (target 66) nearby, which must have closed off a small channel behind the larger dam. Investigation of target 67 revealed a successful closing dam site, an elevated mound that restricted the slough, now covered with vegetation. Finally, GPS target 69 revealed a wing dam that was investigated on foot. The team took GPS site extents and photos of the feature, and noted a fascinating assemblage of log and timber remains extending out of the island (Figures 73 and 74).

FIGURES 73 and 74. Images from GPS 69 showing the structure of the wing dam.

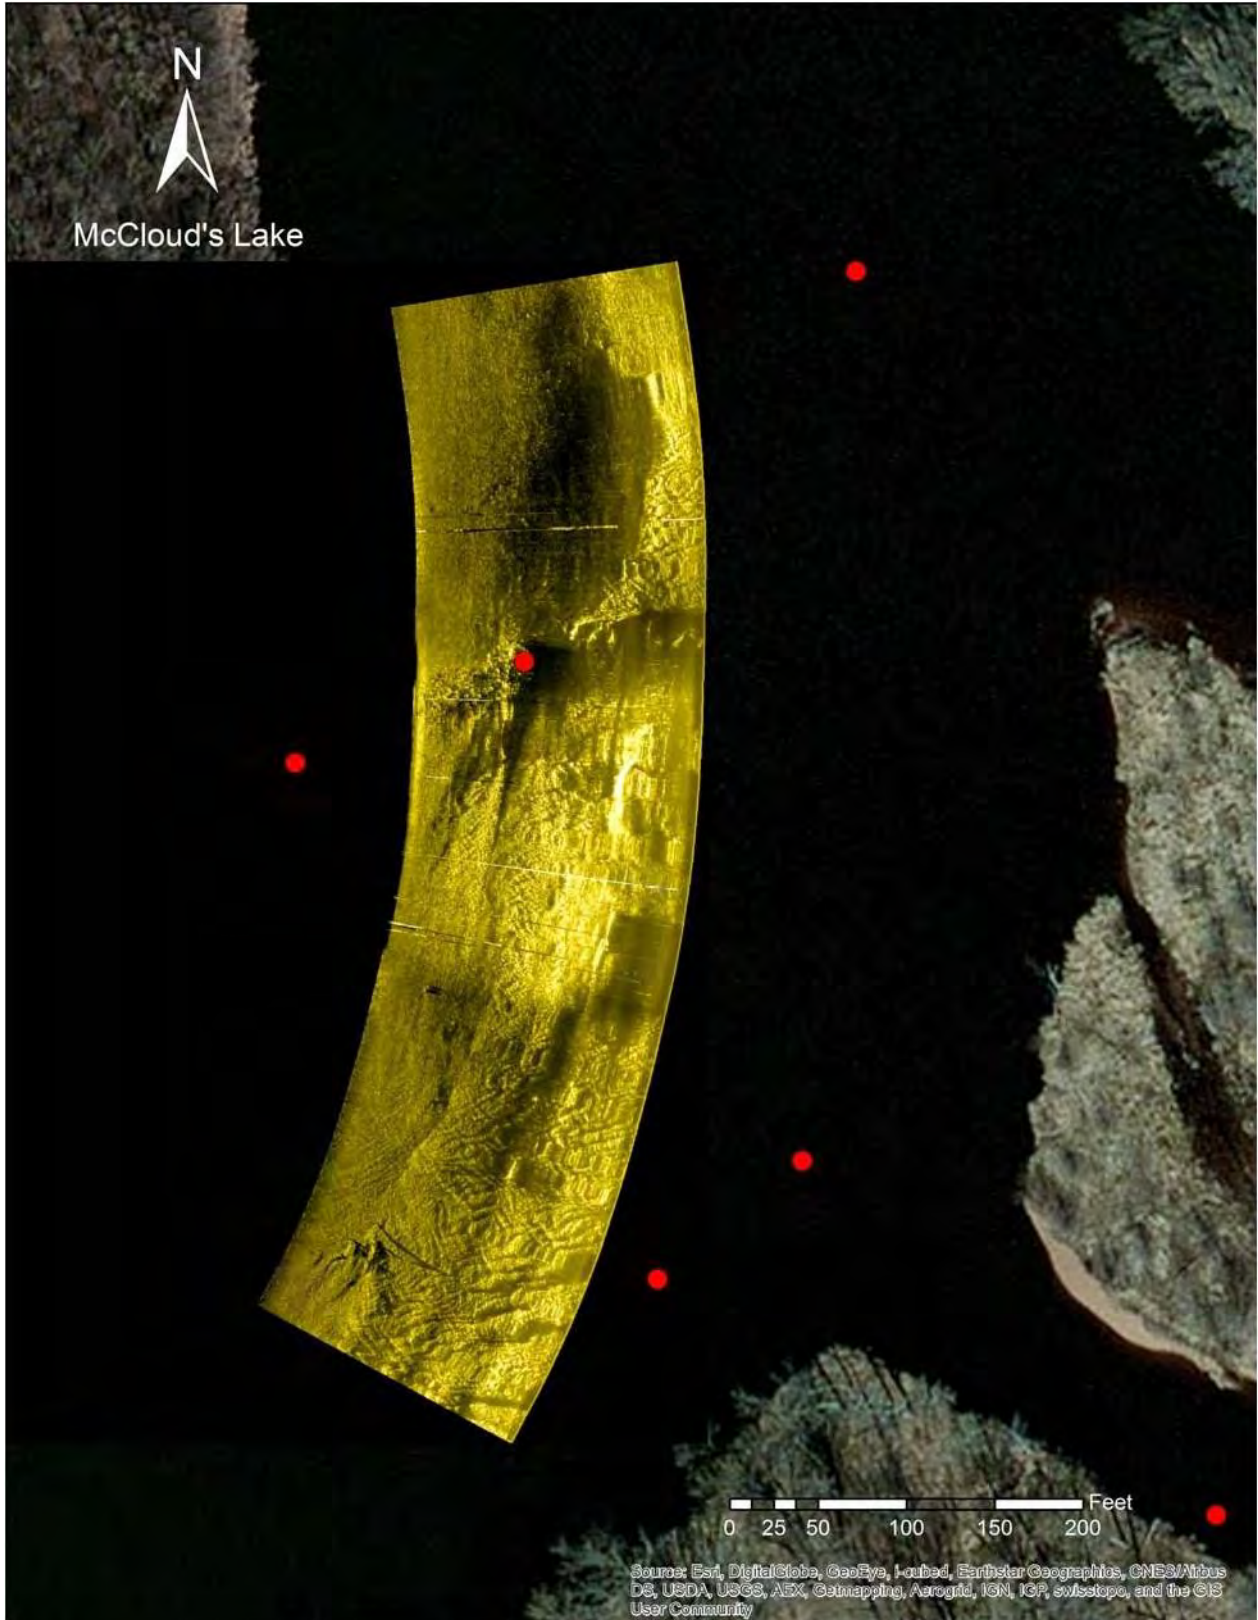
The paucity of data on the specific number of dams constructed, as well as their locations, led to a large survey area. Twelve general GPS targets were selected for sonar data collection (Figures 79 and 81). While the sonar images were complemented by shore investigations, 11 of the targets had negative findings. GPS target 72 proved to be the site of a probable closing dam, located upriver of the marsh (Figures 82 and 83). A GPS point was taken directly over the site, but extents of the feature could not be safely determined, due to a very strong current.

FIGURE 82. The sonar imagery from GPS target 72 at McCloud's Lake.

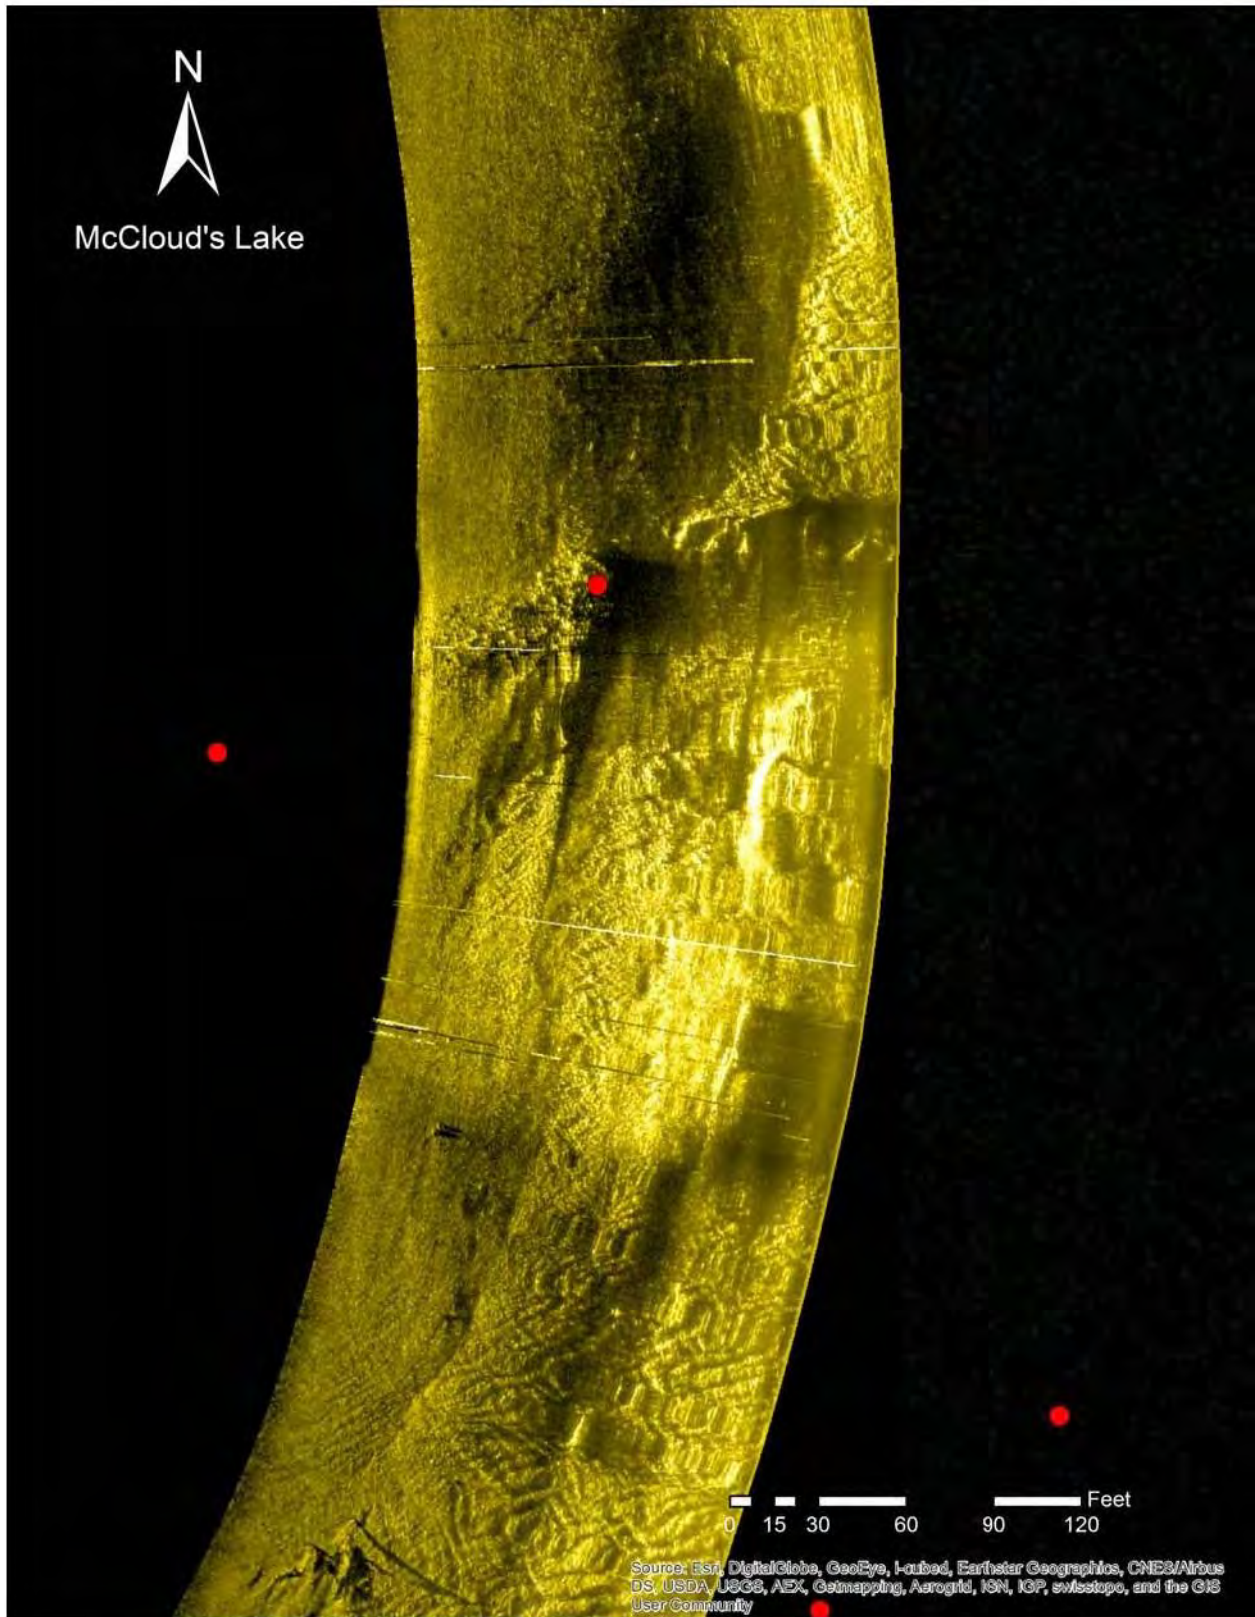
FIGURE 83. A close up of the sonar image from target 72 at McCloud's Lake.

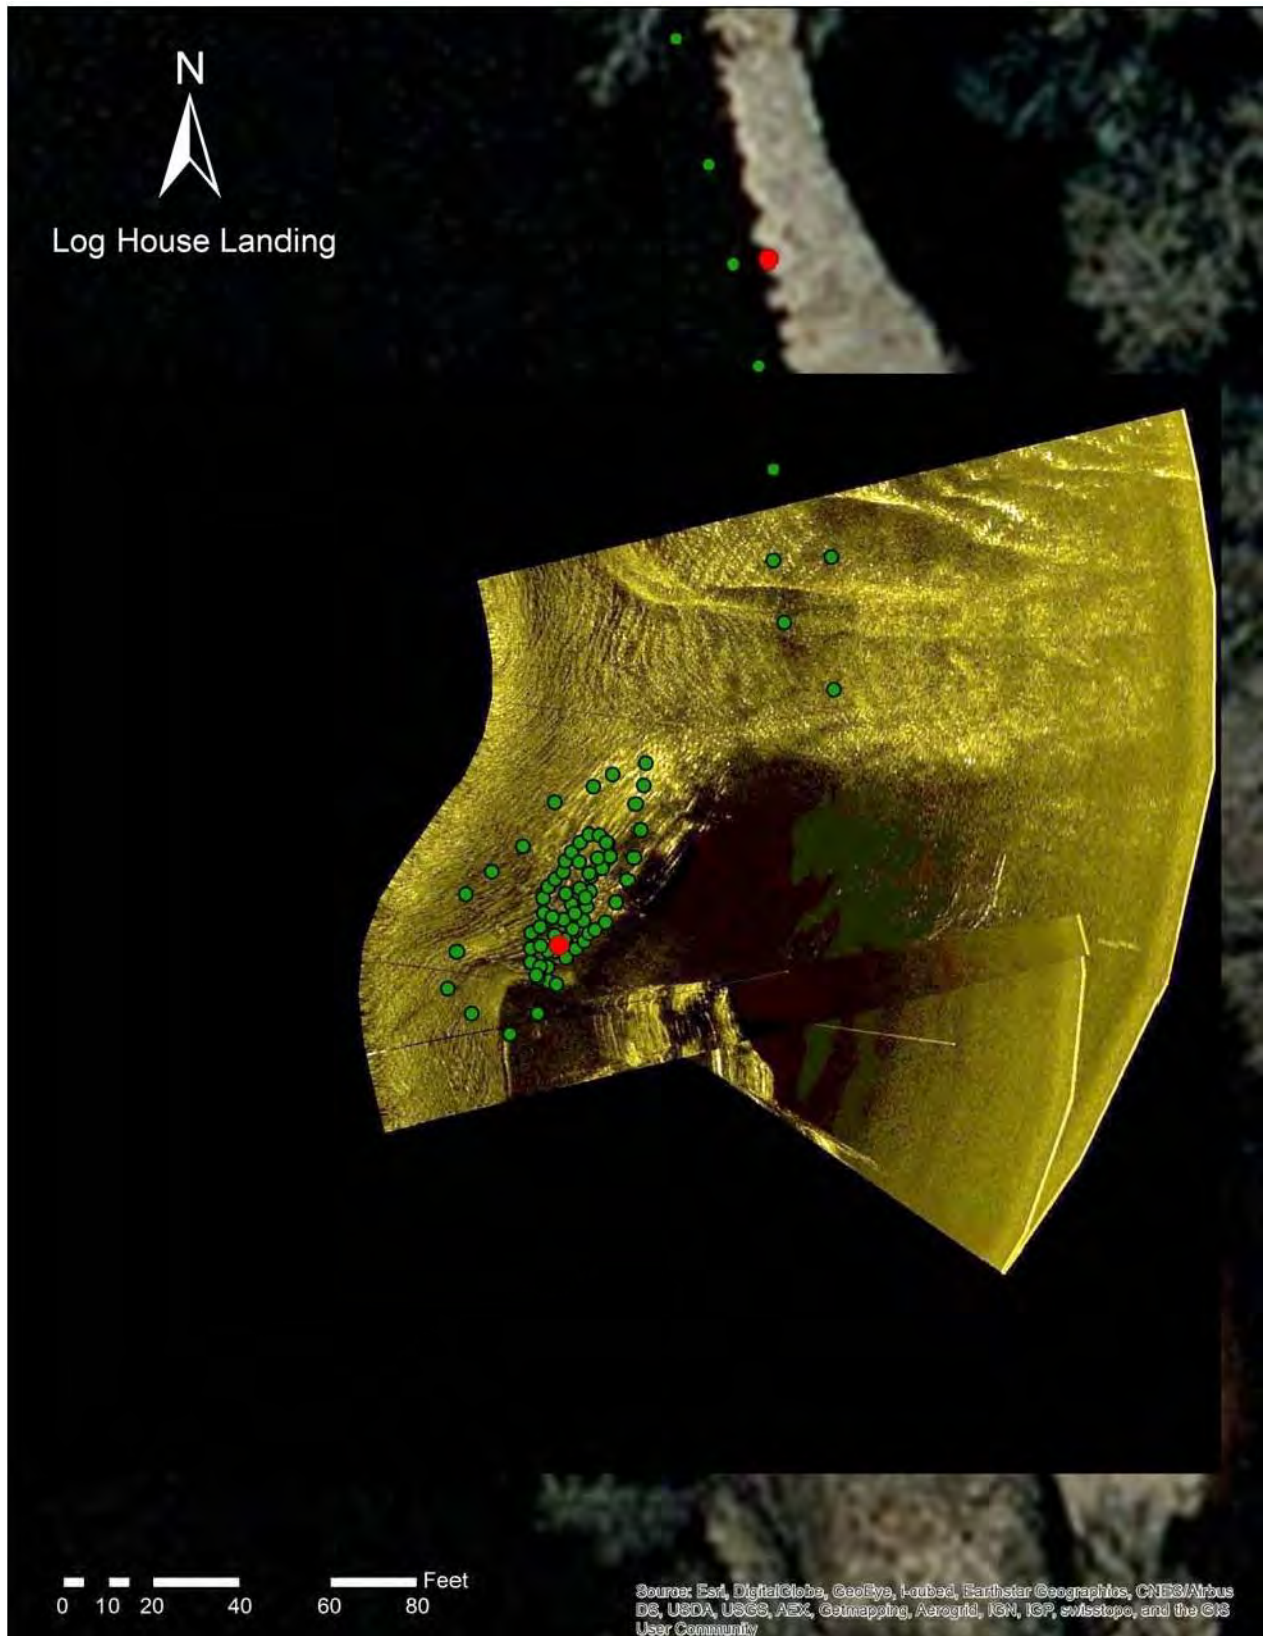
Sonar imagery was collected for three of the targets, and one required investigation via kayak (Figures 87 and 88). Only one point proved to have a dam associated with it, but it was located very close to the point on the 1937 map, and was clearly historically constructed with brush and stone.

FIGURE 88. Sonar imagery of the closing dam showing transit points that have been post-processed to show their spatial locations shown in green.

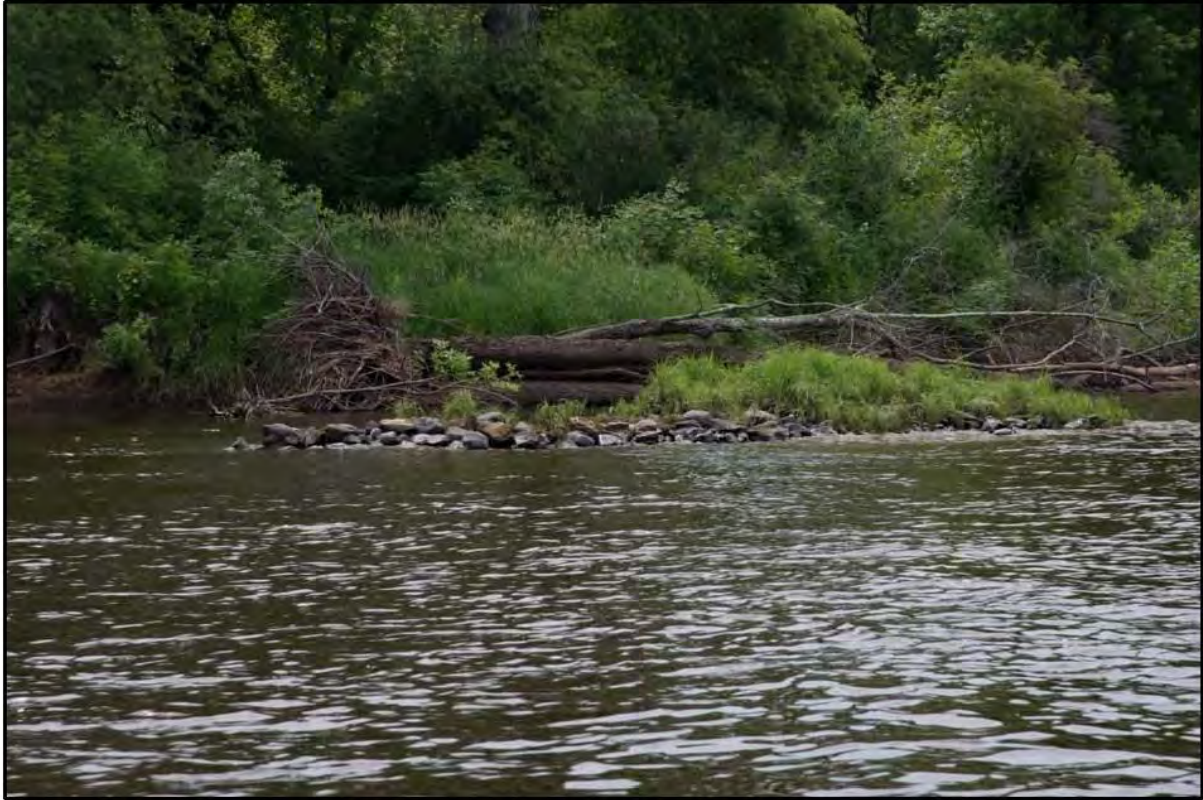
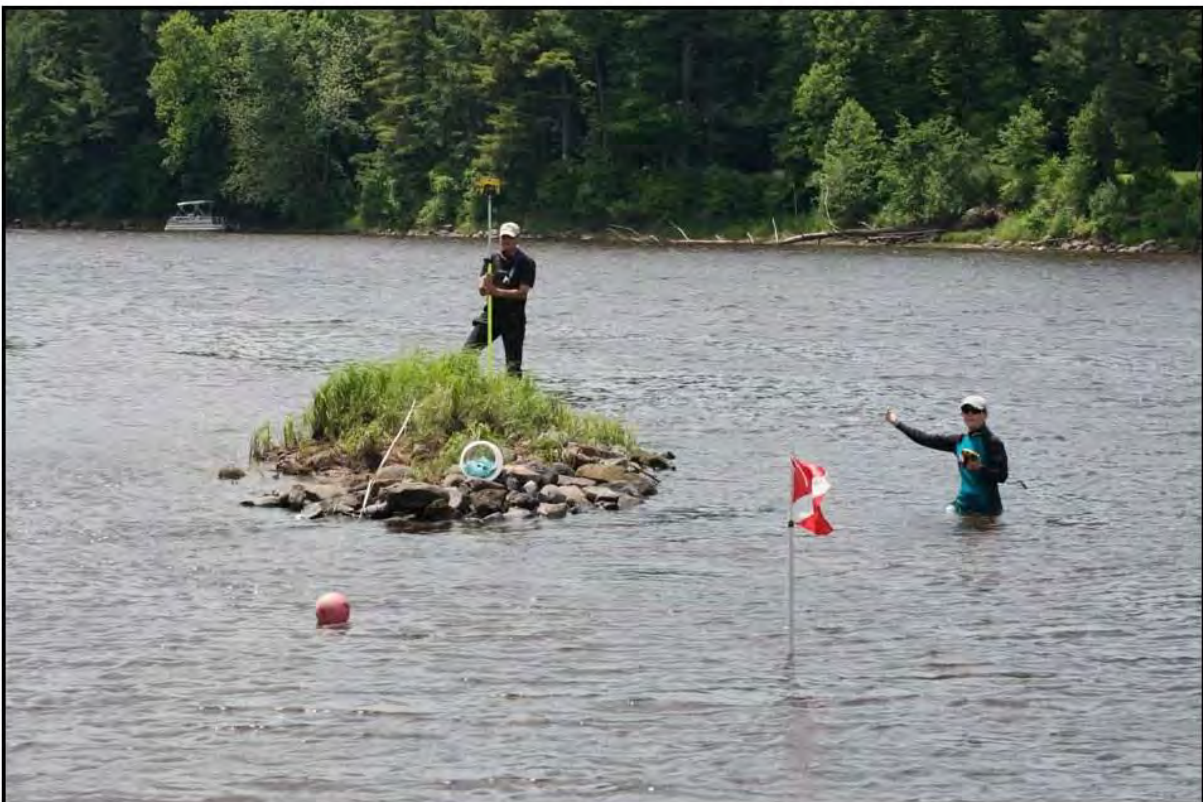
The dam itself comprised a large mounded structure, extending above the water's surface, and composed of layers of brush and rock. The structure's eastern side had a very steep relief of 11.5 feet over a distance of approximately 19 feet, as the dam had formed a deep channel along its bank that had collected significant debris. The slope was much more gradual on the dam's western side, steadily dropping 4.5 feet over a distance of 22 feet to the river bottom. With measurements collected, the team was able to map the plan view of the dam on Mylar, which was later inked (Figure 94).

FIGURES 89 and 90. Images from Log House Landing brush and rock dam.

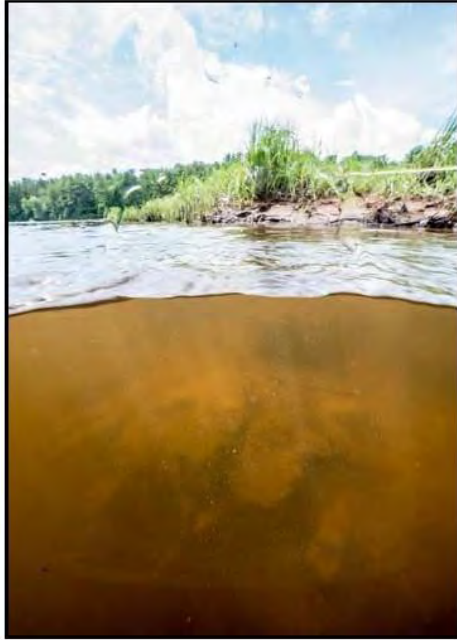
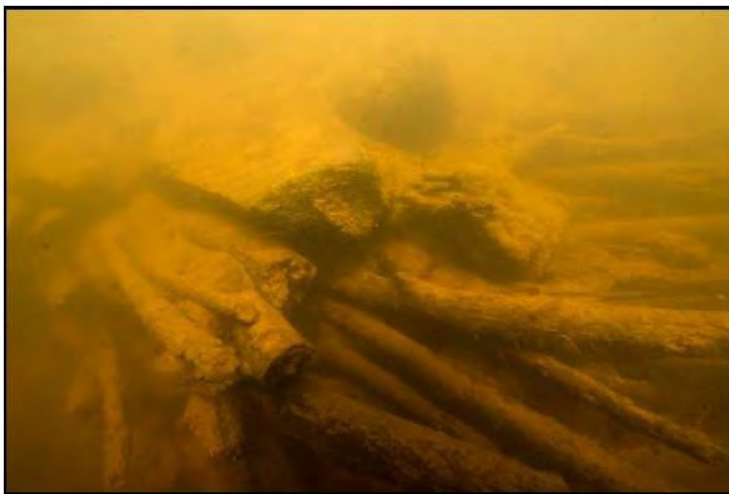
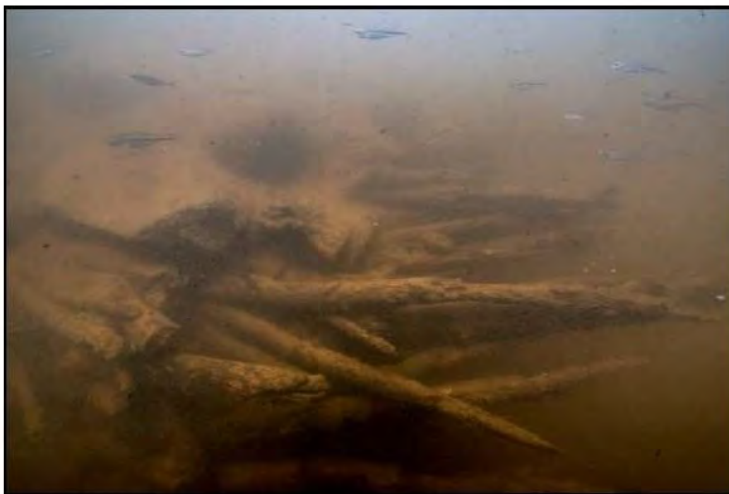
FIGURES 91-93. Images from Log House Landing brush and rock dam.

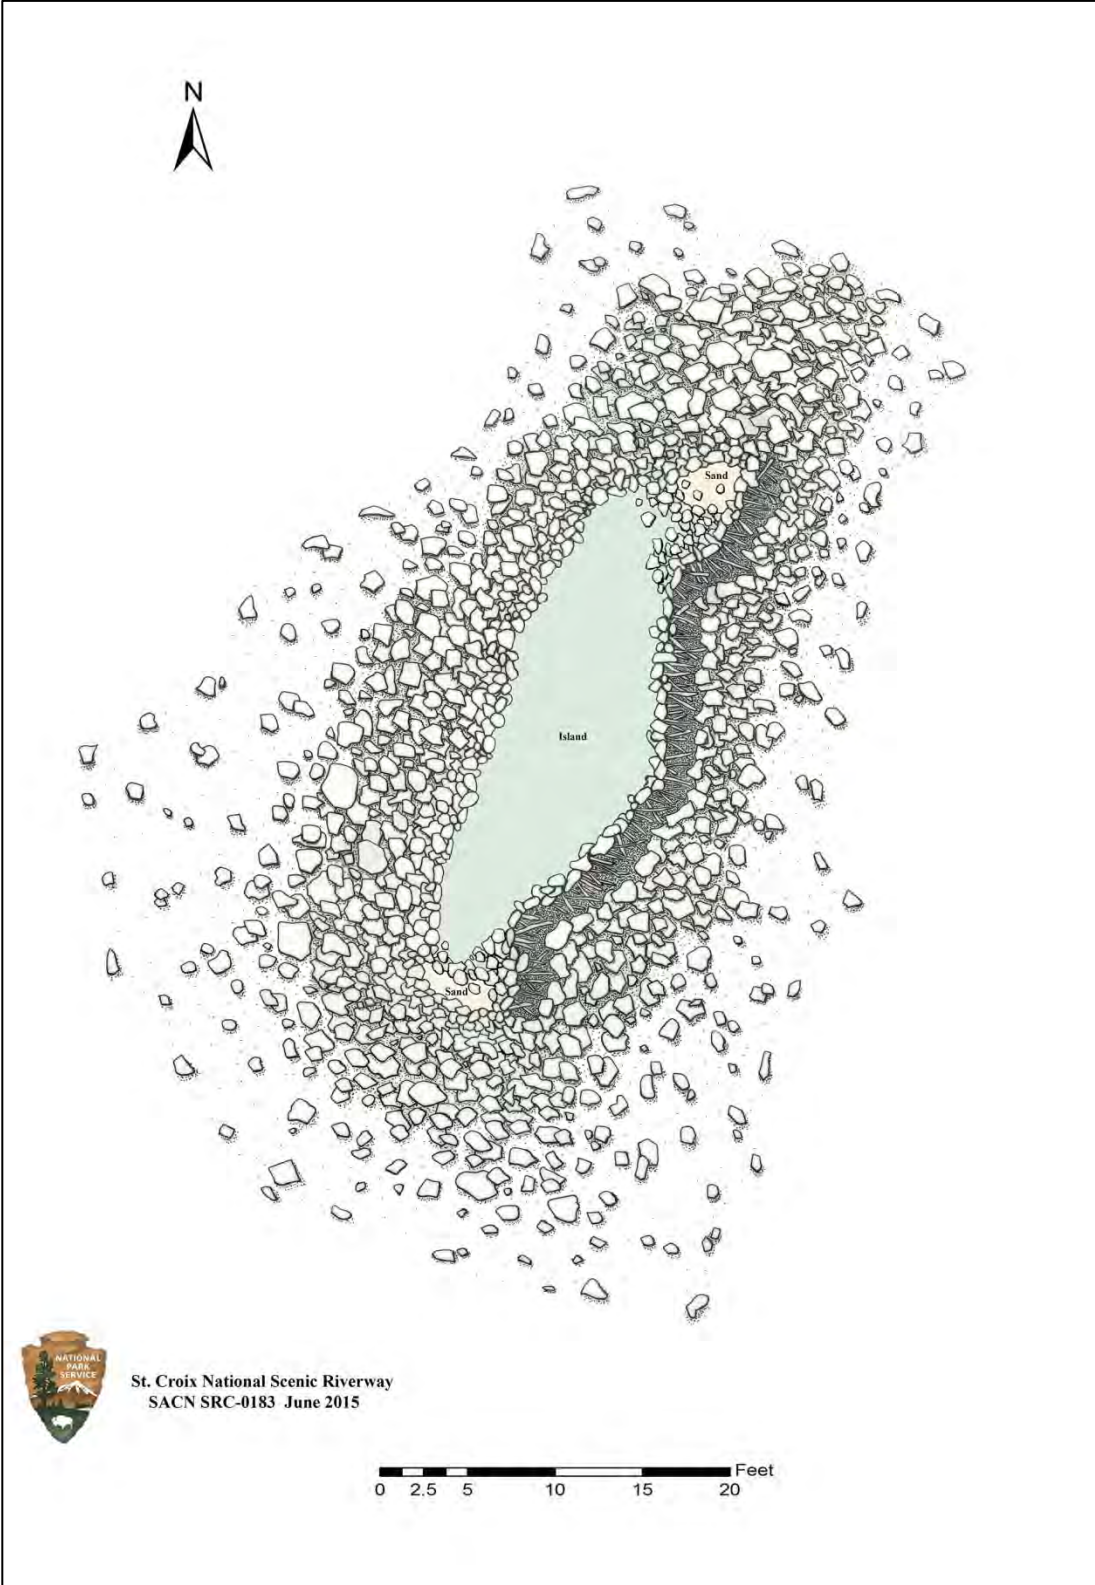
FIGURE 94. Log House Landing site map.
