## *St. Croix National Scenic Riverway*

### *Ruins of a Forgotten Highway: Survey and Documentation of Historic Water Control Features*

A product of the National  
Park Service Submerged  
Resources Center

Denver, Colorado  
2015

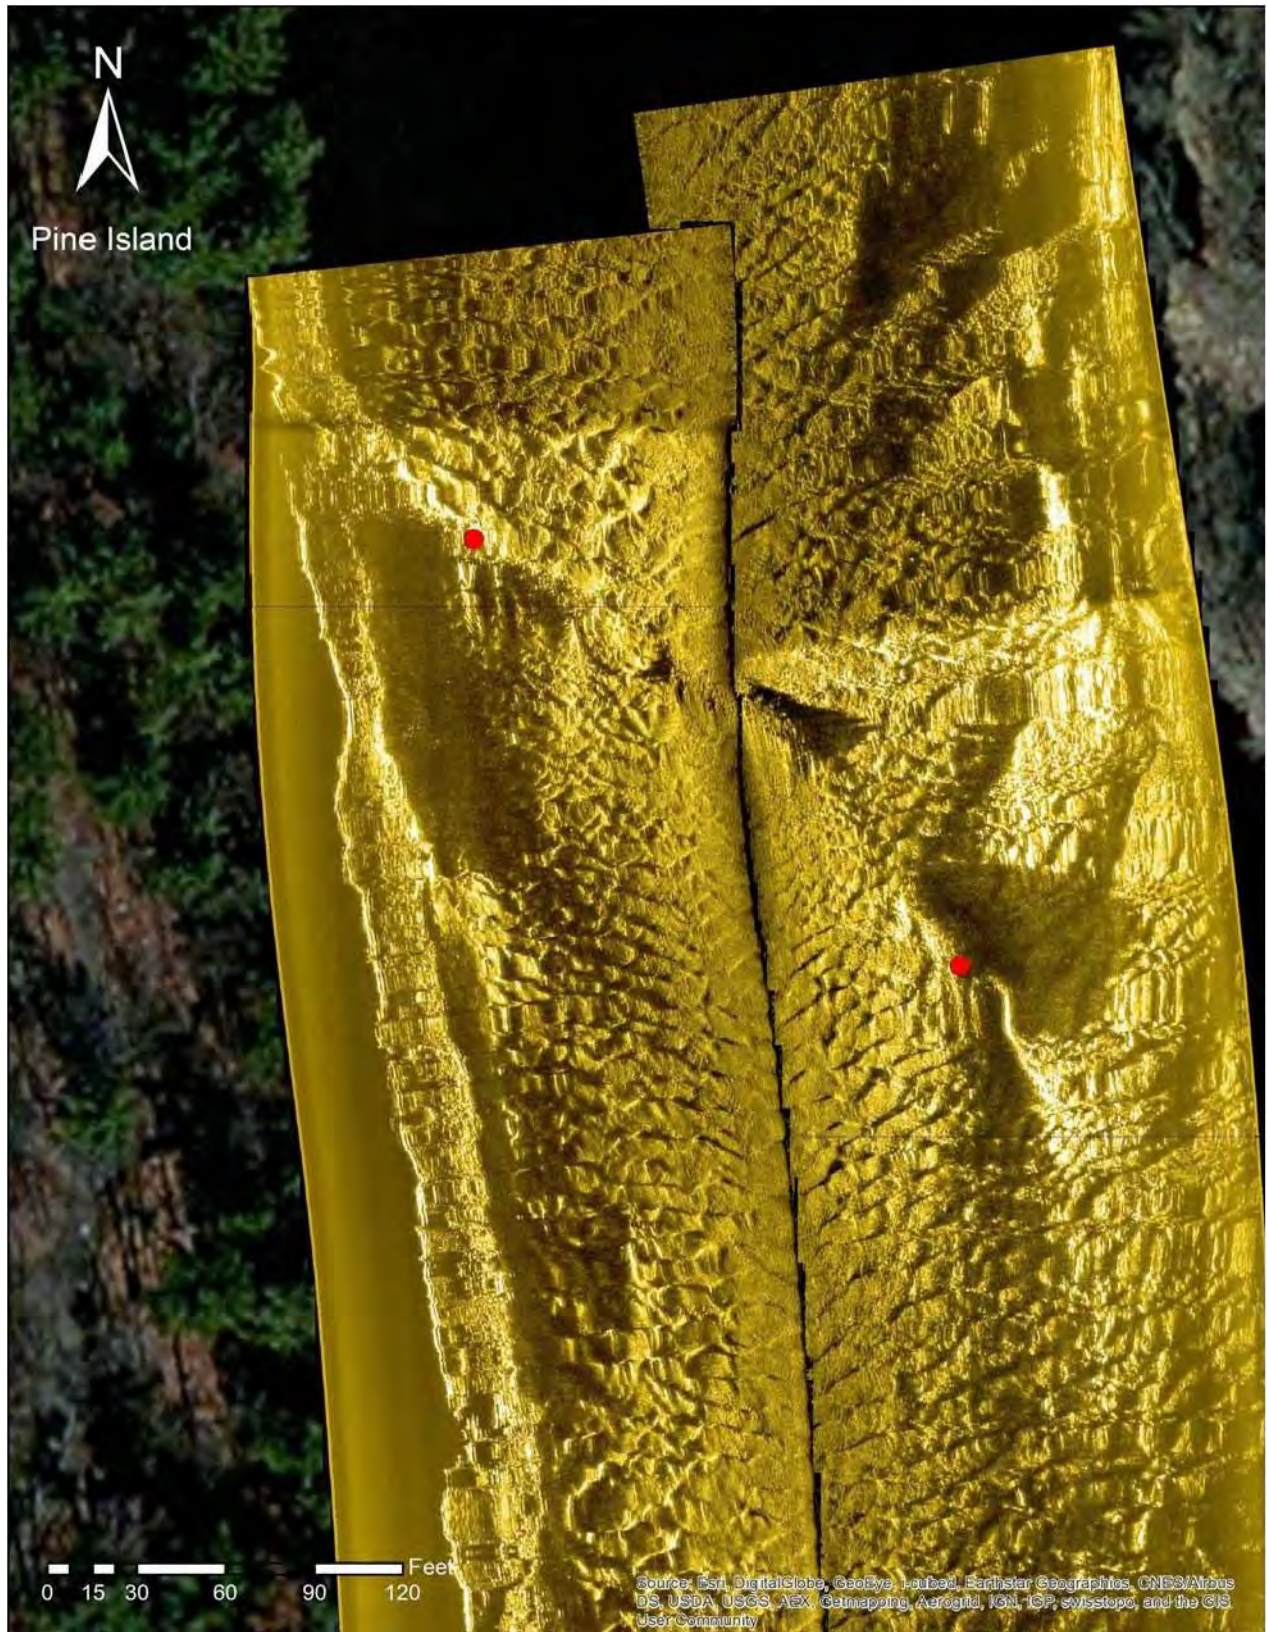
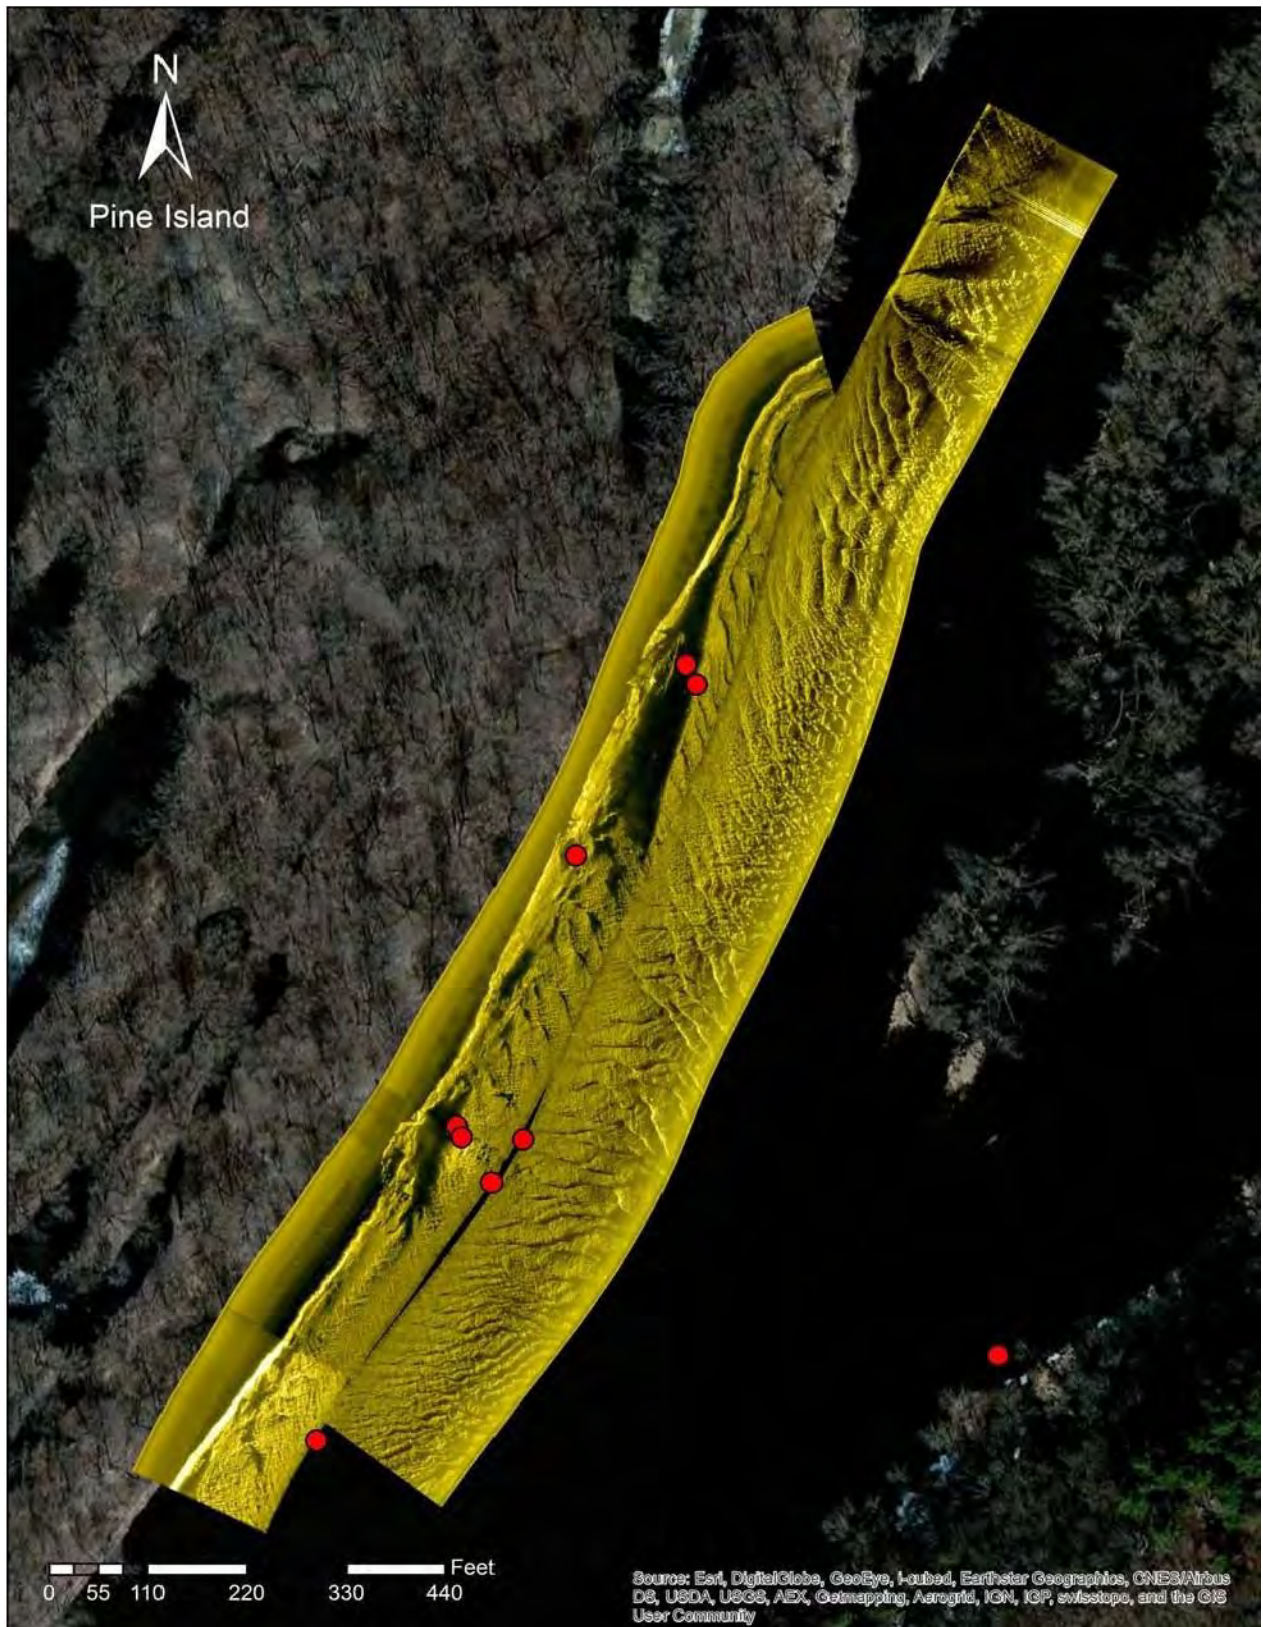
This map greatly assisted the placement of targets for survey and investigation. The team selected twelve areas for sonar survey, and each site with promising sonar imagery was visited in person. GPS target 85 revealed the remains of a wing dam, north of the original GPS target. The identified wing dam was labeled PineIslandLargeWingDam is seen on the 1937 map (Figures 102 and 103). GPS target 83 was confirmed to be the location of the large closing dam present on the 1937 map. The site of target 83 included rocks extending approximately 10 feet west into the water from the southern tip of the island, probably the remains of a larger dam structure that was removed or washed away. GPS target 89 was originally selected via reference to the 1937 overlay; however, during sonar investigation a rock wing dam was discovered and the new location named Pine89 (Figures 104 and 105). The team collected GPS points at Pine89 at northern, southern, and shoreline extents. Sonar imagery revealed the remains of another rock structure labeled Pine.Possible.Structure, but due to the strong current, only one GPS point was collected and it was not investigated further. This feature may be associated with the structures shown on the 1937. While sonar data was collected at each of the other targets, and shore investigations were conducted as necessary, no other cultural remains were located.

FIGURE 102. The sonar imagery from upper Pine Island showing the large wing dam labeled PinelandsLargeWingDam.

FIGURE 103. A close up of the sonar imagery from PinelslandLargeWingDam.

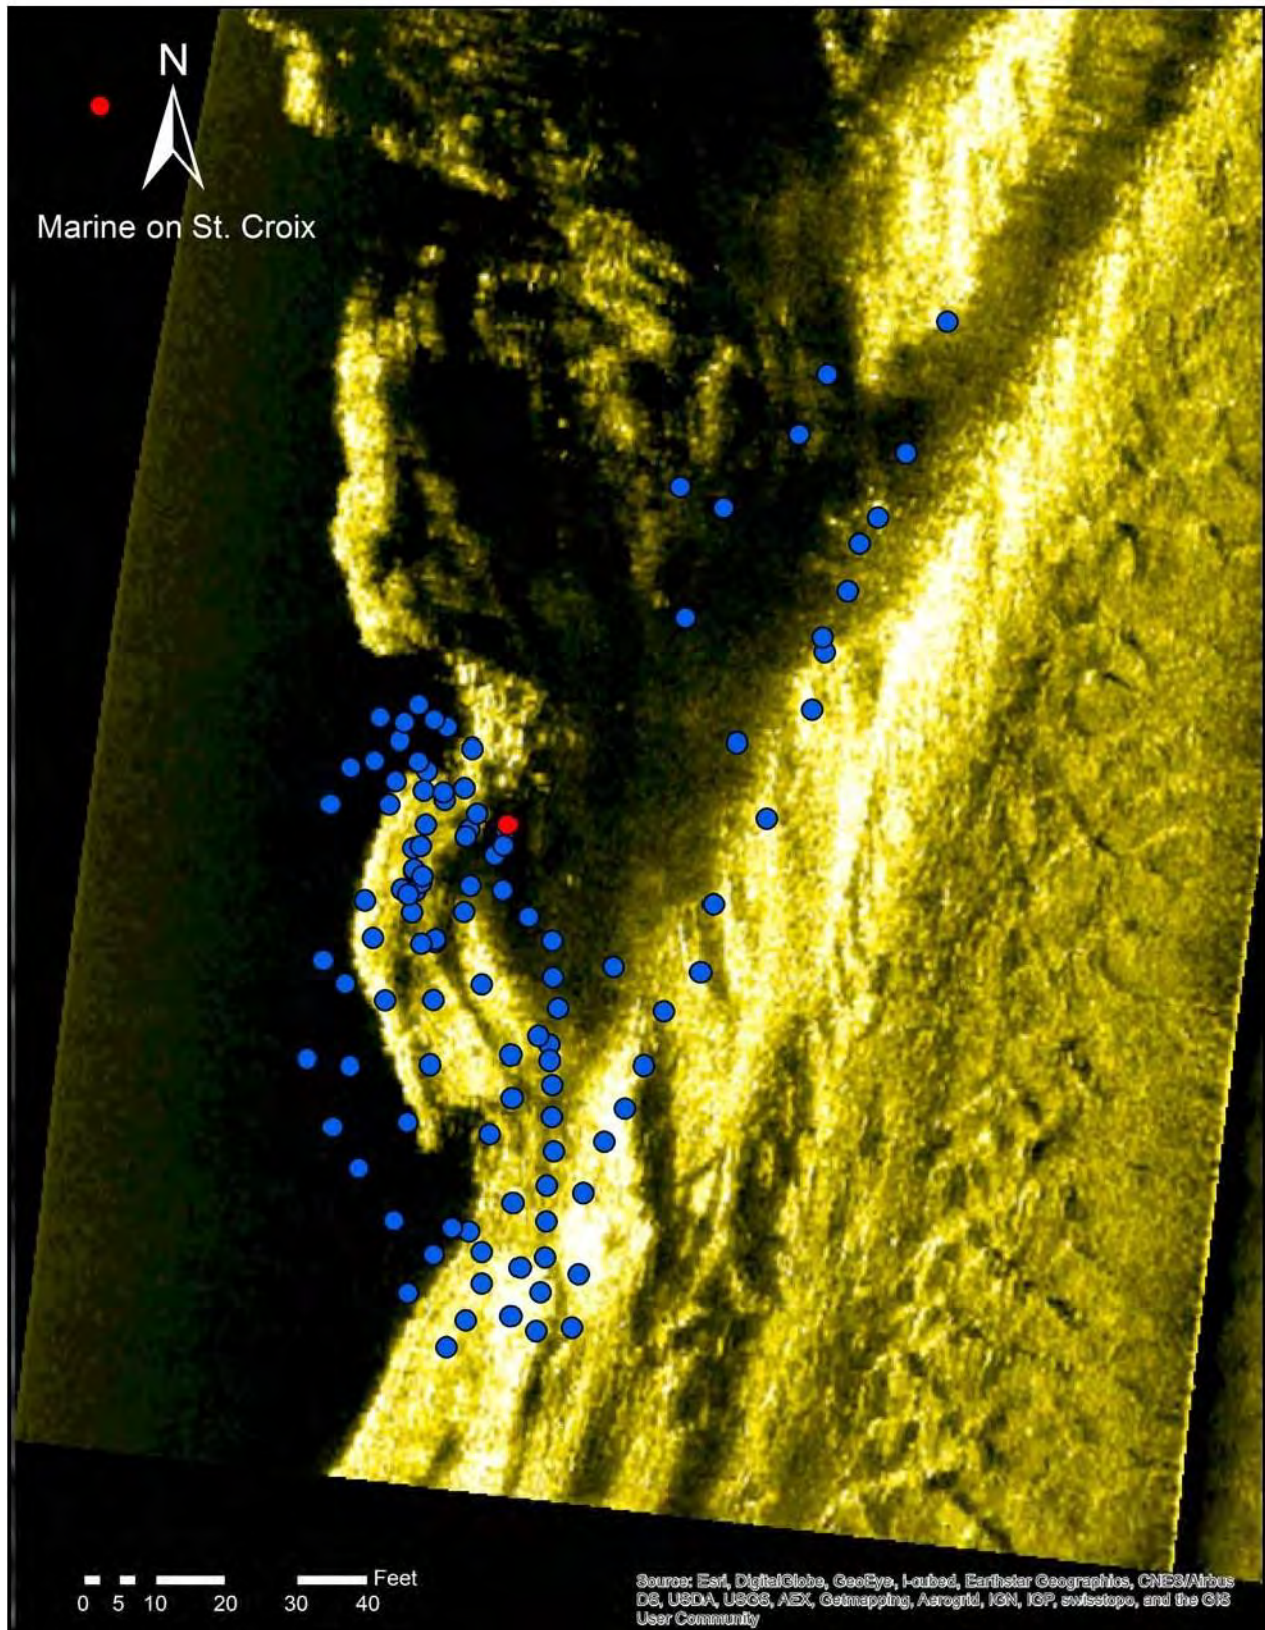
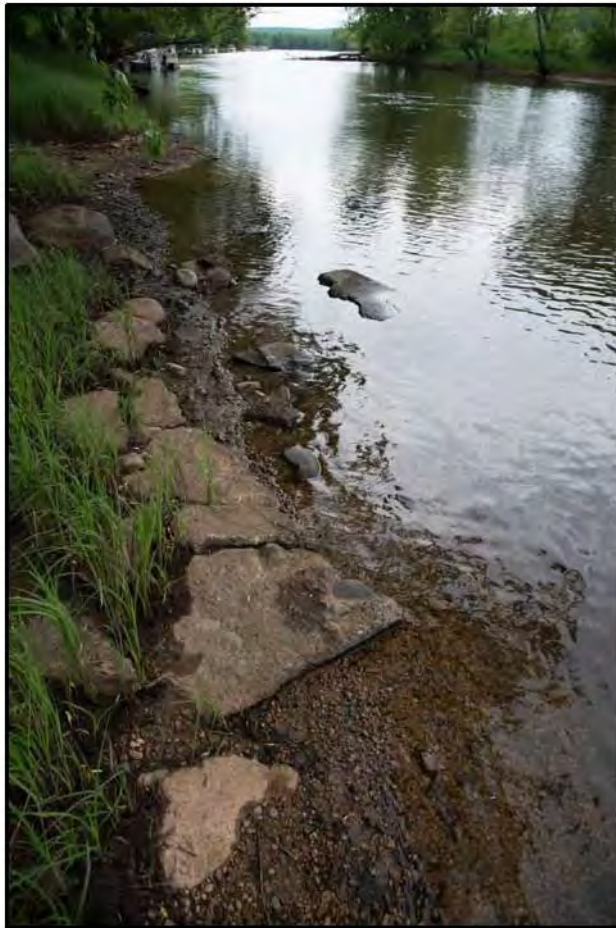
The 1937 USACE map indicated three dams, assisting the survey team in placing nine search targets for survey (Figures 109-111). GPS target 142 revealed two isolated rock piles, but no other remains associated with a dam structure. A second target was examined by sonar, revealing the remains of a wing dam, and a crib, a type of revetment, still remaining on the adjacent island (Figures 112 and 113). A shore search near the Marine on St. Croix landing located the likely remains of a dam, with 4-6 logs on the Minnesota shore, and rocks on both sides of the landing. A third site displayed on shore cribbing with a corresponding rock wing dam. The remaining targets were surveyed with sonar, and investigated in person as needed, but no additional cultural remains were located.

FIGURE 112. Sonar imagery from the wing dam and cribbing at Marine on St. Croix.

FIGURE 113. Sonar imagery of the wing dam and cribbing showing transit points that have been post-processed to show their spatial locations shown in blue.

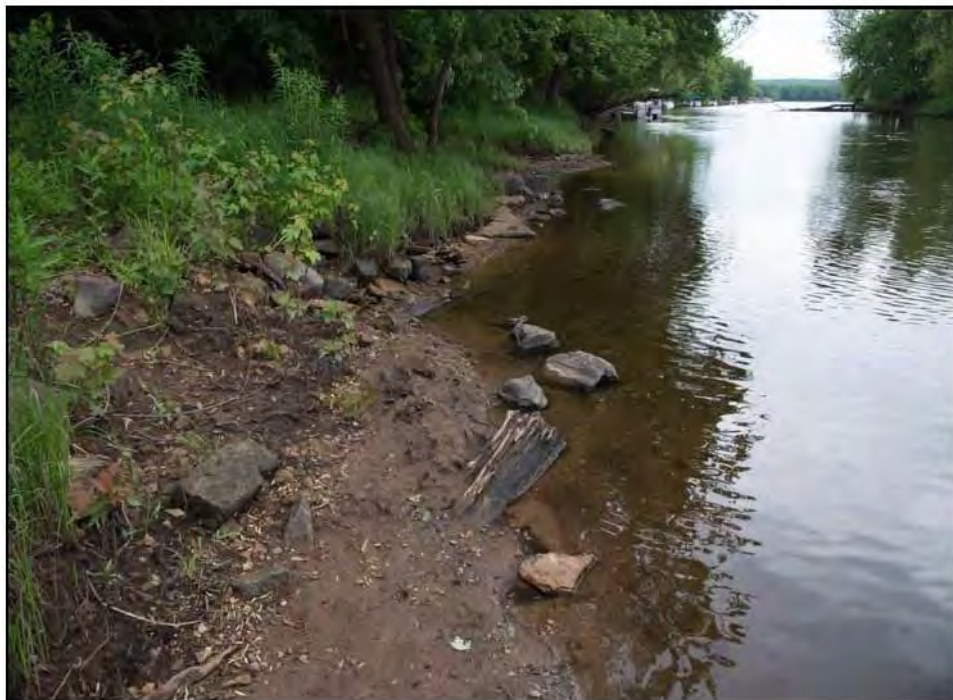
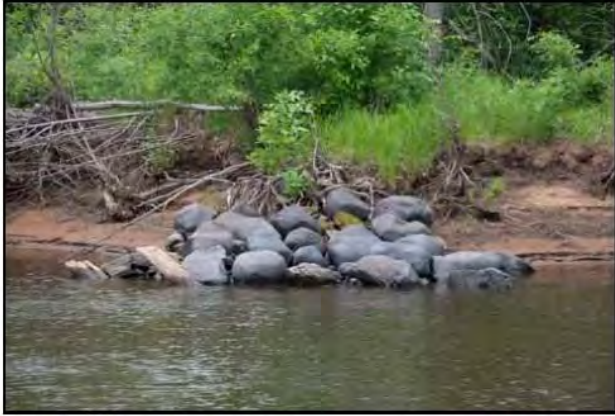
The team selected the wing dam with associated cribbing at Marine on St. Croix for mapping, and collected images of the site (Figures 114-121). The location and structure visibly will benefit visitors as the river levels change throughout the year. To get the full extents of the site, two baselines were established, one across a potential revetment site, 40 feet long at a compass bearing of 320 degrees, and another departing from the first baseline's southern extent at 190 degrees, making a total baseline of 95.6 feet. To gather both plan and profile data, baseline offsets and depth measurements were acquired every five feet. The team soon realized that the dam extended almost 100 feet further into the river than first realized, and took GPS and Total Station measurements of features, baselines, and shoreline. Additional points were used from the sonar imaging to create the full site extents as swift current, increased water depth, and low visibility created possible error during physical investigations. Additionally, the team took trilateration measurements from the first baseline to map the locations of the log cribbing. The plan view of the site, and a profile view of the revetment were mapped onto Mylar, then inked (Figures 122-124).

FIGURES 114 and 115. Images from GPS 69 showing the structure of the wing dam.

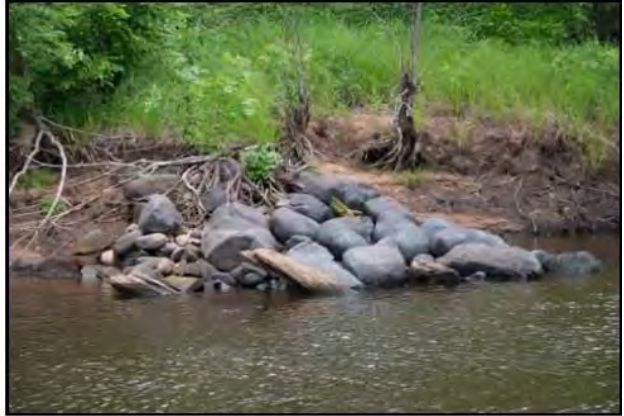
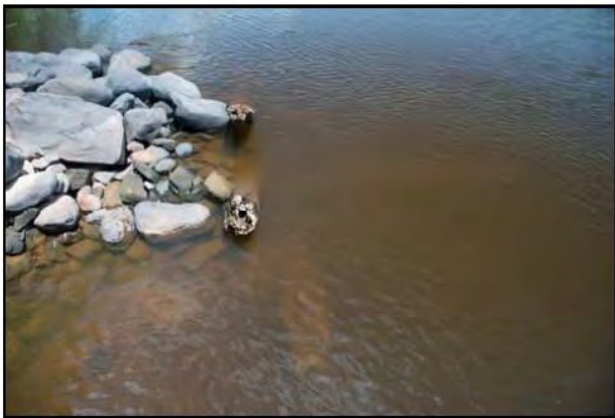
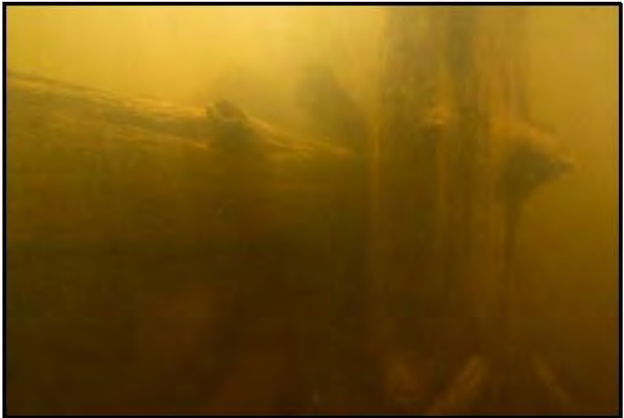
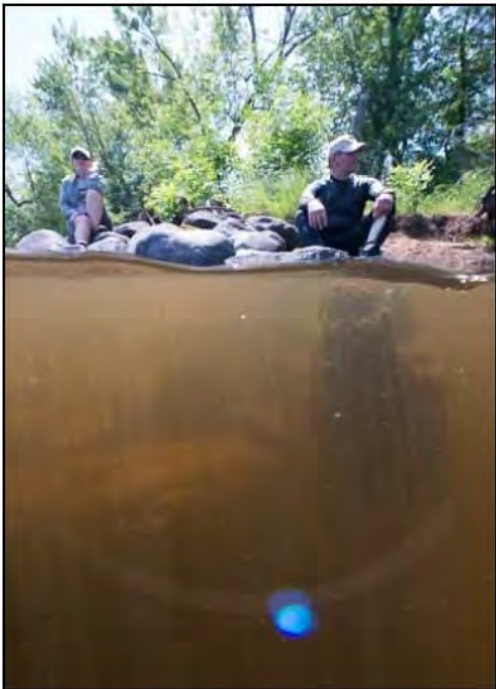
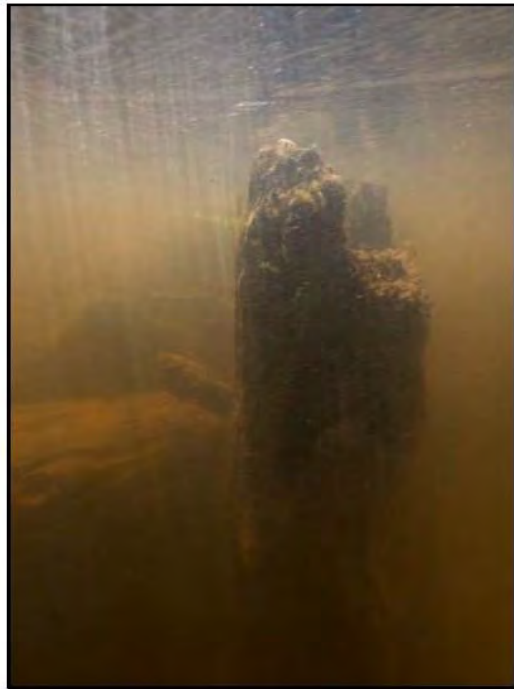
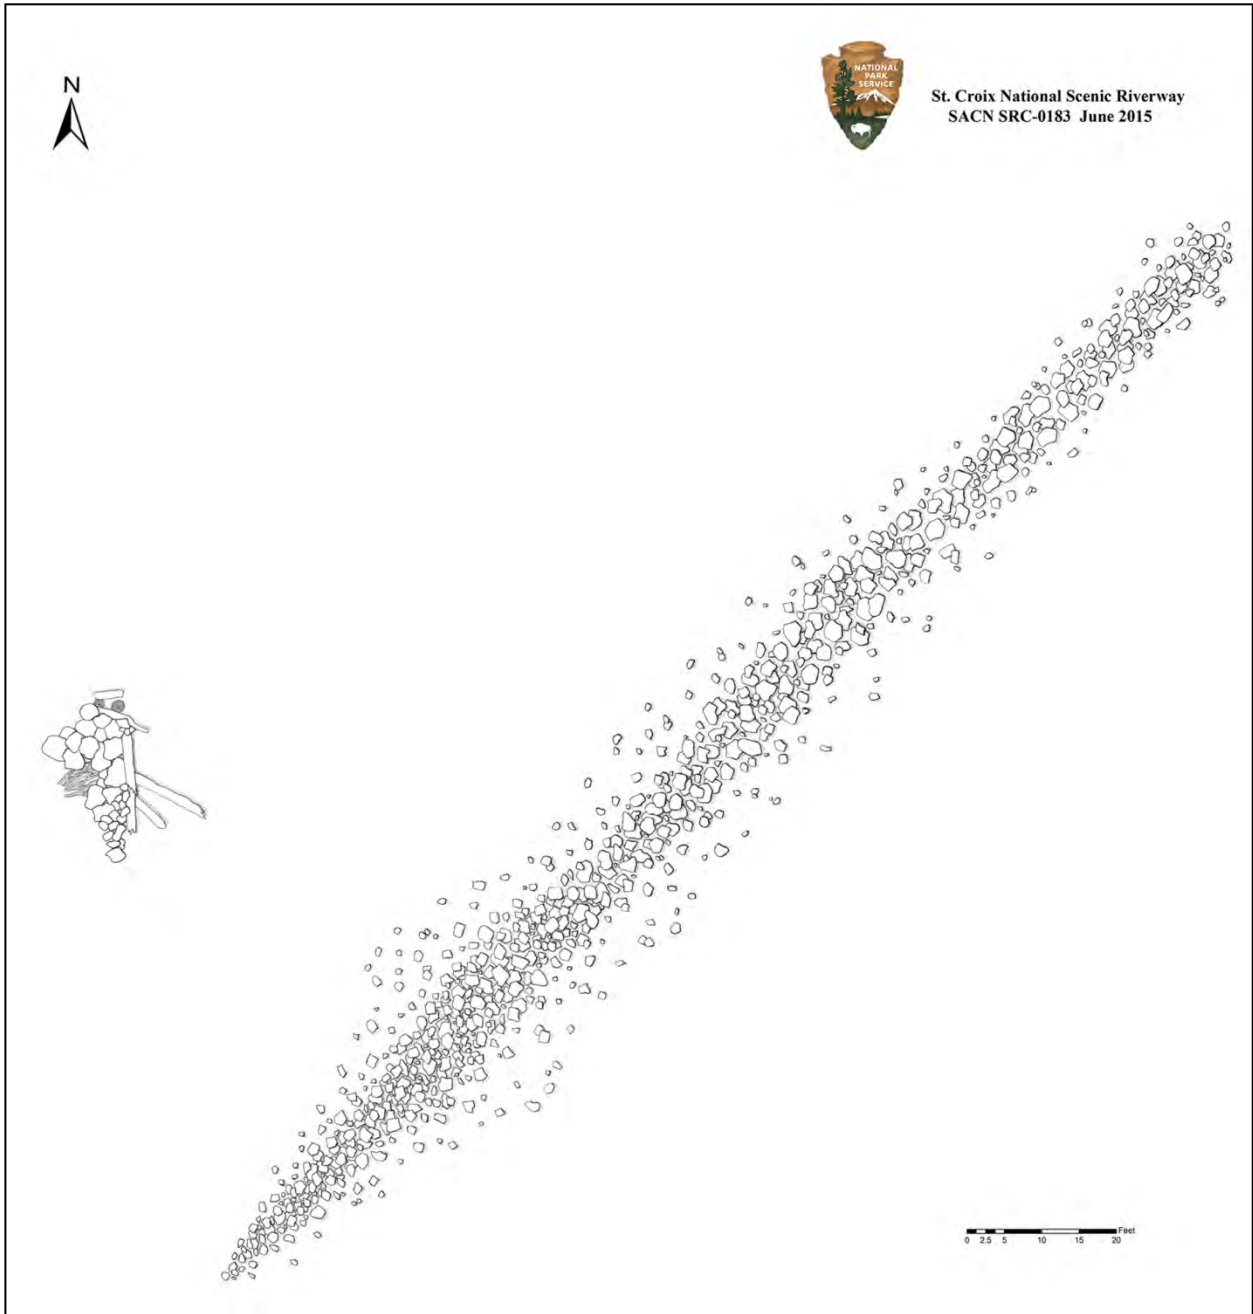
FIGURES 116-121. Images from Marine on St. Croix showing the structure of the cribbing.

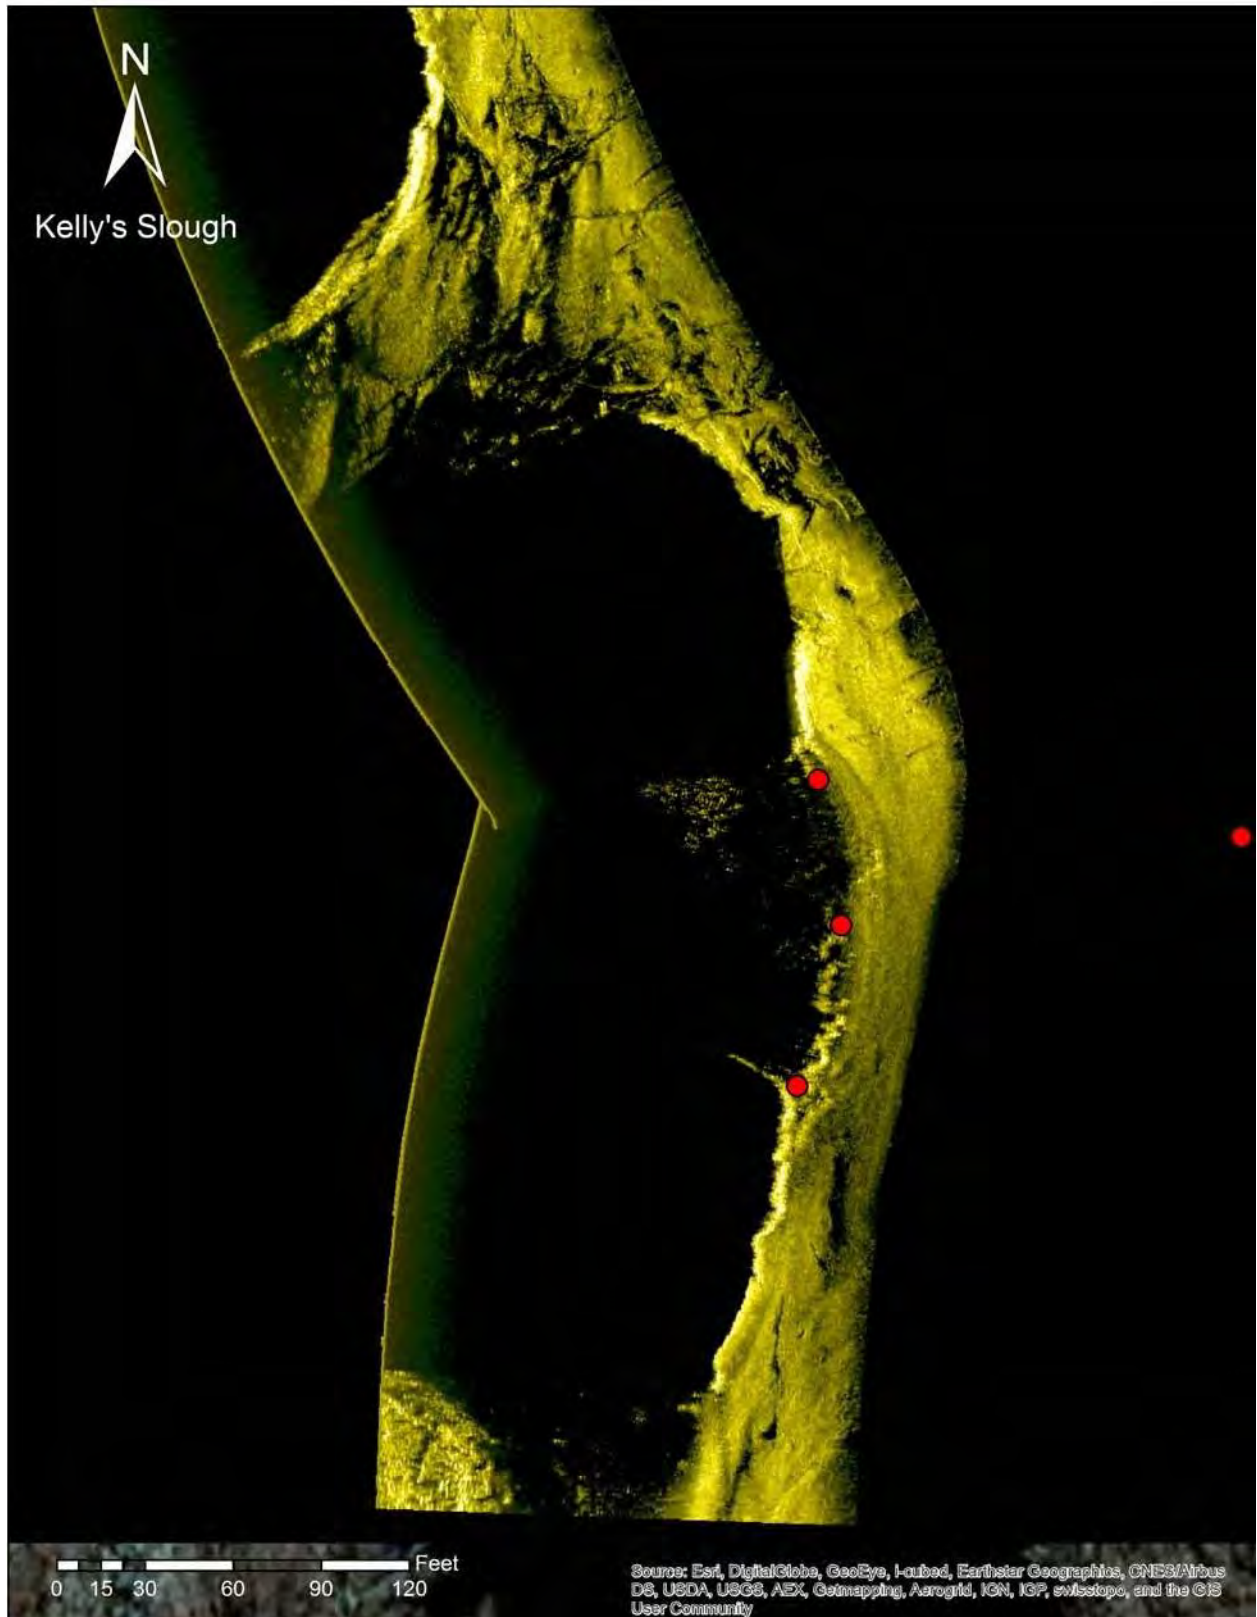
With limited geographic data on the location of dam structures at Kelly's Slough, but with the knowledge that the high number of caving banks and the known work in the 19th century likely left cultural remains *in situ*, the team completed sonar survey over a great deal of the area, focusing on 21 GPS targets. Targets producing promising imagery were investigated in person, either via diving or shore searches. A majority of the sites investigated revealed only bottom contours, with only two sites identified. GPS target 107 appeared to be a successful closing dam completely covered in sediment (Figures 136 and 137). Its placement between the two islands and sharp contoured edges support this assumption.

FIGURE 136. The sonar imagery from GPS target 107 at Kelly's Slough.

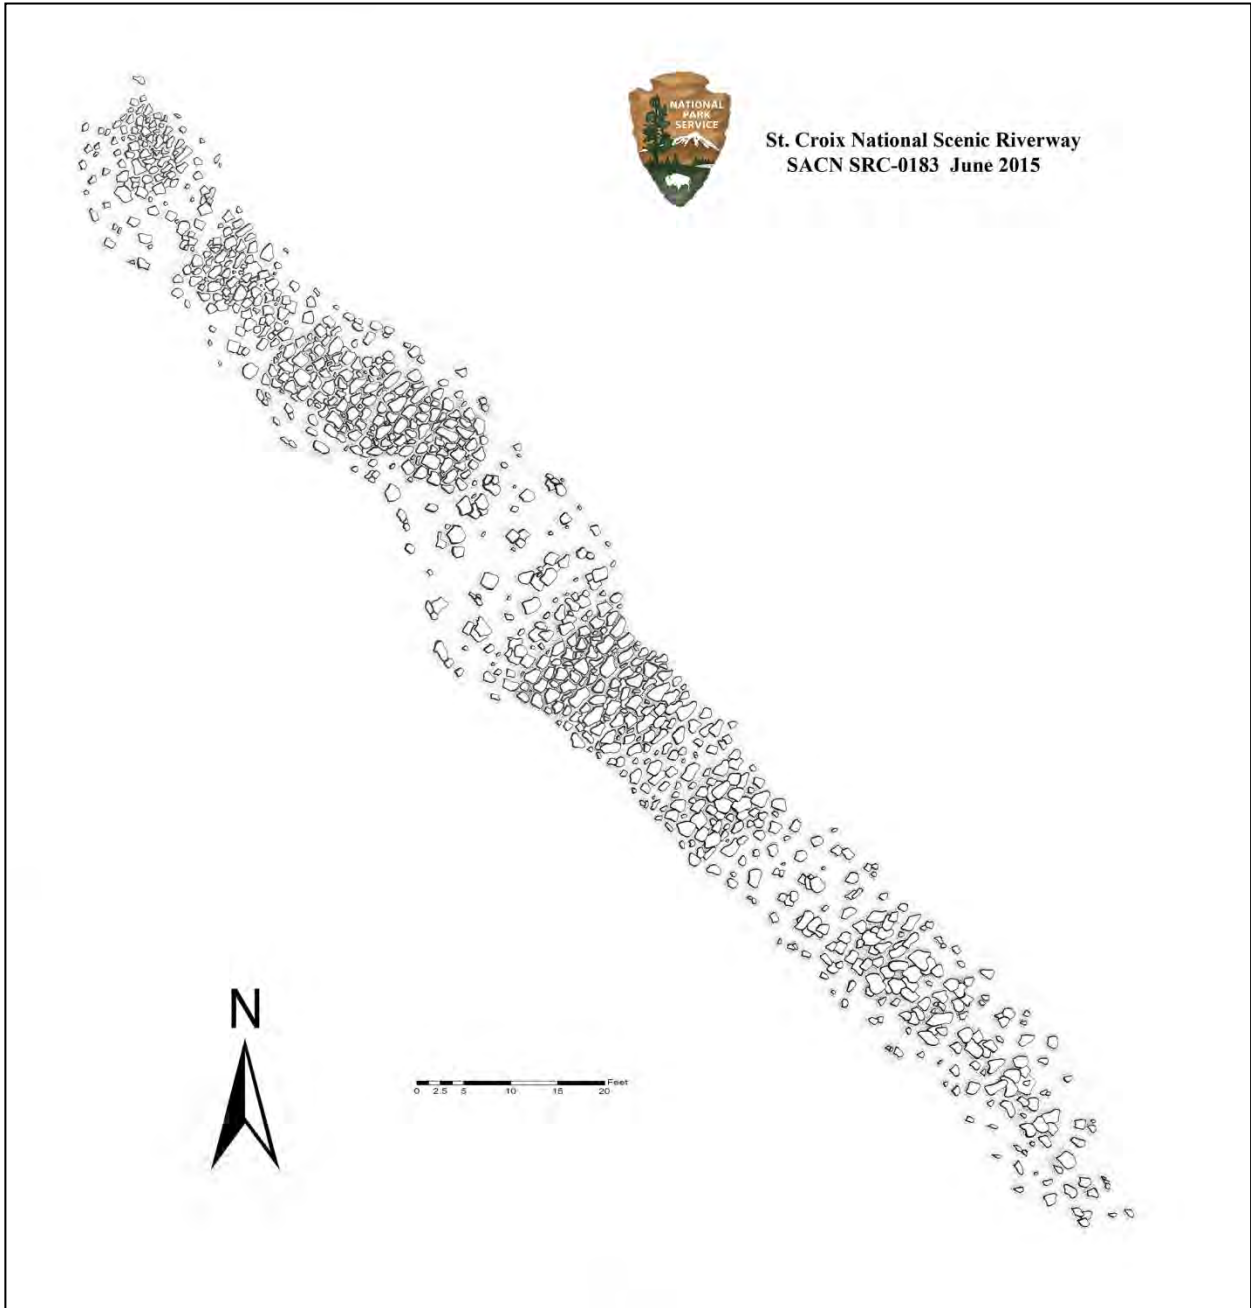
FIGURE 139. Kelly's Slough site map.

GPS target 115 proved to be the remains of a rock closing dam, which was selected for mapping and photography (Figure 138). The team established a 167 foot long baseline, at a compass bearing of 140 degrees. The dam itself was composed entirely of rocks, with very little relief. The mapping team took baseline offsets every ten feet to indicate the perimeter of the dam. They also acquired depth measurements every ten feet along the baseline, but changes in relief along the entire structure were limited to approximately one foot. Total Station and GPS points were acquired as well. Once all measurements were complete, the site was mapped on Mylar, and later inked (Figure 139). No other GPS targets at Kelly's Slough were associated with cultural remains.

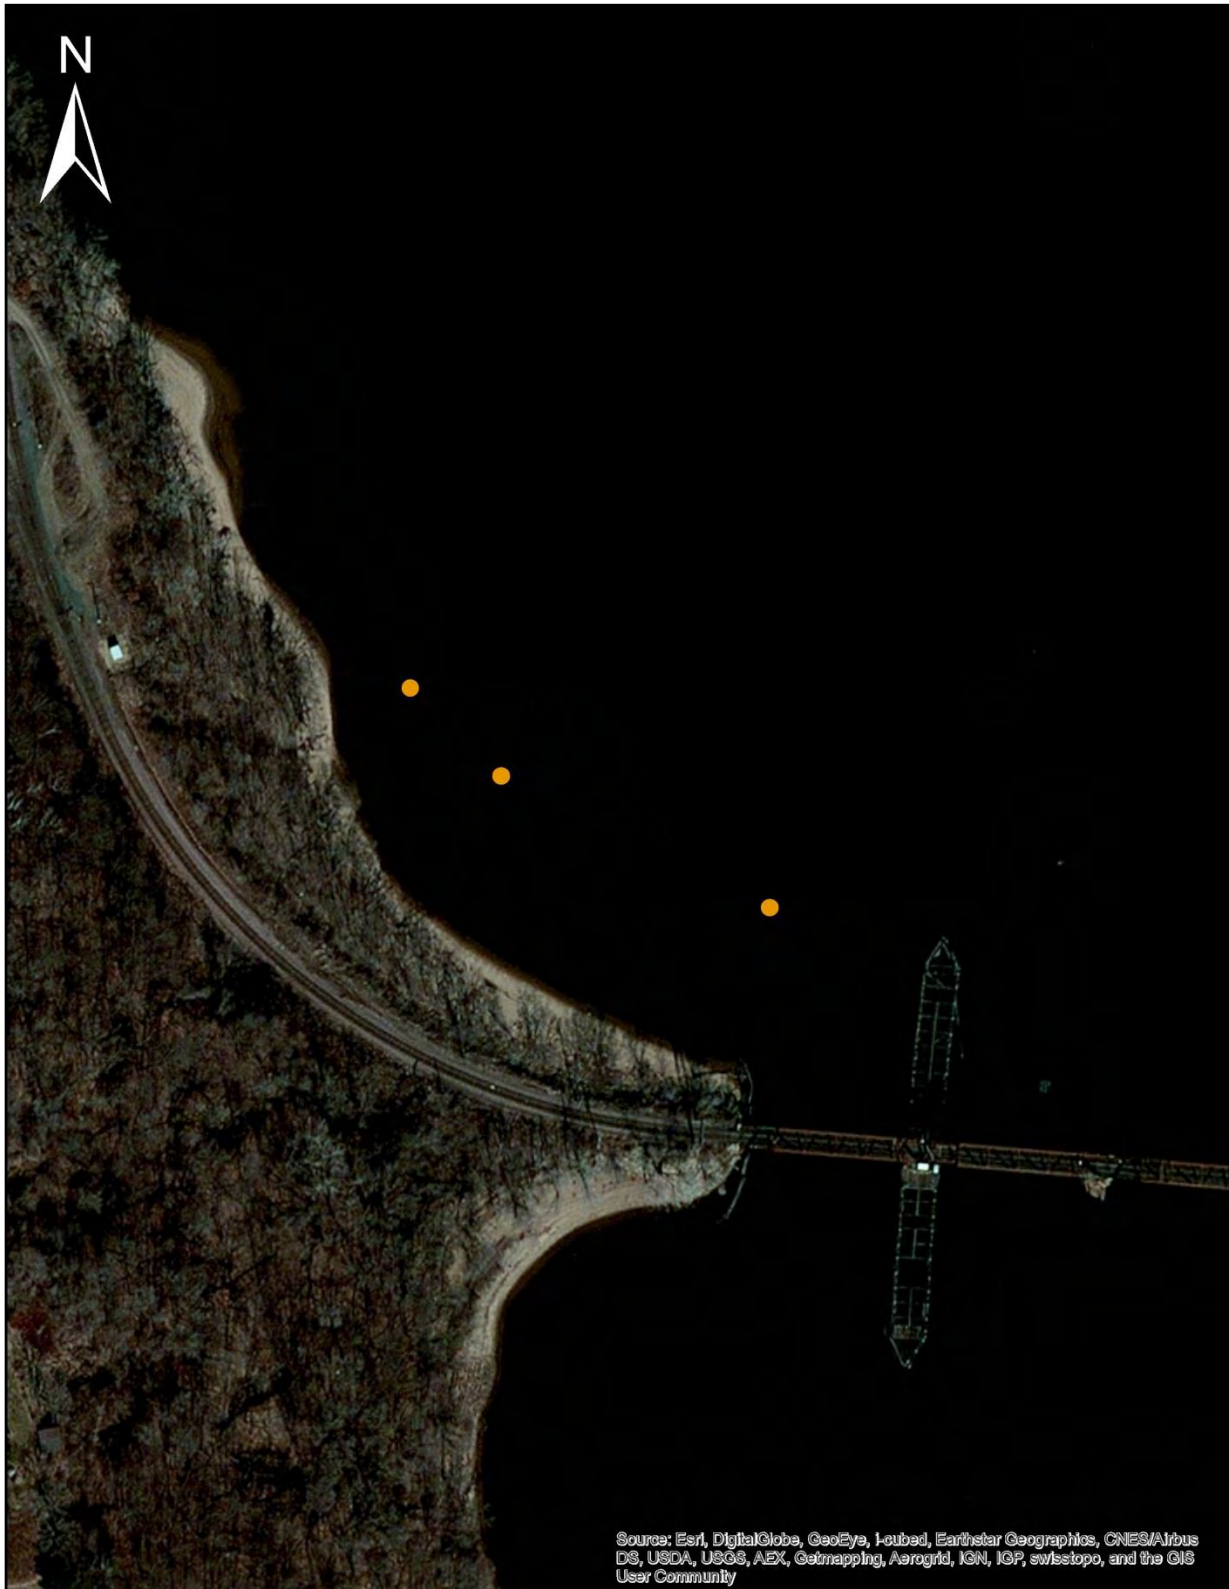
Using the detailed locational and descriptive information expressed by the historical documents above, the survey team was able to direct their efforts to a primary focal point in the Hudson area (Figure 143). Sonar imagery was collected along the bar above the still-present trestle railroad bridge. This imagery revealed the probable location of the historic dam structure, based on bottom contours (Figure 144).

FIGURE 143. ESRI aerial map with Hudson GPS targets.

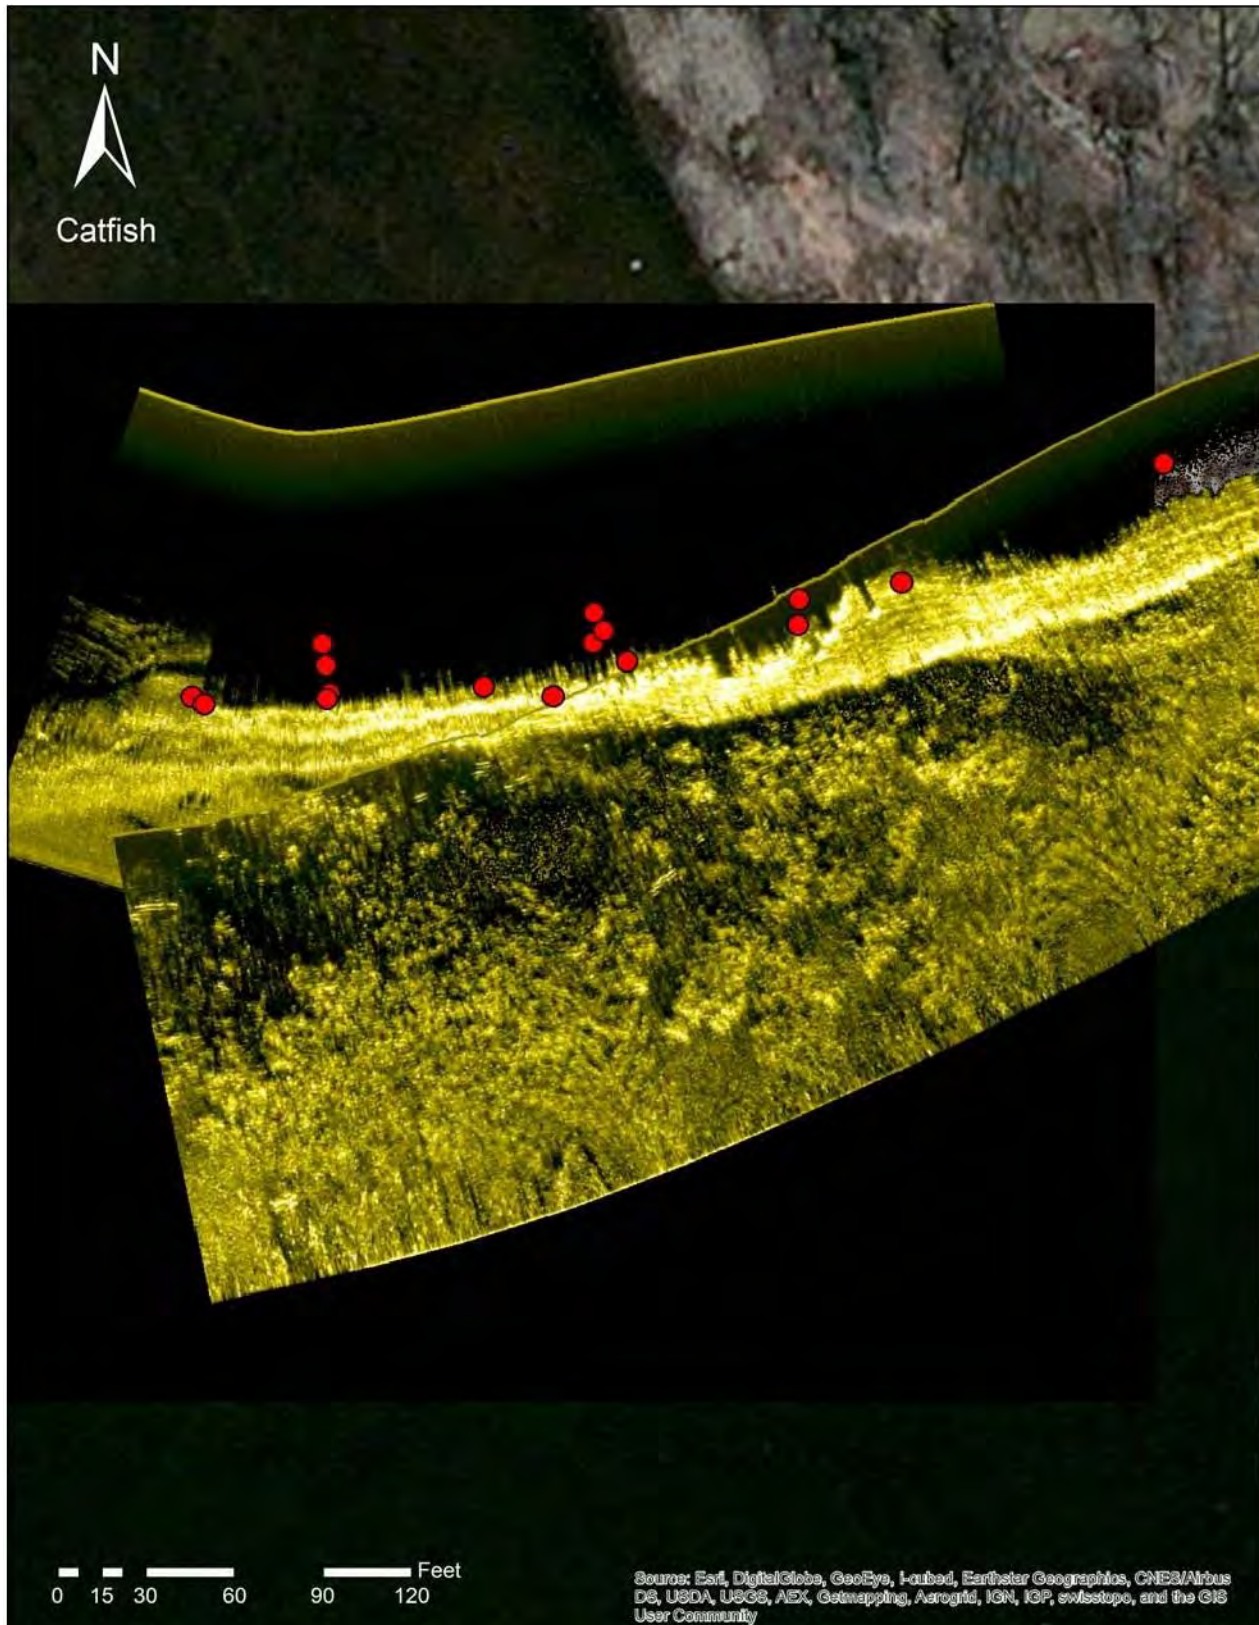
The 2015 survey team used the historical data above to isolate their survey patterns along the Minnesota bank at Catfish (Figure 147). The sonar imagery revealed the remains of the wing dam (Figure 148). Divers investigated and systematically searched the area designated by the sonar, but the structure was covered entirely with sediment. They identified clear extents of the structure, however, and took nine GPS coordinates defining the site for depiction in ArcGIS (Figure 149). Additional sonar GPS targets were added during post-processing to aid in the delineation of the structure, and topside photos were acquired at the site (Figures 150 and 151).

FIGURE 148. The sonar imagery from Catfish dam showing both sonar and handheld GPS points.

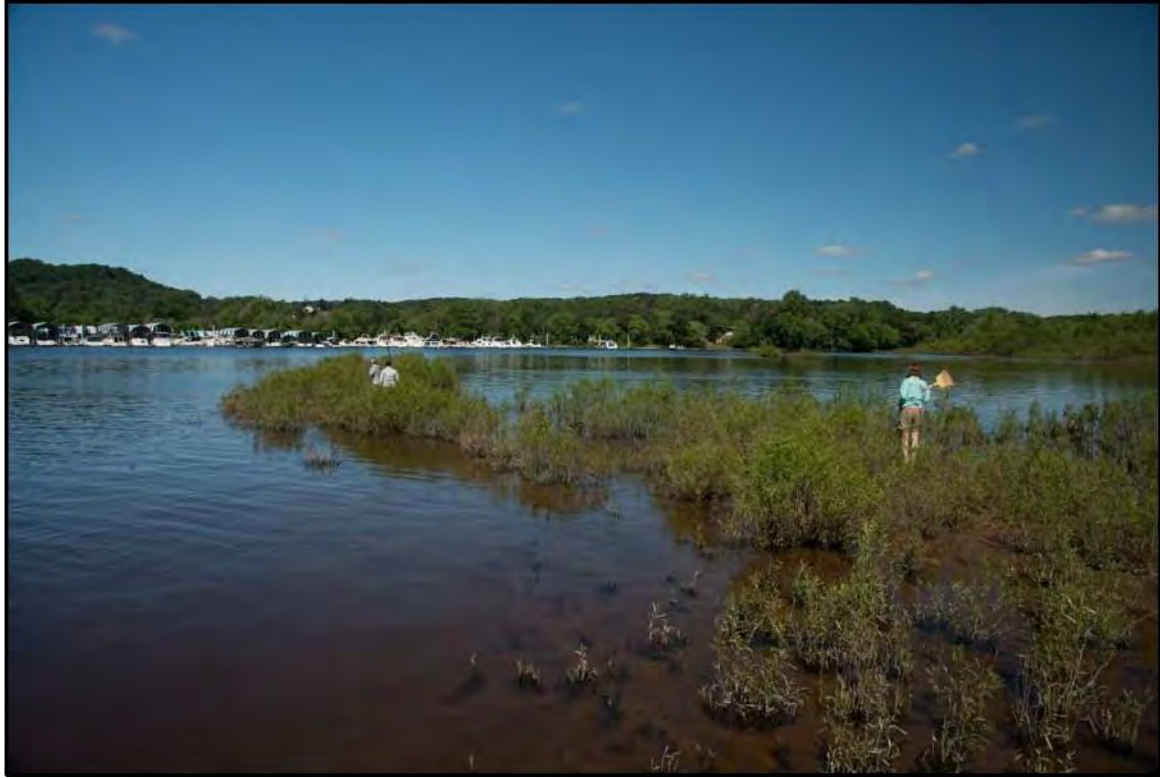
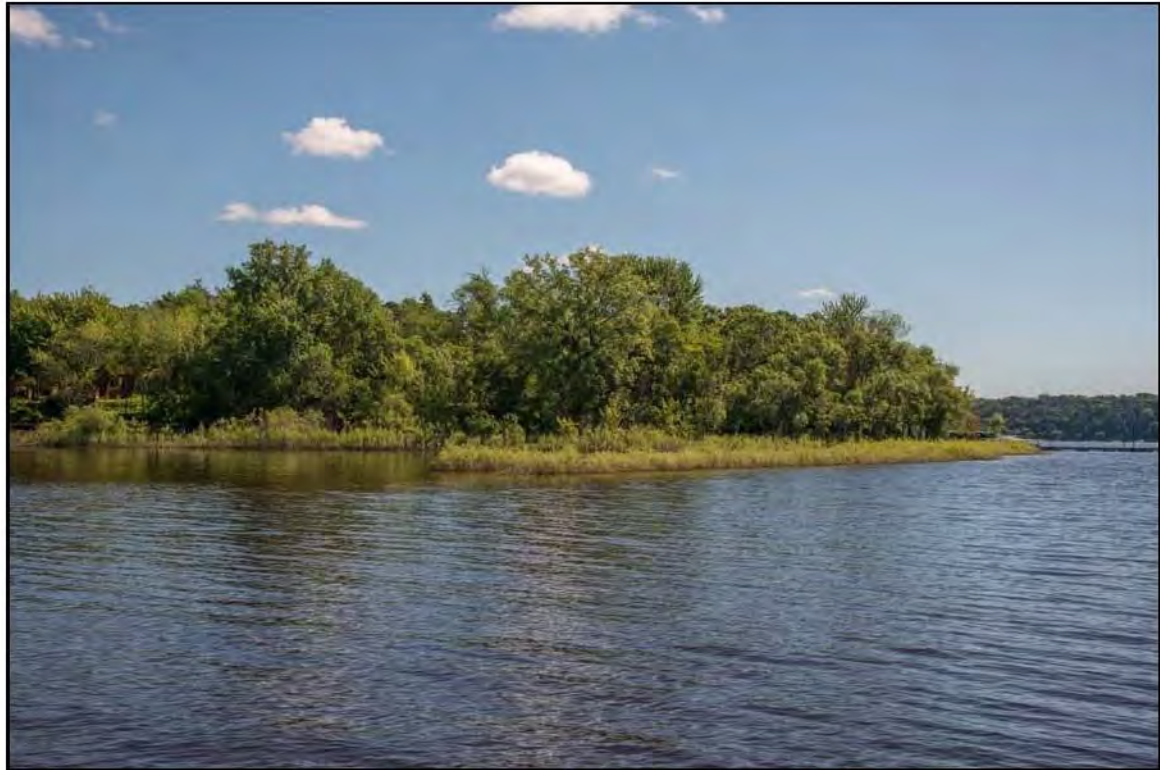
FIGURES 150 and 151. Images from Catfish showing the sediment-covered remains.
