## *St. Croix National Scenic Riverway*

### *Ruins of a Forgotten Highway: Survey and Documentation of Historic Water Control Features*

A product of the National  
Park Service Submerged  
Resources Center

Denver, Colorado  
2015

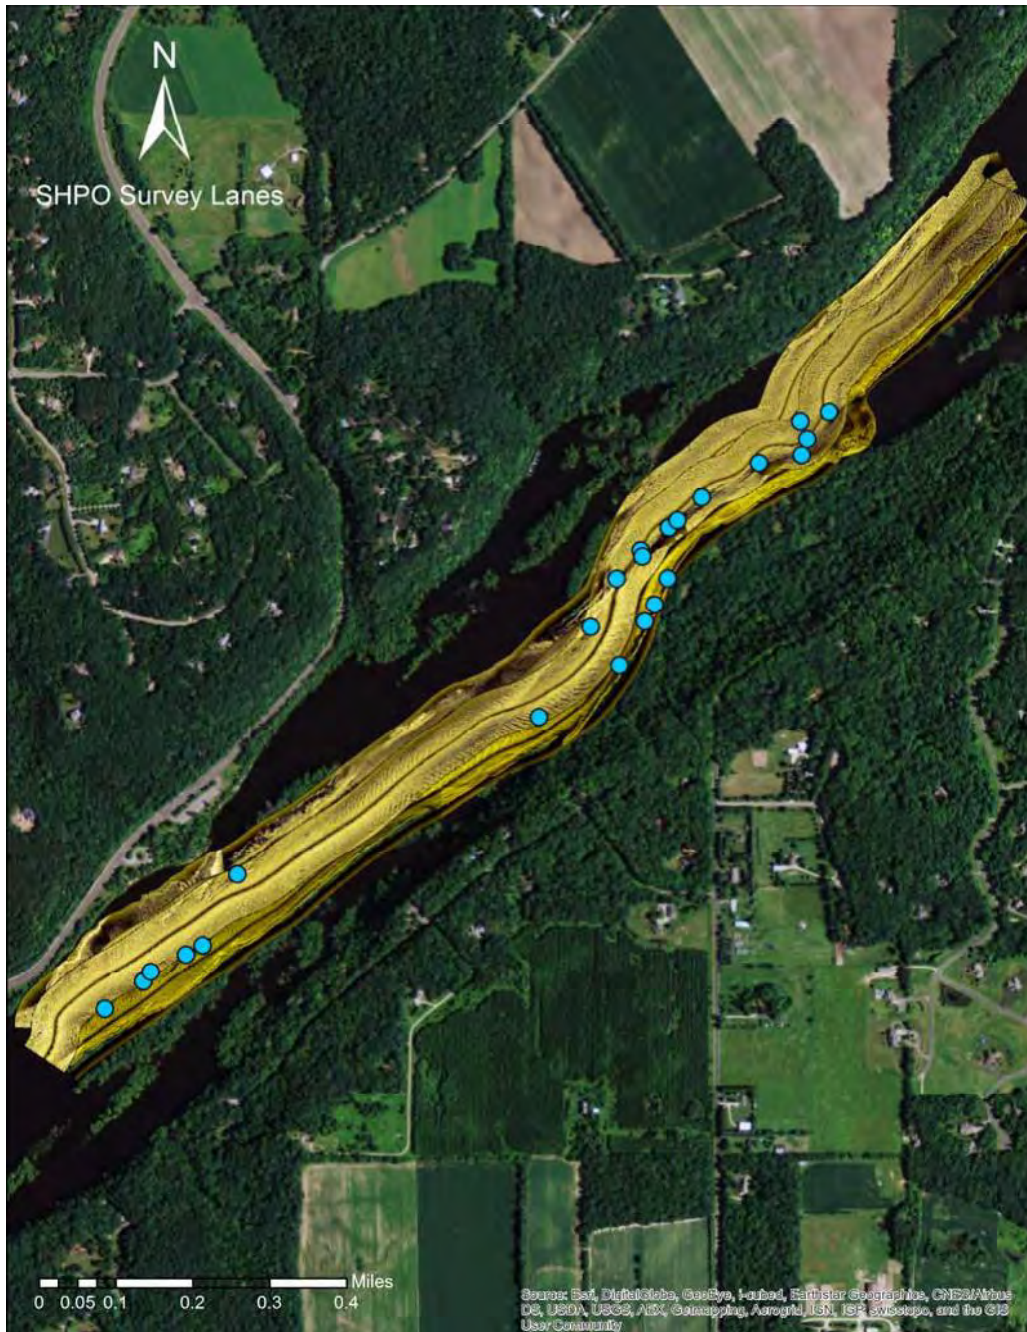
Per the request of the Minnesota SHPO, the Stillwater Boom Grounds were surveyed with side scan sonar (Figures 152 and 153). Approximately 0.25 square miles (1.7 miles along the river) were surveyed and resulted in the identification of 23 possible targets (Figures 154 and 155). Physical investigations of these targets were not requested by SACN during this project. The locations of the targets are listed in a separate Excel spreadsheet from the rest of the project's targets and results. Reference to the Boom Grounds may provide insight to the targets once investigated (Figures 156 and 157).

FIGURE 152. ESRI aerial map with the Stillwater Boom Ground sonar survey and identified targets.

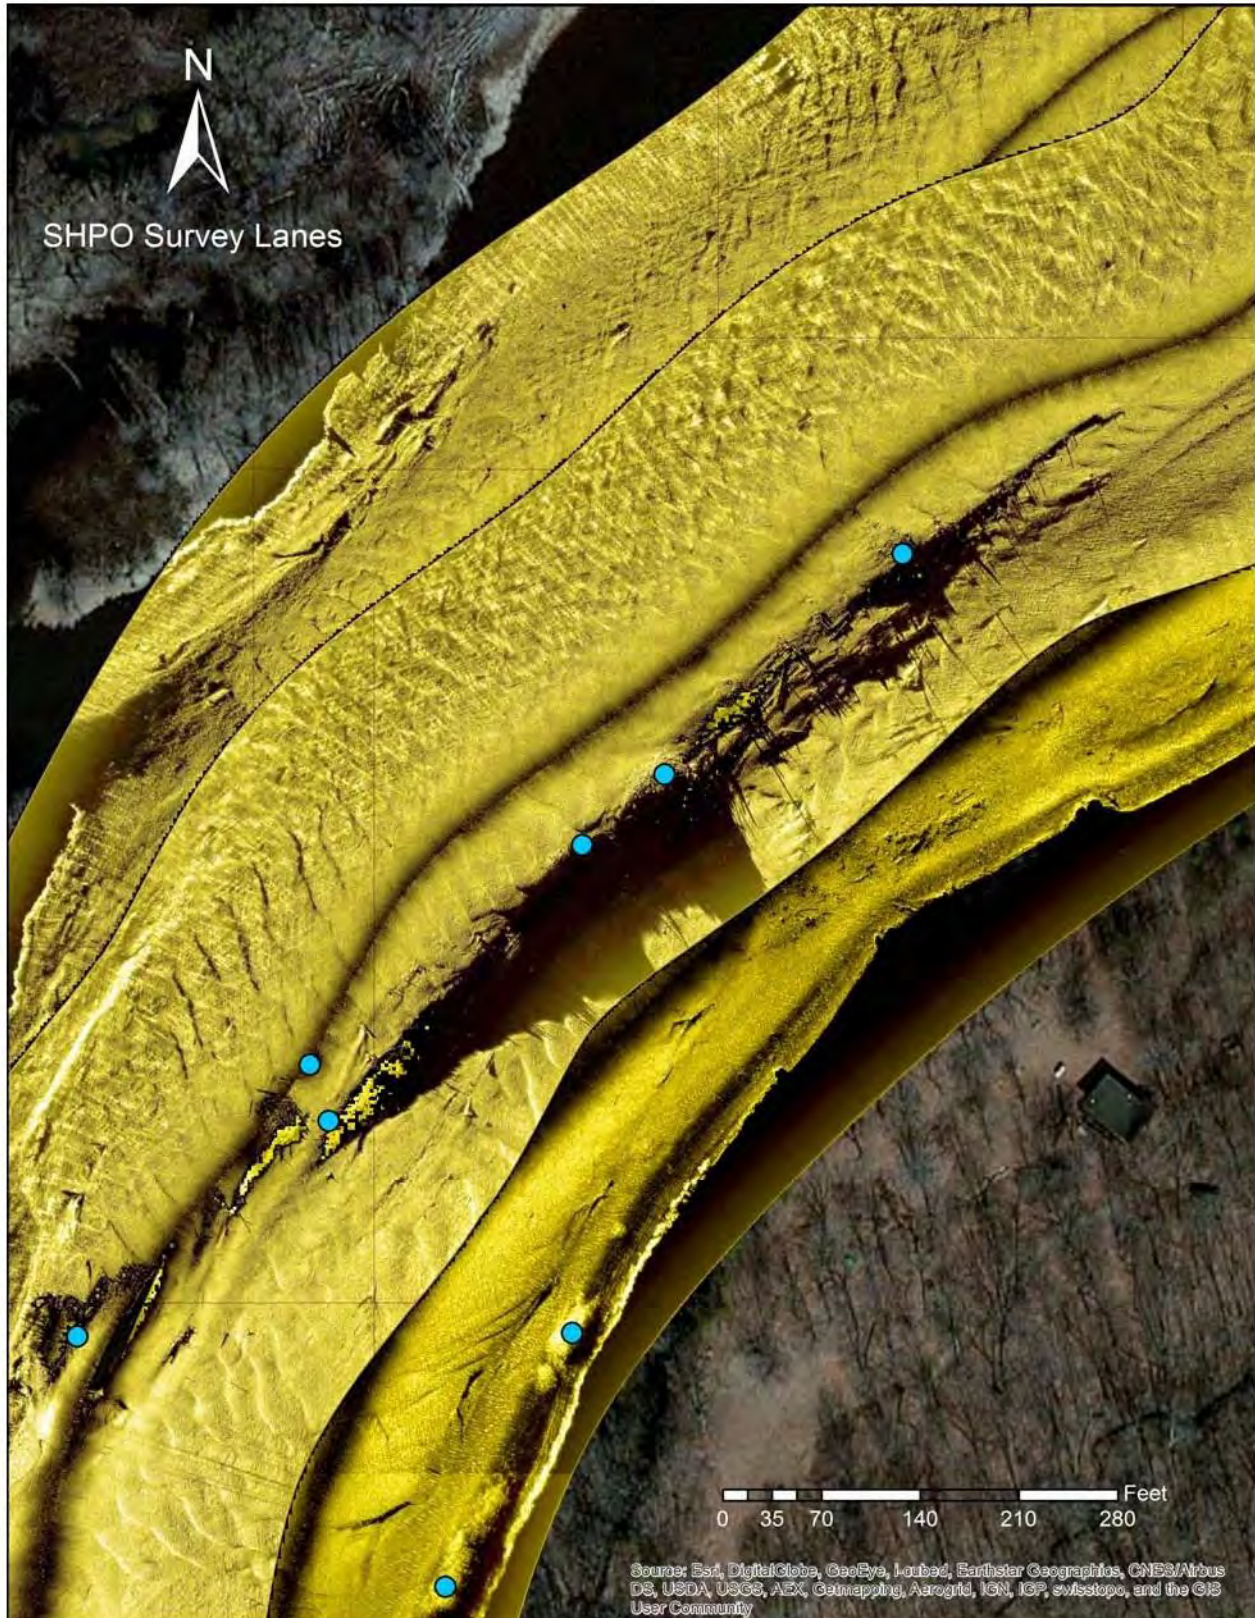
FIGURE 153. A section of the sonar imagery showing a number of targets in the Stillwater Boom Grounds.
